# **ELECTRICAL INCIDENT REPORT**

## **BUSHFIRE NEAR RIVER and FOLEWOOD ROADS TOODYAY WESTERN AUSTRALIA 29 DECEMBER 2009**

15 February 2010

EIS 2009-2630

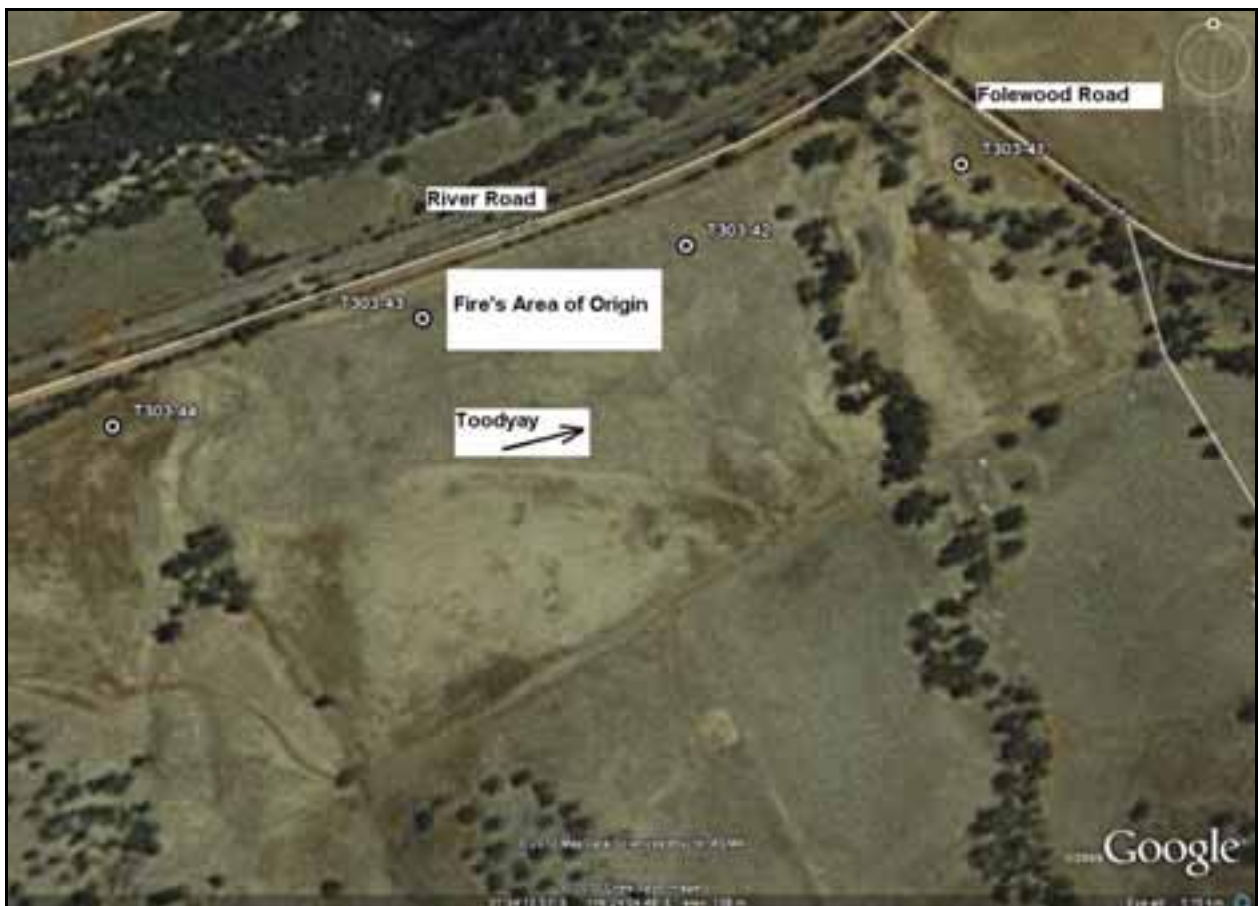
FESA and WA Police Arson Squad fire investigators have tracked the bushfire's path back to an "area of origin"<sup>1</sup> but the exact "point of origin"<sup>2</sup> was not able to be established. The area of origin is in the vicinity of Western Power's T303 spur power line between wooden poles numbered T303-42 and T303-43. The satellite image below shows the location of these poles (prior to the bushfire) and the bushfire's area of origin.
