Government of **Western Australia**  
Department of **Commerce**  
*EnergySafety*

## **2008 DISTRIBUTION WOOD POLE AUDIT REVIEW**

**A Review of Western Power's Response to the  
2006 Regulatory Compliance Assessment of Western Power's  
Distribution Wood Pole Management Systems**

**May 2009**

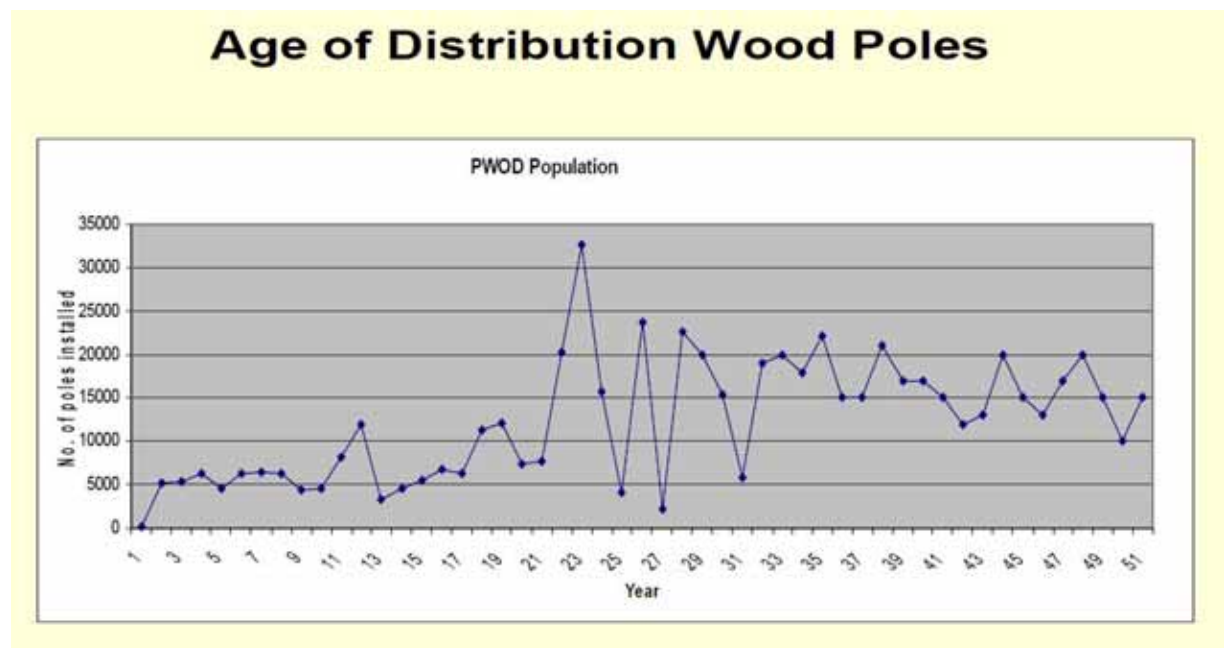
### Distribution Wood Pole Age Profile - Network Performance Seminar 11 June 2008

Clearly, the oldest poles at the right hand of the chart should be replaced first. There may be some debate about the significance of the highs and lows in the chart, but the inescapable conclusion is that such older poles should be replaced immediately, with the work continuing for at least 25 years at 15,000 poles per annum. All the poles older than about 28 years are

untreated jarrah with service lives of 15-25 years un-reinforced and 40 years reinforced<sup>12</sup>. Untreated jarrah poles older than 25 years should either be replaced, or if suitable, reinforced. All untreated jarrah poles older than 40 years should be replaced immediately.
