ENVIRONMENTAL INCIDENT REPORT
WESTERN BASIN DREDGING AND DISPOSAL PROJECT
 Incident No. 008 Hydraulic Oil Spillage Multicat Voe Jarl

Report: Hydraulic Equipment and Hoses Vessel: Heron October 2011

ENVIRONMENTAL INCIDENT REPORT

Incident No. 010 Hydraulic Oil Spillage BHD Simson

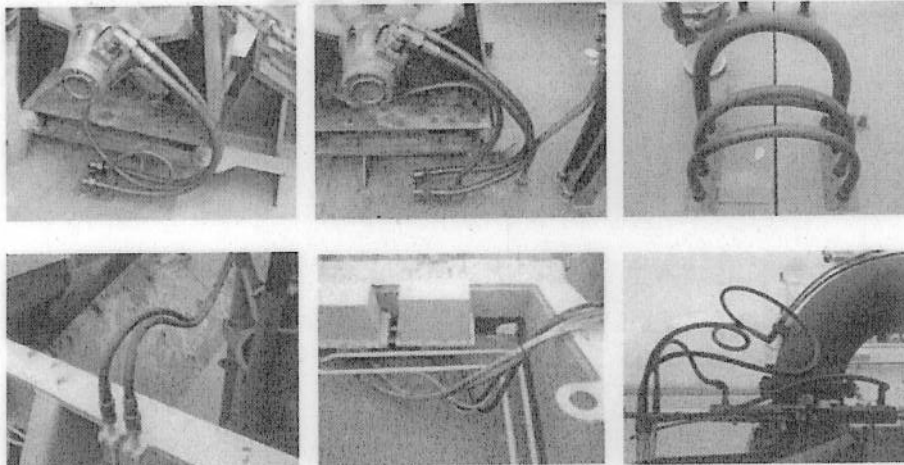
- The vessel inspected was Heron on the 5th October 2011.
- This vessel is in good condition.
- The vessel hydraulics has been maintained and needs to stay maintained.
- Slight hydraulic leaks on steering, will need to be monitored to insure leak does not increase.

All components on the vessel are in good condition and the vessel has been maintained. Speaking to the crew on board has kept the vessel in good working order.

- It is important that the existing hydraulic components be maintained.
- Visual inspection should be performed regularly to ensure hydraulic components stay in good working order.
- If leaking on steering ram increases to make arrangements to remove and repair.
- Small hydraulic leak on door ram needs to be monitored.
