**TRAFFIC MANAGEMENT REPORT**

**PARLIAMENT DRIVE**

**ROAD SAFETY ASSESSMENT**

R D Gossip Pty Ltd Pty Ltd  
2 Lawry Place  
Macquarie ACT 2614  
Australia  
Telephone :+61 2 6251 6313  
Facsimile :+61 2 6253 1989  
Date : 30 August 2007  
Reference : Report RG 06055-2/0  
Status : Final

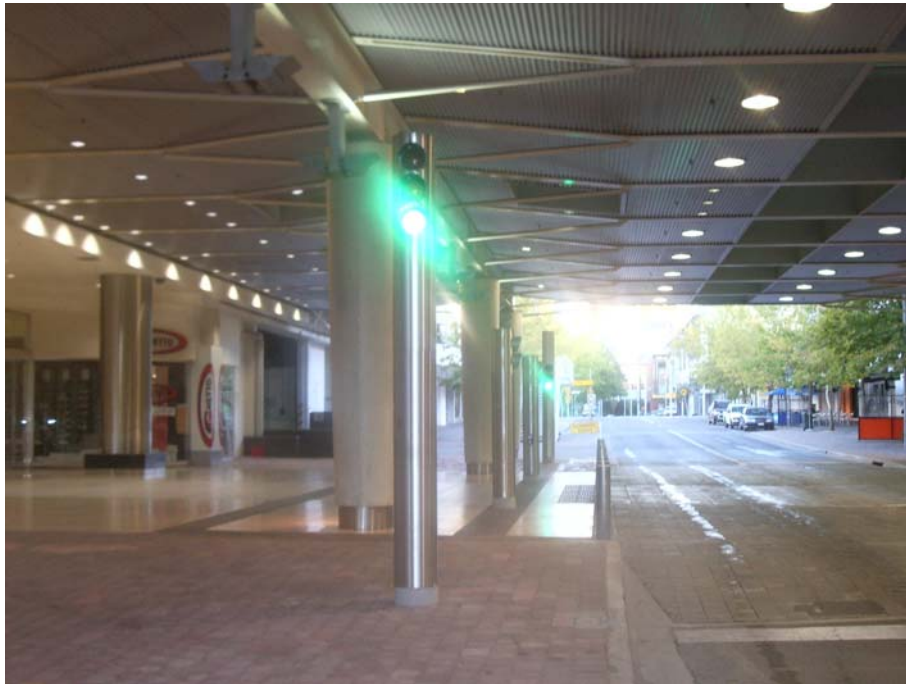
Stainless Steel traffic signal hardware used on Bunda Street at the Canberra Centre.

- 4.3.9 Additionally new styles of signals are available to provide improved aesthetics. Stainless steel signal hardware has recently been installed at the crossing of Bunda Street at the Canberra Centre.
- 4.3.10 This hardware could be adopted for use in the Parliament House precinct providing an architectural link with other external features of Parliament House and its surrounds.
