Project  
Water Fountain Waterproofing Scoping  
Study

Client  
High Court of Australia,  
Parkes Place, Parkes ACT

Prepared by  
Hoadley Budge Olphert & Edwards  
Madigan Torzillio Briggs Pty Ltd  
ABN: 41 091 139 972

# High Court of Australia Water Fountain Waterproofing Scoping Study

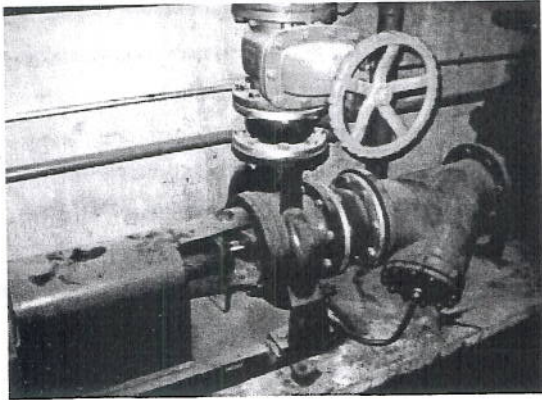
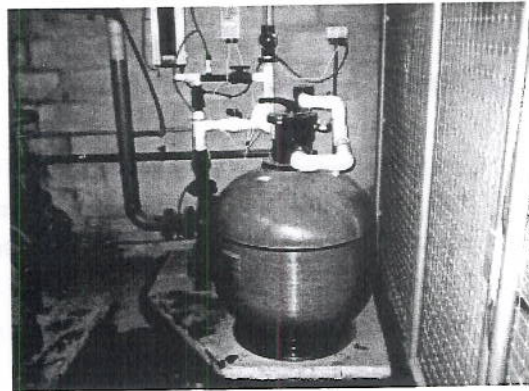
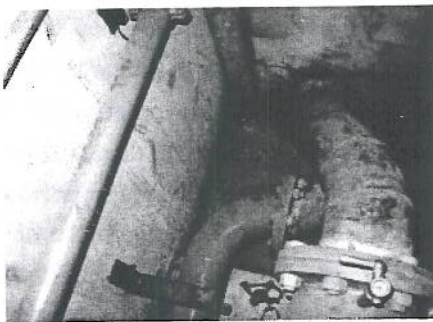
Based on the observations during our preliminary investigation there are several recommendations which relate directly to the proper function of the Water Feature and the integrity of the 'waterproofness' of the Source Pool, cascade pools, Holding Pool and Holding Tank. This integrity is relative to the soundness of the installed membrane in the pools and how that membrane still is an effective barrier to water egress from the Water Feature, and how the Water Feature acts as a source of water which appears to escape from the pools to the east, via the ramp membrane screed and trench drains, albeit the membrane identified in these trench drains show obvious signs of failure.
