ATSB TRANSPORT SAFETY REPORT  
Aviation Short Investigations  
AB-2011-128  
Final

# Aviation Short Investigation Bulletin: Third Quarter 2011

Issue 7

Report No.	Publication date	ISBN
AB-2011-128	December 2011	978-1-74251-232-7

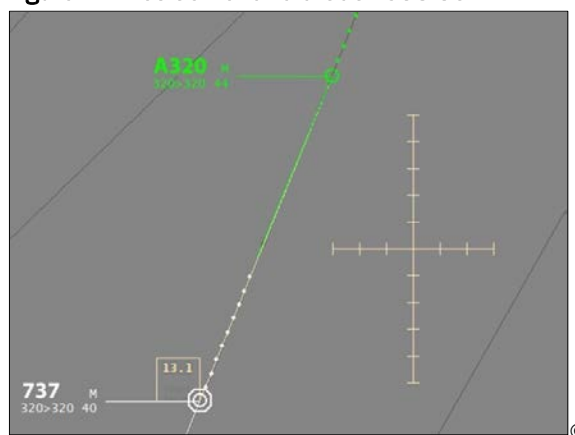
Figure 1: Position of aircraft at 1638:35

At 1638:35, the flight crew of the 737 contacted ATC and reported that their aircraft was maintaining FL320. The controller issued the flight crew with a Standard Arrival clearance to runway 25 at Sydney. At that time, the following A320 was 13.1 NM (24.28 km) behind, with a closing ground speed of 40 kts (Figure 1).

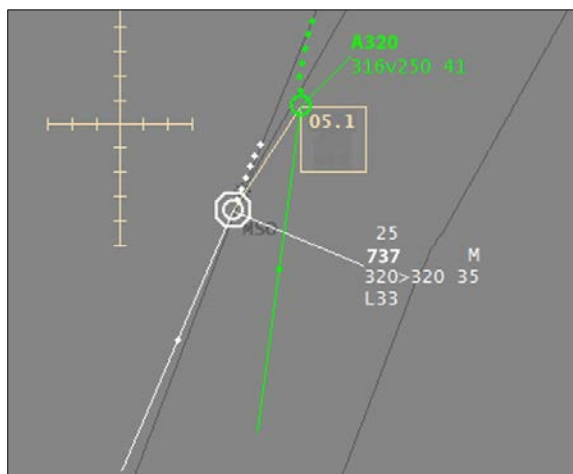
**Figure 2: Position of aircraft at 1648:27**

Separation between the aircraft closed to 5.1 NM (9.45 km) at 1648:27 as the A320 became established in the turn onto the assigned heading, before the distance between the aircraft began to increase (Figure 2).

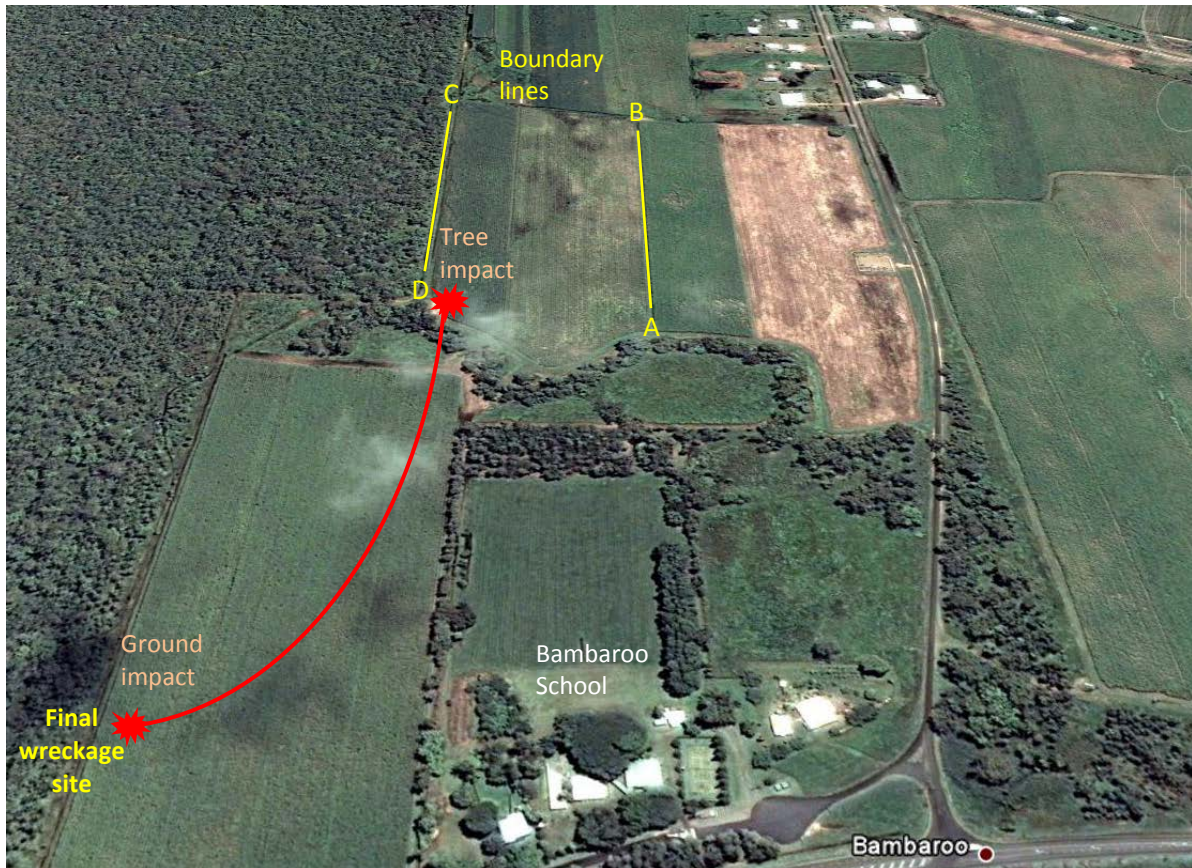
Figure 1: Spray field and ground impact site

Although the pilot's injuries were serious, his being securely restrained and wearing a helmet significantly reduced the potential level of injury.

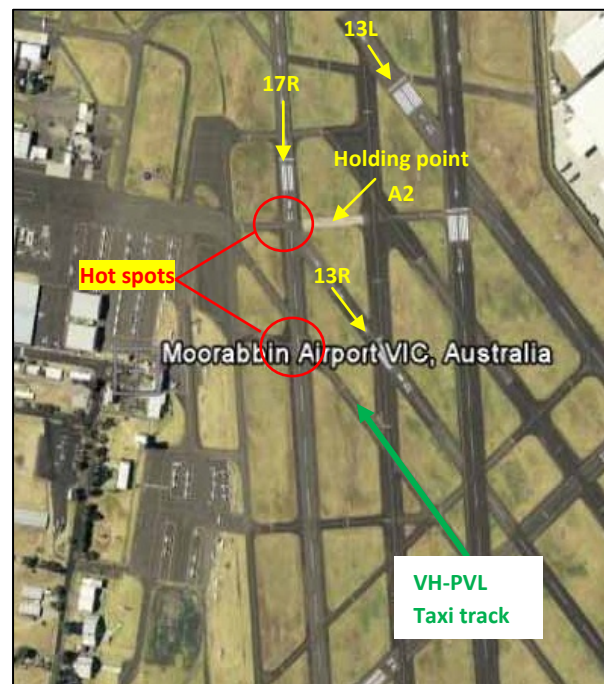
Figure 1: Moorabbin Airport

Aerodrome Controller (ADC) who instructed BZE to cancel the takeoff and exit the runway via the first taxiway. BZE was taxied back to the apron and parked. PVL also continued taxiing to the apron and parked (Figure 1). The instructor of PVL reported the aircraft came within 100 m of each other before stopping.

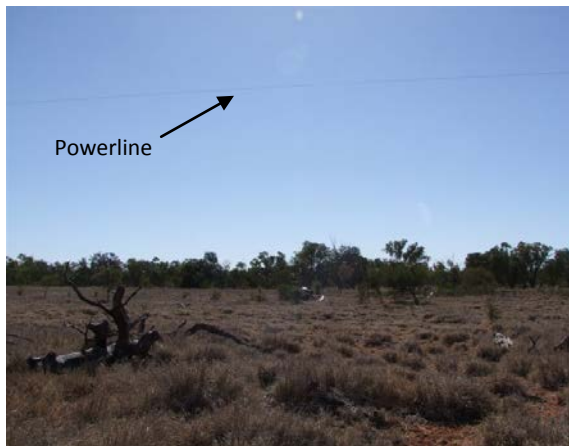
Figure 3: Powerline above ground level

the powerline at the point of collision to be about 8-9 m above the ground (Figure 3).
