ATSB TRANSPORT SAFETY REPORT
Aviation Short Investigations
AB-2011-128
Final

Aviation Short Investigation Bulletin: Third Quarter 2011

Issue 7

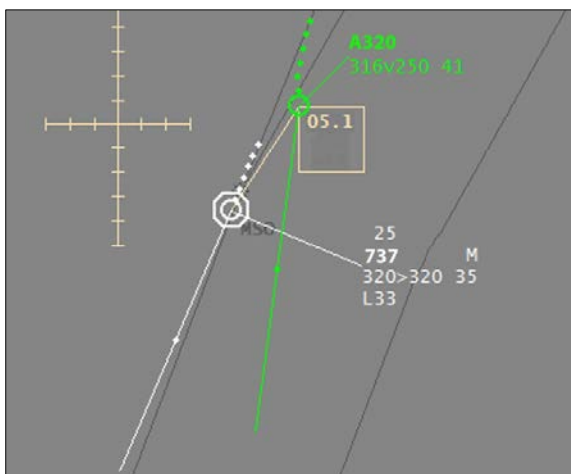
Figure 2: Position of aircraft at 1648:27

Separation between the aircraft closed to 5.1 NM (9.45 km) at 1648:27 as the A320 became established in the turn onto the assigned heading, before the distance between the aircraft began to increase (Figure 2).

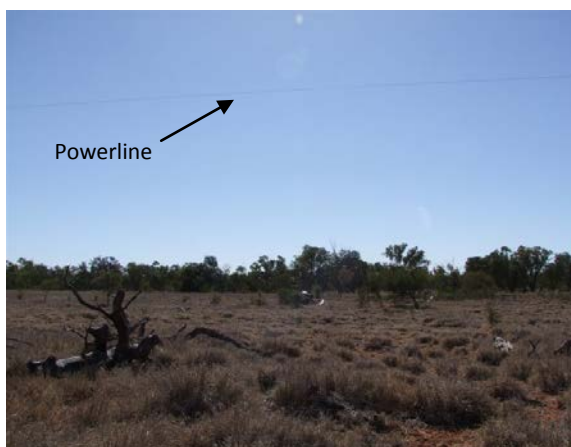
Figure 3: Powerline above ground level

the powerline at the point of collision to be about 8-9 m above the ground (Figure 3).
