Thank you for sending through your photos of Barmah-Millewa Forest (attached for reference). We have followed up the causes behind the stands of dead river red gums with one of our colleagues in the NSW government who has a long working history in Millewa Forest. Their response follows.

Jody Swirepik
Commonwealth Environmental Water Holder

2 March 2020

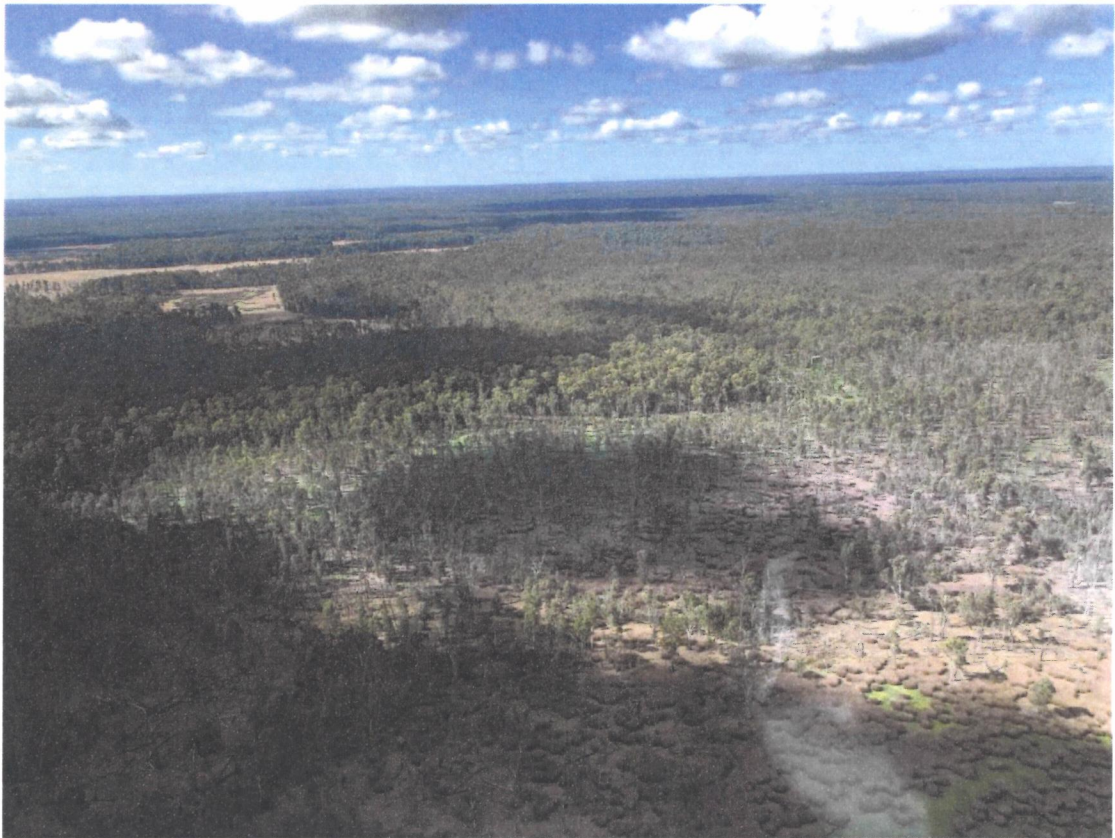
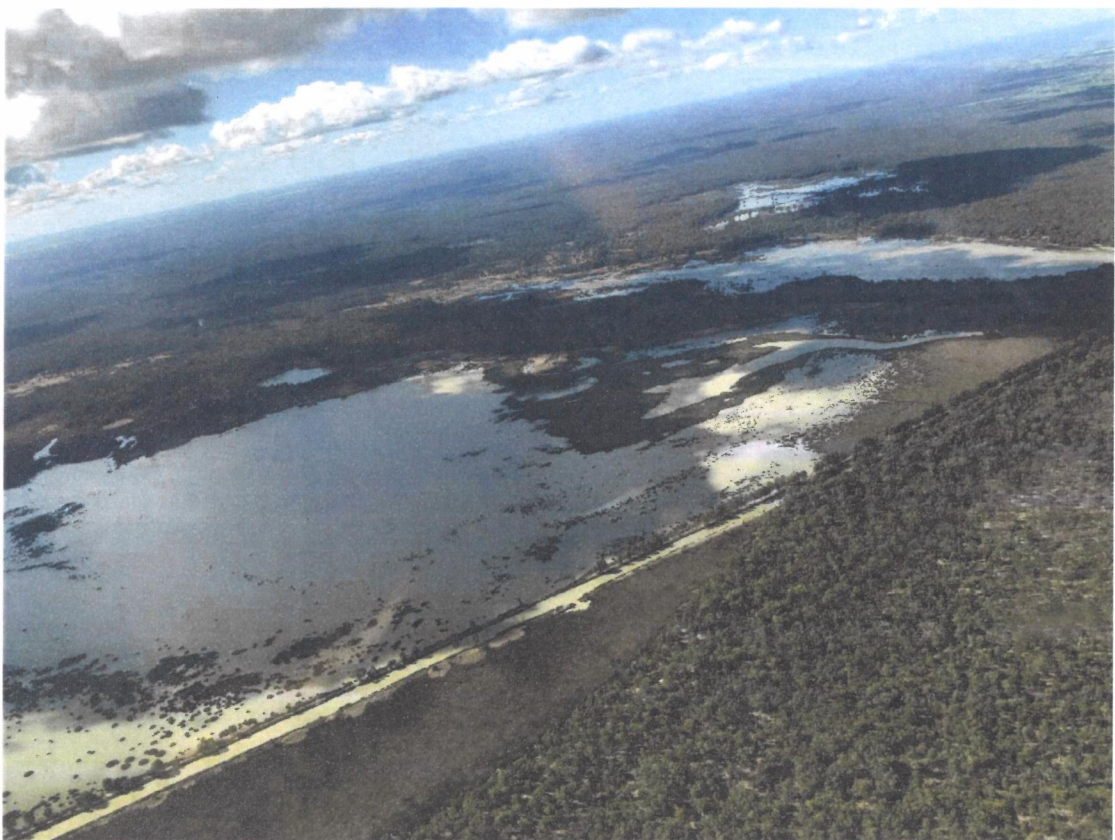
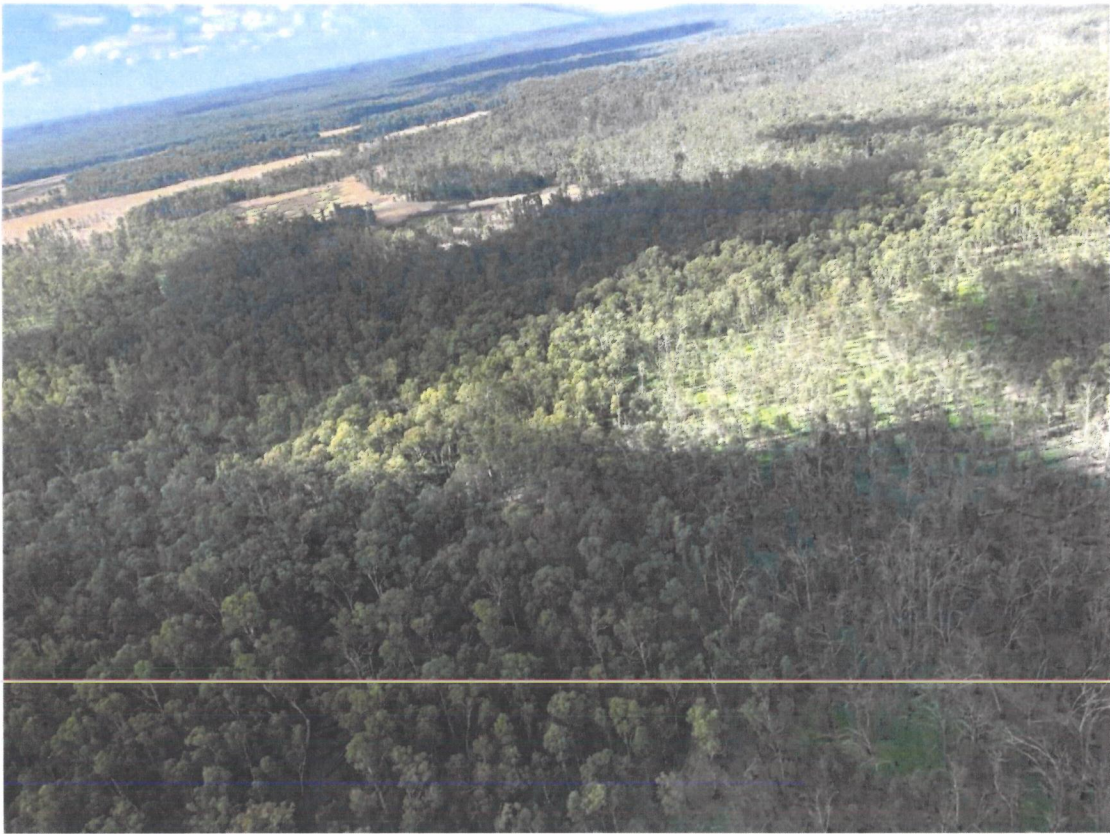
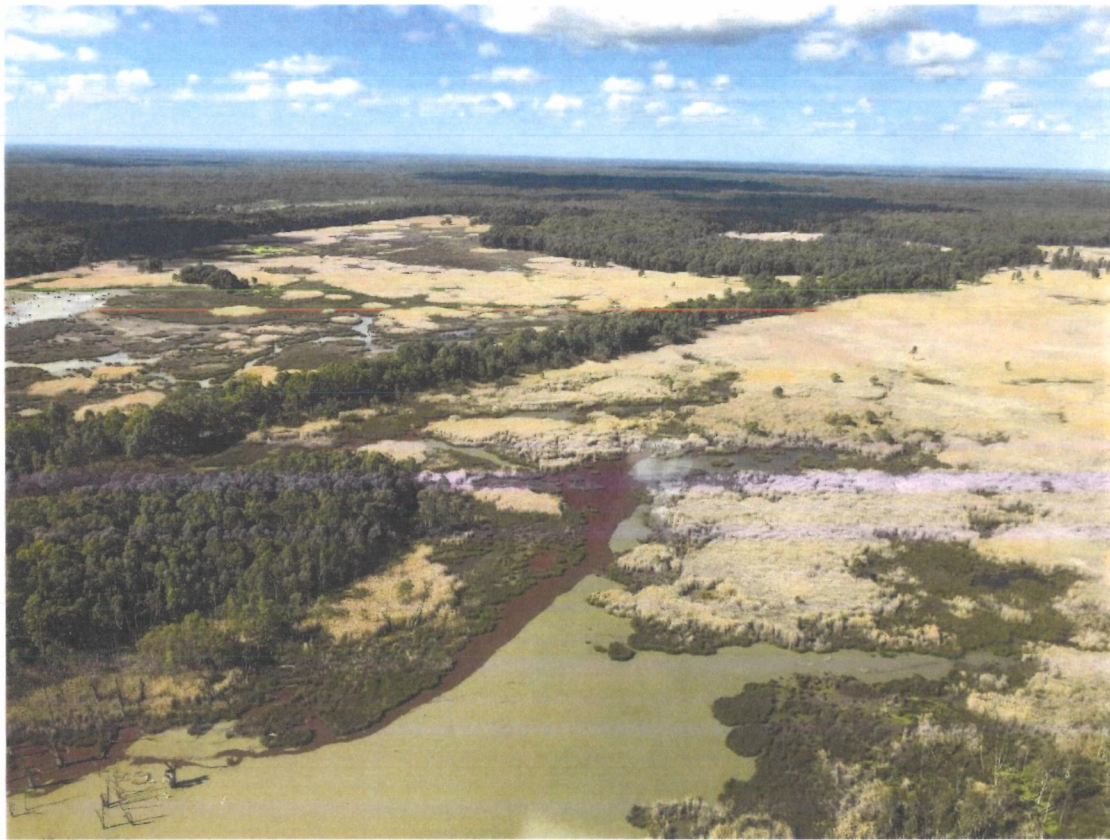
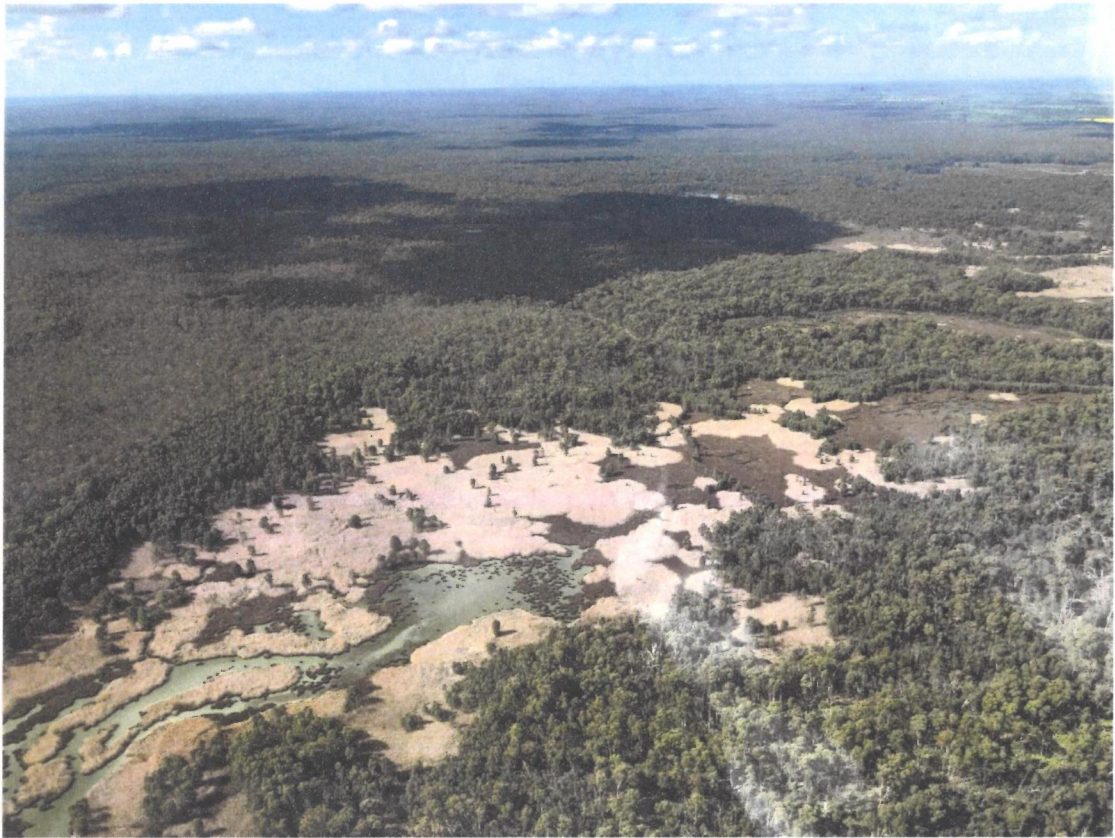
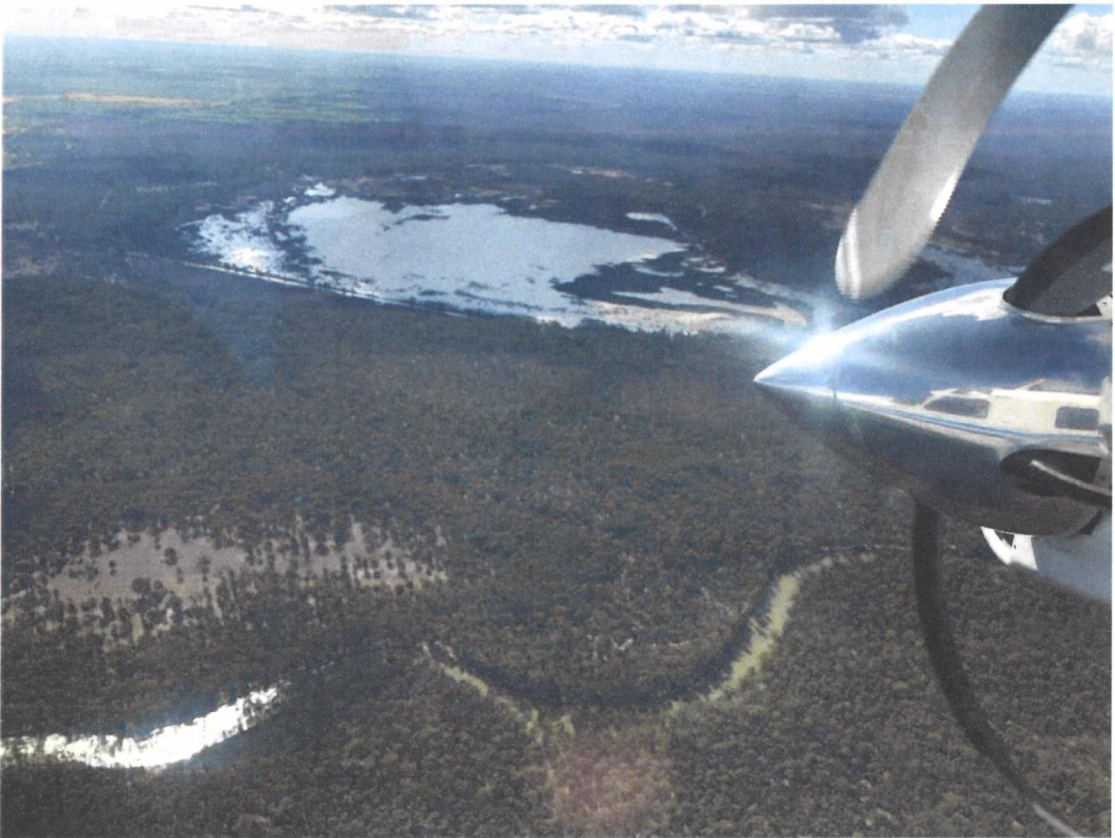
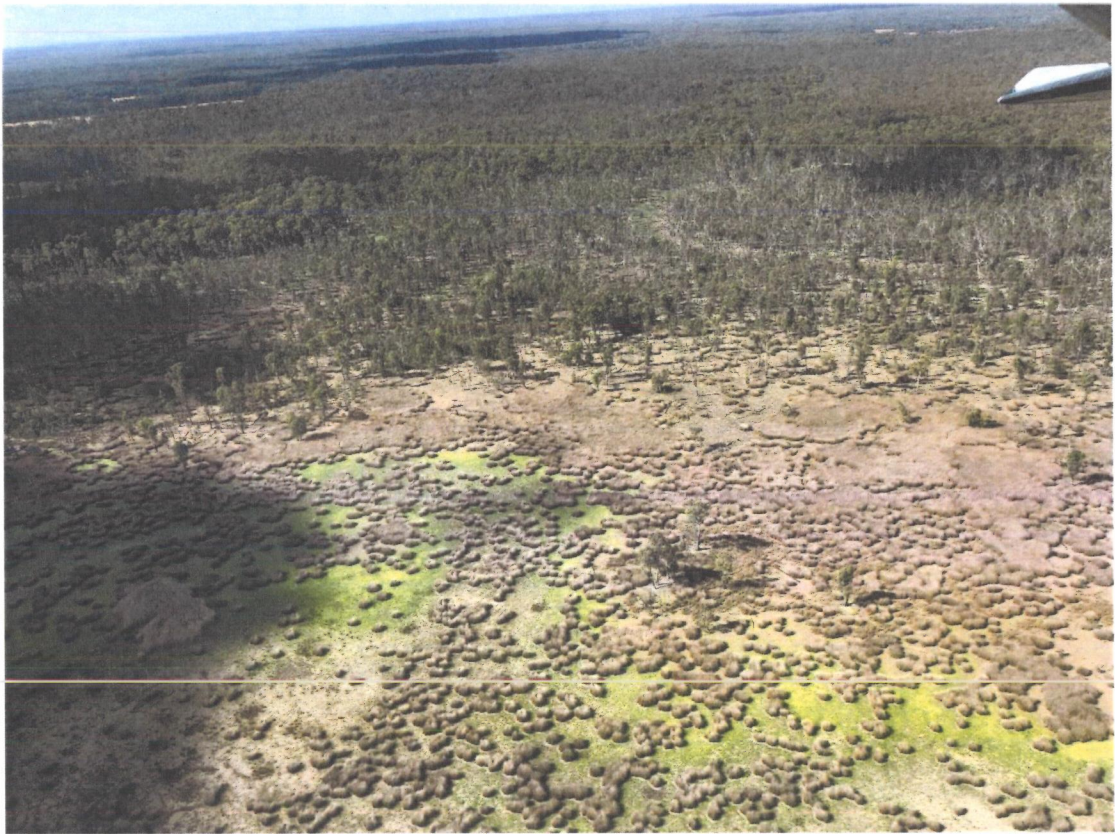
The photos were taken at sites where trees were killed by wildfire at Coppingers Swamp-Duck Lagoon in 2008 and around Moira Lake in 2005. Both fires killed large areas of river red gum forest, including many very large mature trees.

The photos also show stands of river red gums in Millewa that died 60-80 years ago as a result of permanent inundation during the early days of river regulation, i.e. from the 1940s. These dead stands are located in wetlands such as St Helena, Reed Beds, Black Swamp, White Swamp and Little Edward. One of the main reasons why the forest regulators were installed along the Murray River, Edward River and Gulpa Creek from the 1950s onwards was to restrict unseasonal flooding of the forest in summer and autumn from irrigation deliveries.

The photos also show large areas of previously open (tree-less) floodplain that have been lost to river red gum encroachment (e.g. the Moira grass plains). This has been a consequence of river regulation, where the open areas were previously maintained by annual flooding (seedlings were drowned by successive floods), but nowadays the overbank events are of smaller magnitude, are less frequent and much shorter duration, which has allowed river red gums to germinate and establish in areas of floodplain where they did not occur under natural conditions.

No mature stands of river red gums have been killed or negatively affected by environmental watering which occurs at a seasonally appropriate time. Only a relatively small area of Barmah-Millewa Forest can be watered due to the current flow constraints (approximately 25 per cent of the total forest area). Therefore, a large proportion of Millewa Forest is presently severely drought stressed. There are stands of trees located on more elevated sites that are extremely stressed and many trees appear to have died.

We aim to emulate the annual winter-spring flooding and summer-autumn drying regimes that would have occurred naturally (prior to river regulation). This is why we open the forest regulators into Barmah-Millewa Forest in early July and close them at the end of December (sometimes earlier) each year. This operating strategy allows a drying phase to be achieved for the forest, but also provides connectivity for native fish over the spring breeding period. We also aim to hold water in some of the forest creeks (such as the Toupna Creek) to maintain drought refuge for native fish (especially threatened small bodied species and juvenile Murray cod and trout cod) and other water dependant species such as turtles, etc. River red gum trees would not be negatively affected by this watering regime.
