NATIONAL RADIOACTIVE WASTE MANAGEMENT FACILITY

Site Characterisation - Technical Report - Wallerberdina

Client: Commonwealth Department of Industry, Innovation and Science

20-Jul-2018

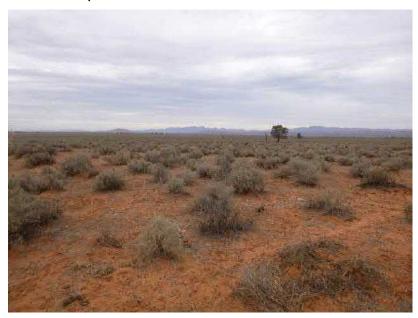
Figure 2 Wallerberdina Site 2 Chenopod Shrubland

Wallerberdina Station is a pastoral lease which has been historically stocked with sheep and cattle. Native vegetation present within the expanded Study Area comprises grazed Chenopod shrubland. The considerable history of grazing will have reduced species richness of native herbs and recruitment of juvenile chenopod species.

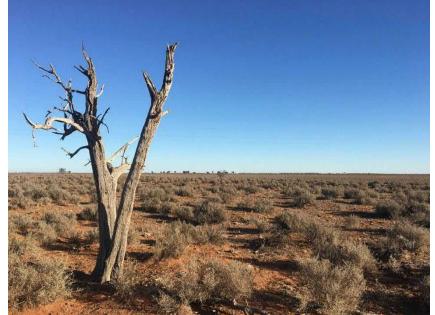
Figure 5 Representative photo of habitat within the site footprint

Habitat values within the Study Area were largely consistent with that observed within the site footprint with the exception of areas of tall open shrub land to the south- east of the site. These areas align with A2 and A3 vegetation mapping as described above.

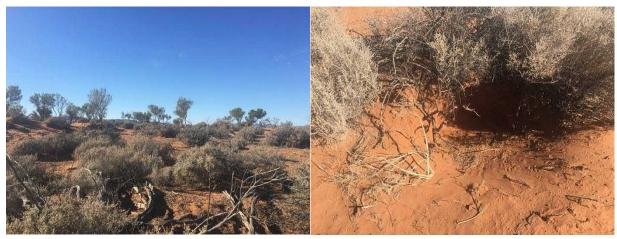
Figure 6 Open shrubland

The A2 area provided extensive areas of woody debris, perching and nesting opportunities for birds. Undulating terrain in this area provided further habitat complexity with depressions formed in the sand by sheltering animals at the base of tussocks prevalent and often positioned at the base of gentle slopes. The area was also noted to have prevalent scats and tracks though the majority are thought to have been left there by transient species such as kangaroos.

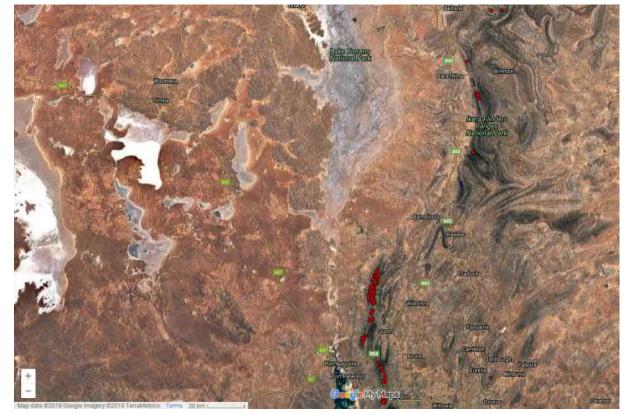
Figure 87 Pumped Hydro atlas, red circles indicate identified potential pumped hydro sites [29]

While pumped hydro is a form of storage, rather than generation, noted below is potential sites identified through studies recently conducted by the Australian National University. The image below shows the identified sites near the Wallerberdina region. The surrounding Flinders Ranges have potential sites nominated but the transmission between the pumped hydro sites back to the NRWMF at Wallerberdina would unlikely be cost effective.

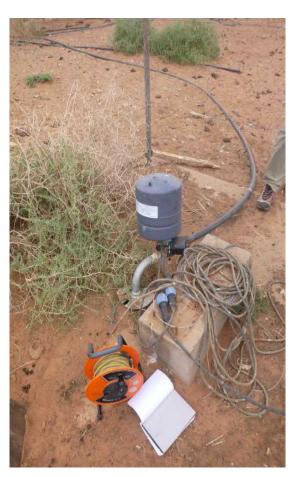
Close up of pump set up at well west of Hookina Creek (6534-269)
