**NATIONAL  
RADIOACTIVE  
WASTE MANAGEMENT  
FACILITY**

## Site Characterisation Technical Report - Lyndhurst

Client: Commonwealth Department of Industry, Innovation and Science

**AECOM Australia Pty Ltd**

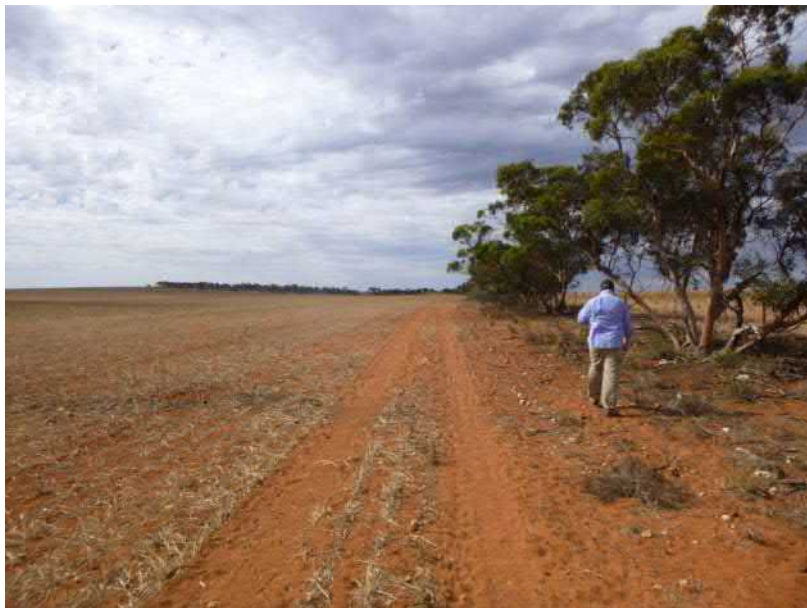
Lyndhurst Site Linear Corridor of Native Vegetation (Mallee trees) Along Eastern Property Boundary

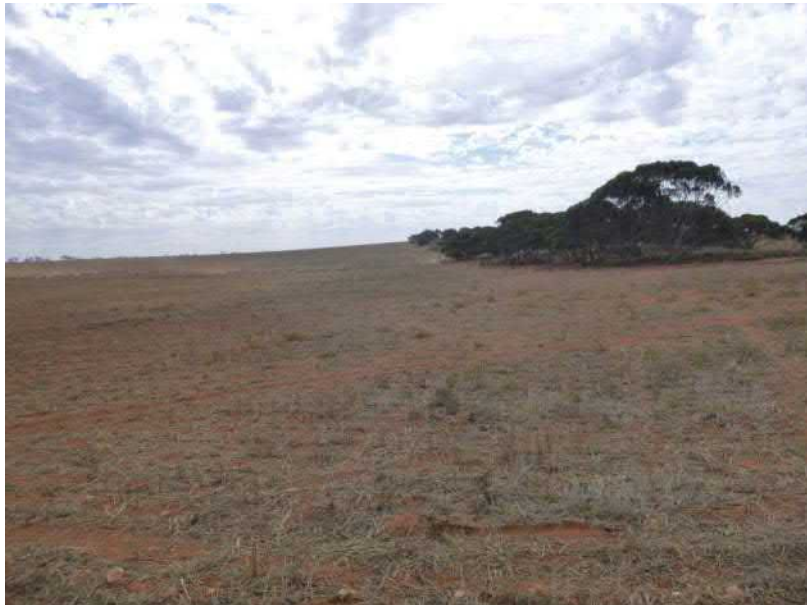
**Lyndhurst Site Native Vegetation (Mallee trees) on Sand Ridges**

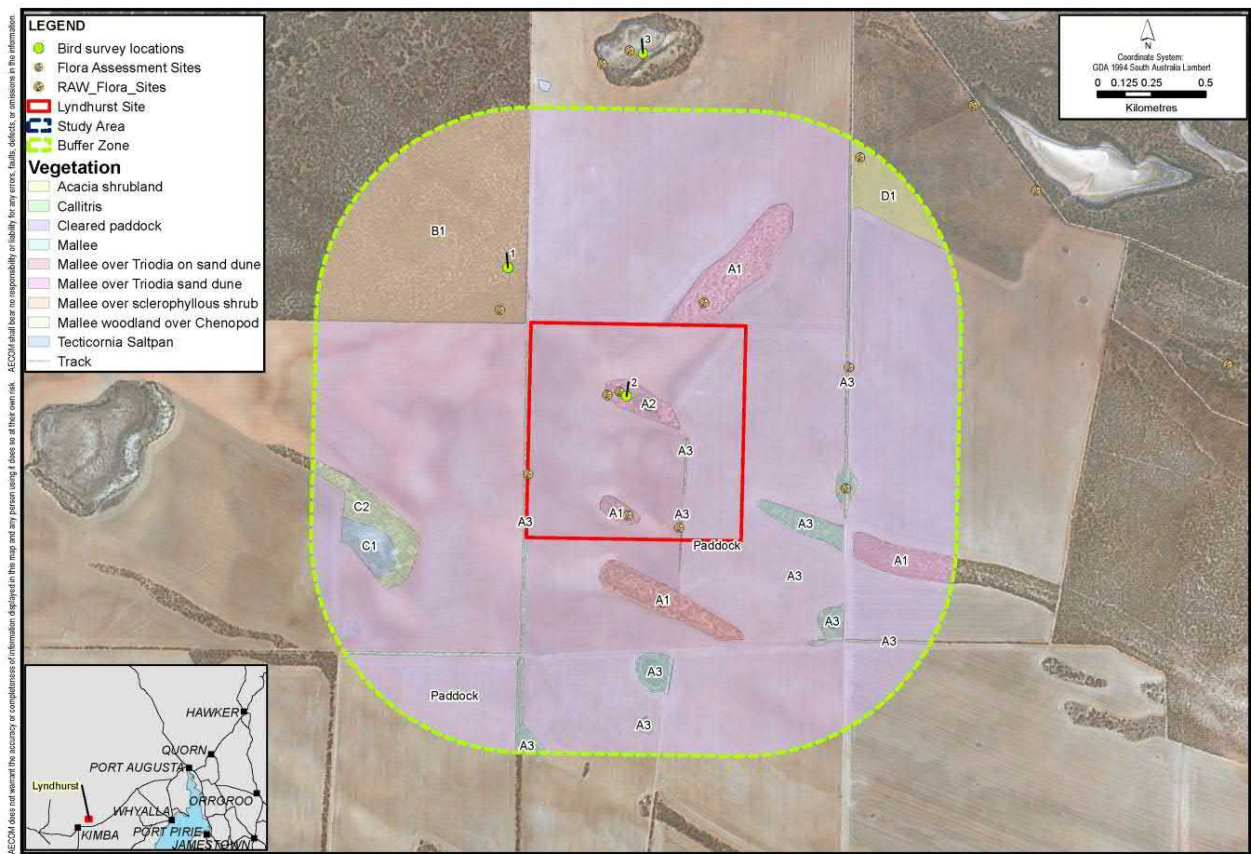
**Figure 3 Vegetation types and condition**

Vegetation condition is mapped in Figure 3.

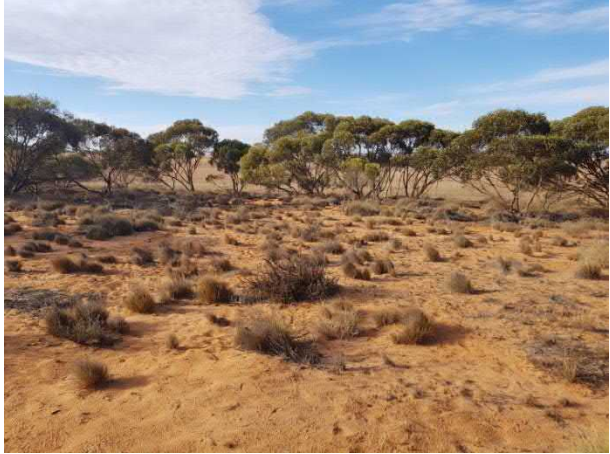
| Code | Vegetation Description | Photograph |
|---|---|--|
| A1 | <p>Open mallee woodland over <i>Triodia</i></p> <p>Open mallee of <i>Eucalyptus socialis</i> subsp. <i>viridans</i> over <i>Melaleuca lanceolata</i>, <i>Acacia hakeoides</i> and <i>Eremophila deserti</i> tall open shrubland over <i>Olearia muelleri</i>, <i>Lomandra leucocephala</i> subsp. <i>robusta</i> and <i>Triodia irritans</i> low shrubs and hummock grassland.</p> <p>Recorded on sandy soils on dune systems. Diversity of native species varied as a result of historical impacts of grazing and isolation. Vegetation type represented by Lyn 1, 2, and 3.</p> | |

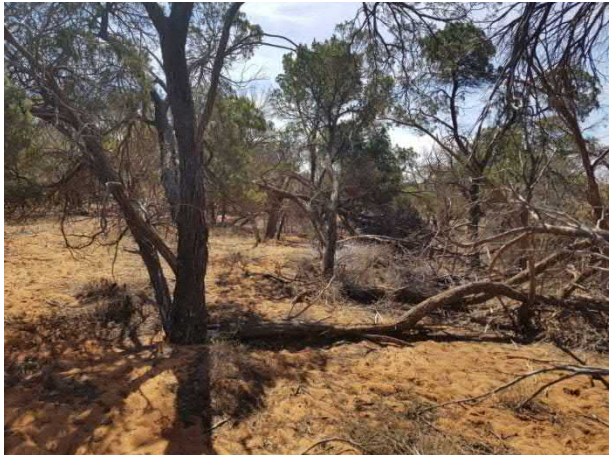
| Code | Vegetation Description | Photograph |
|---|---|--|
| A2 | <p>Low Woodland <i>Callitris gracilis</i> over Chenopods</p> <p>Low woodland <i>Callitris gracilis</i> and <i>Eucalyptus incrassata</i> over <i>Enchylaena tomentosa</i> var. <i>tomentosa</i>, <i>Rhagodia spinescens</i>, <i>Dianella revoluta</i> and sparse grasses.</p> <p>Disturbed sandy patch of <i>Callitris</i> with evidence of dieback in trees. Understorey appears more susceptible to impacts from grazing. Vegetation type represented by Lyn 6.</p> | |

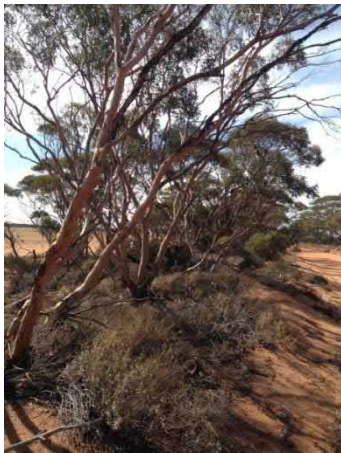
| Code | Vegetation Description | Photograph |
|---|---|--|
| A3 | <p>Mallee</p> <p>Mallee woodland of <i>Eucalyptus socialis</i> over mixed shrubs including <i>Enchylaena tomentosa</i>, <i>Cratystylis conocephala</i>, <i>Maireana</i> sp., and <i>Atriplex</i> sp.</p> <p>Vegetation in linear corridors varying in condition due to extensive clearing. Likely weed invasion present following rain. Vegetation type described from observations only.</p> | |

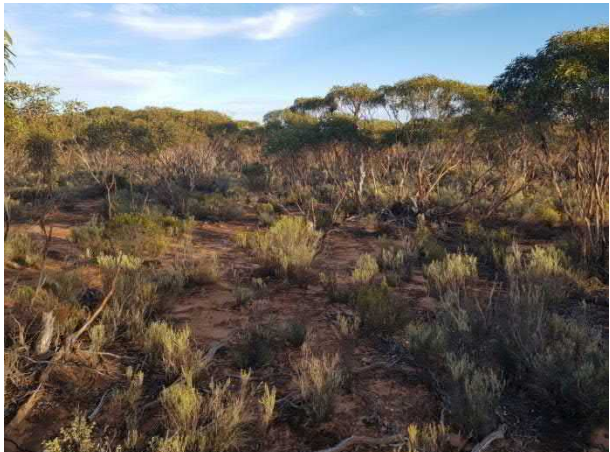
| Code | Vegetation Description | Photograph |
|---|--|--|
| B1 | <p>Mallee woodland over sclerophyllous shrubs</p> <p>Low mallee woodland of <i>Eucalyptus socialis</i>, <i>Eucalyptus gracilis</i>, <i>Eucalyptus porosa</i> and <i>Eucalyptus brachycalyx</i> over <i>Eremophila scoparia</i> and <i>Olearia muelleri</i>, <i>Westringia rigida</i> mid shrubland.</p> <p>Excellent condition vegetation in large block of native remnant vegetation on undulating flats. Vegetation type represented by Lyn 4.</p> | |

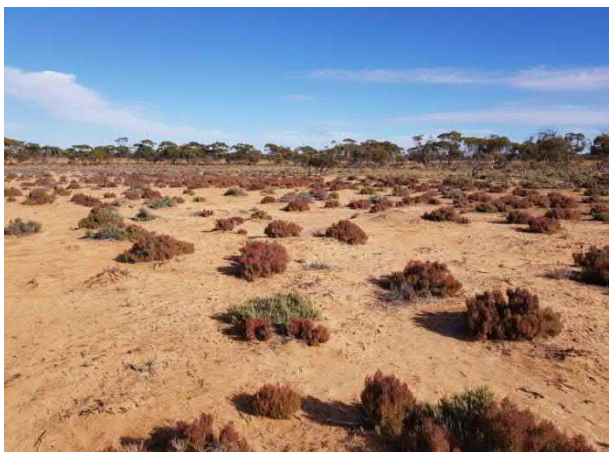
| Code | Vegetation Description | Photograph |
|---|--|--|
| C1 | <p>Tecticornia saltpan</p> <p>Low open shrubland of <i>Tecticornia indica</i> and <i>Tecticornia halocnemoides</i> with isolated <i>Maireana Astrotricha</i> and <i>Tecticornia pergranulata</i>.</p> <p>Located on clay soils with salt residue on surface. Isolated dead trees throughout. Vegetation type represented by Lyn 7.</p> | |

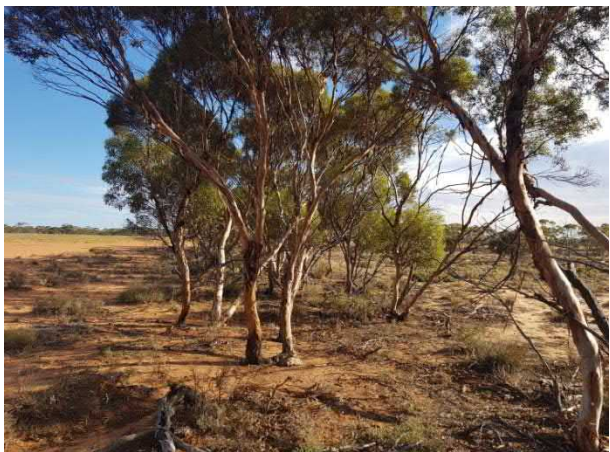
| Code | Vegetation Description | Photograph |
|---|--|--|
| C2 | <p>Mallee woodland over Chenopods</p> <p>Open mallee woodland of <i>Eucalyptus incrassata</i> over <i>Enchylaena tomentosa</i> var. <i>tomentosa</i>, <i>Rhagodia spinescens</i> low open shrubland with sparse dead grasses.</p> <p>Ecotone community represents the edge of the Tecticornia saltpan. Patches of dead trees and further characterised by sparse understorey. Vegetation type represented by Lyn 5.</p> | |

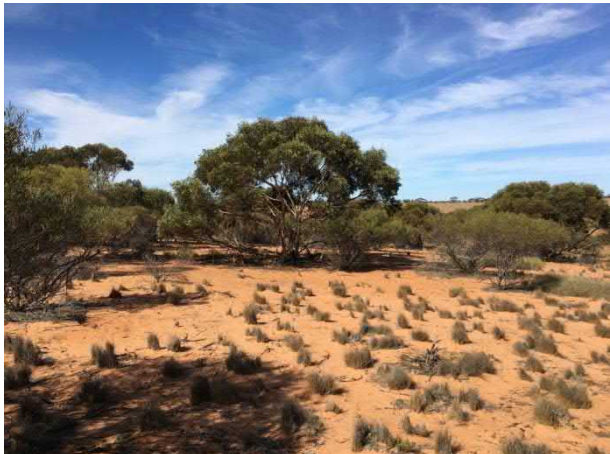
| Code | Vegetation Description | Photograph |
|---|---|---|
| D1 | <p><i>Acacia</i> shrubland</p> <p>Mid shrubland of <i>Acacia</i> and <i>Eremophila</i> over sterile grasses.</p> <p>Isolated to one occurrence, this community appears to represent potential rehabilitation or restoration of the area as evident by lack of mallee trees and age of species. Isolated to corner of survey area.</p> | |

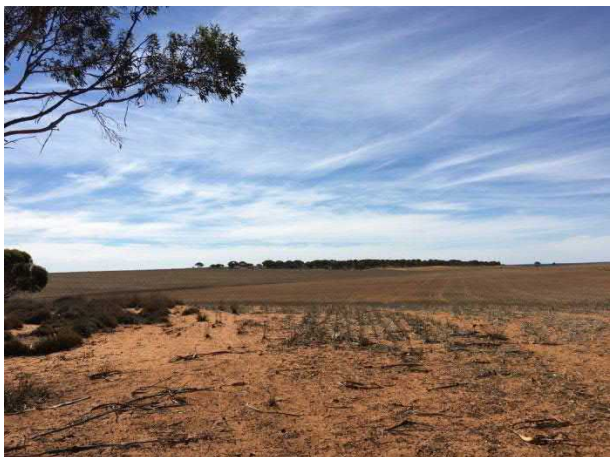
| Code | Vegetation Description | Photograph |
|---|---|---|
| Paddock | <p>Open farmland of undulating terrain supporting introduced grass and herb species.</p> | |

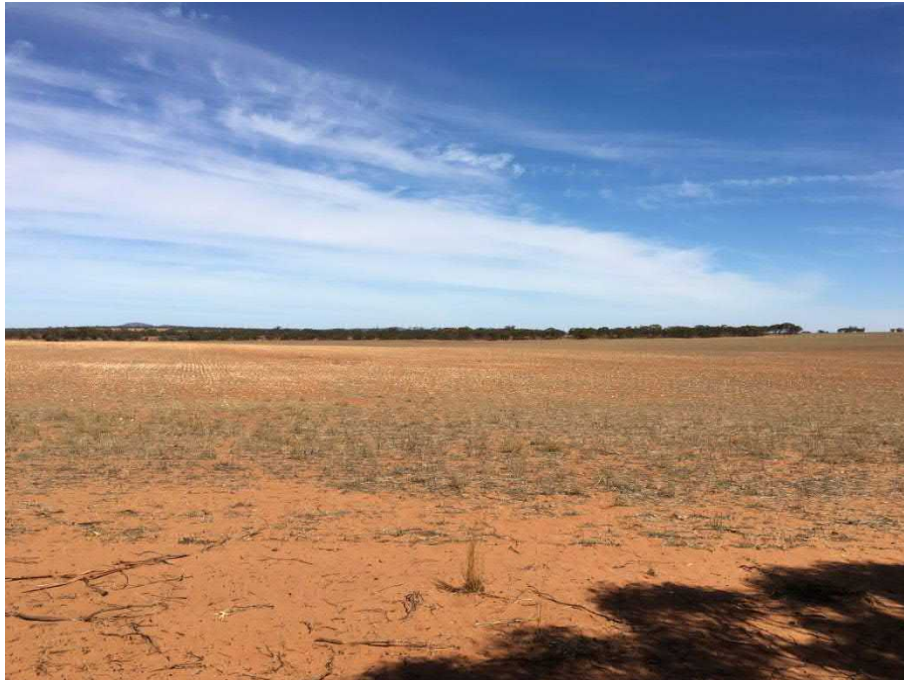
Open farmland was the dominant habitat type within the proposed site footprint and much of the adjoining paddocks. This area was almost entirely denuded of living vegetation and was dominated by a mixture of bare ground and crop stubble (dead organic matter). No current cropping activities were apparent though sheep grazing was noted within the southern of the paddocks in which the site footprint is situated. Open farmland is considered of negligible habitat value.

**Open farmland within Lyndhurst Site**

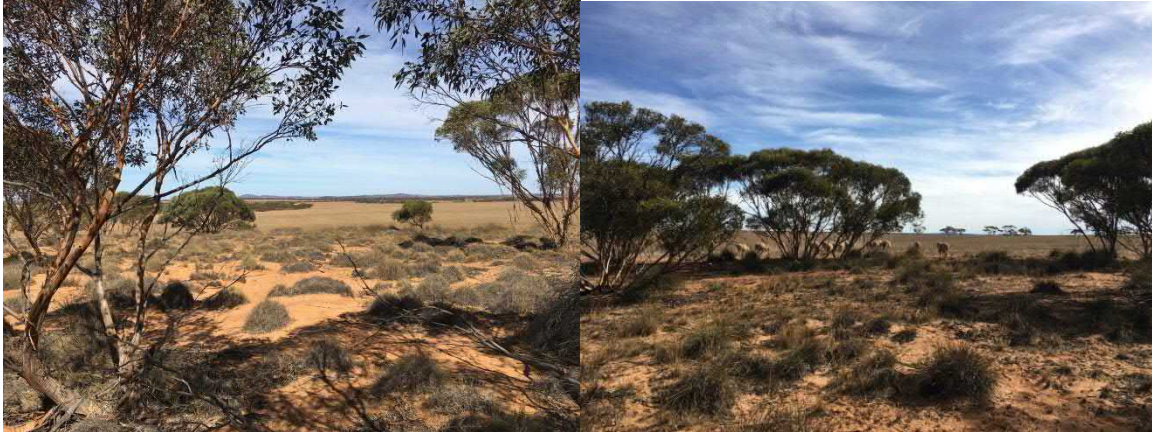
Also, two discrete isolated patches of Mallee Woodland occur within the site footprint (as described in Table 8 as A1 and A3). This habitat aligns with vegetation type A1. The northern and largest of these two patches consisted of open Mallee Woodland above small tussocks of hummock grass. At the woodlands centre was a small stand of Buloke. Organic debris and soil crust was sparse however wood debris and greater habitat complexity was present toward the patches centre. The second, and smaller of the two patches, was located toward the southern portion of the site footprint. Habitat composition was similar however it had less cover of hummock grass and less woody debris. Buloke was absent. Both patches may provide low quality habitat for ground dwelling fauna and dispersal and occasional habitat for woodland birds. Both patches show evidence of recent grazing pressure with a small flock of sheep observed in the smaller of the two patches and likely to be adversely impacting ground cover. A further third patch of habitat of similar composition was also identified beyond the Lyndhurst sites southern boundary.

**Mallee woodland in site boundary large patch left and small patch right.**

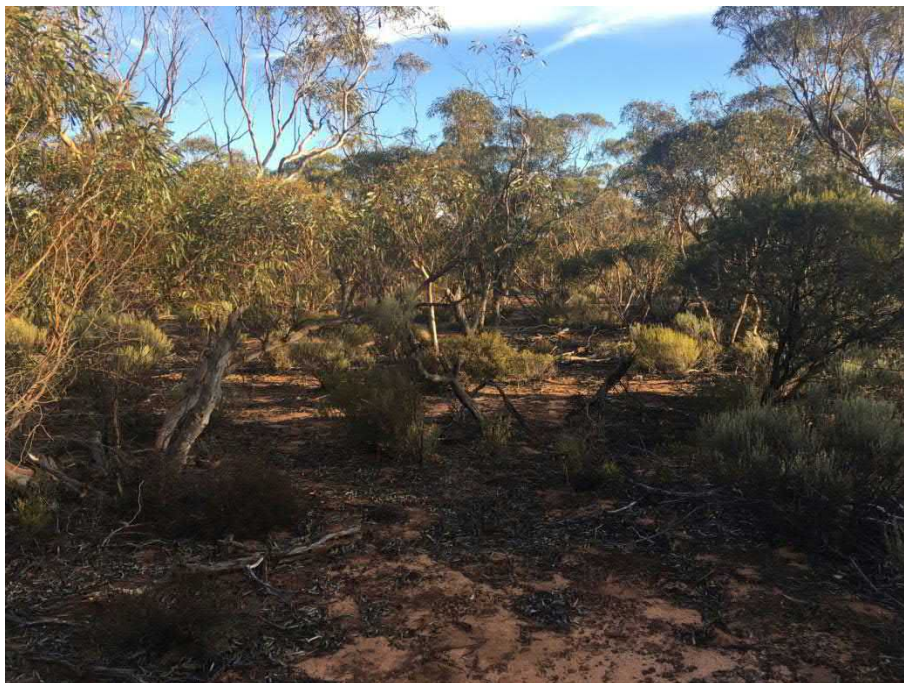
Within the buffer zone, high quality Mallee Woodland habitat was present within an area of woodland reserve and to north east of the site boundary. This habitat type aligns with vegetation code B1. Habitat within this area consisted of dense Mallee overstorey with an acacia mid storey and ground cover consisting of saltbush and occasional hummock grass. This area contained a significant amount of woody debris had greater habitat complexity than Mallee within the site footprint. Vegetation provided good habitat for small to large ground dwelling fauna and woodland birds. Bird activity and diversity was noted to be high at this location.

**High value Mallee woodland**

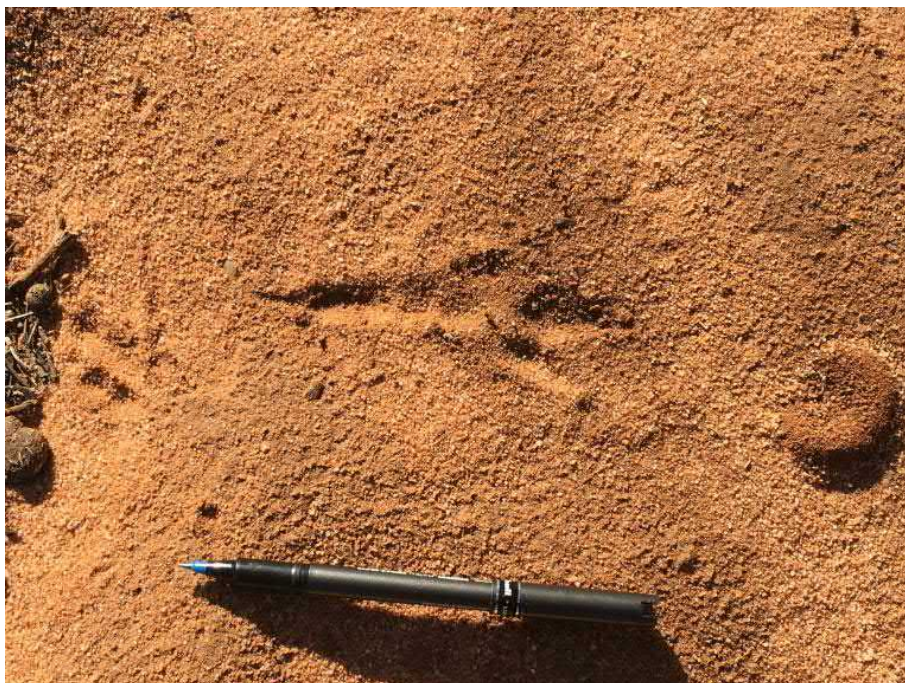
Tracks believed to be consistent with Malleefowl were identified in habitat to the north of the buffer zone. The observed footprints were approximately 12 cm in length and are consistent with guidance within the National Manual for the Mallee Fowl Monitoring system (NHT, 2008). A search of connected habitat failed to detect any birds or breeding mounds. Based on available evidence, it is thought that the species is likely to use the area as part of its foraging habitat. The habitat in question is within 300 m of large areas of vegetation continuous with Lake Gilles Conservation Reserve which is known to support Malleefowl. This area was less grazed than that within the site boundary and typically in better condition than habitat assessed in the buffer area with the exception of Mallee vegetation to the northwest of the site.

**Footprints' believed to be Mallee fowl**

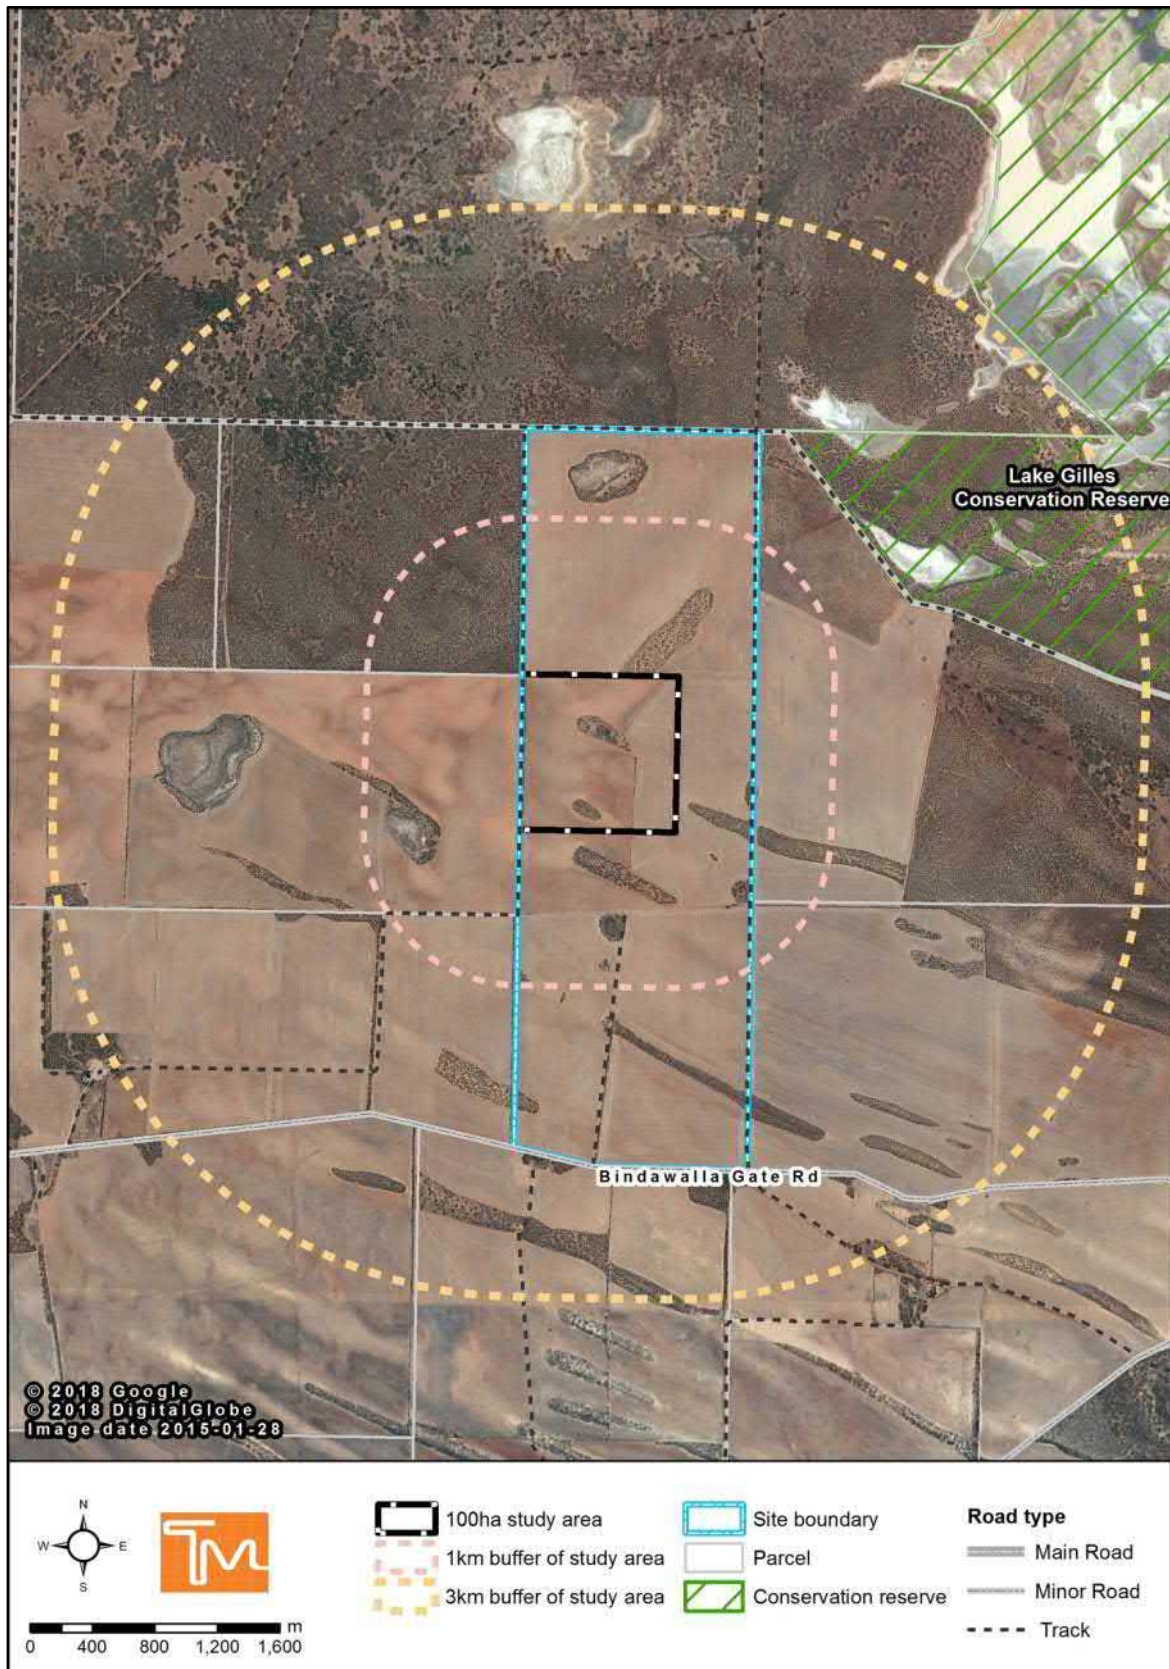
Figure 8 Lyndhurst landscape assessment to 3km.

The South Australian prescribed burning guide identifies that semi-arid Mallee vegetation occurs across large areas of the central to northern Eyre Peninsula and describes this vegetation as '*Low open eucalypt dominated vegetation with an understorey of smaller shrubs, grasses and herbs. The fuel array is typically highly discontinuous*' (DENR, 2011). AECOM provided photos and descriptions of vegetation on and round the site (MacDonnell, 2018; AECOM, 2018a) that match this descriptor and accord best with a Mallee-Mulga classification under AS 3959-2009.

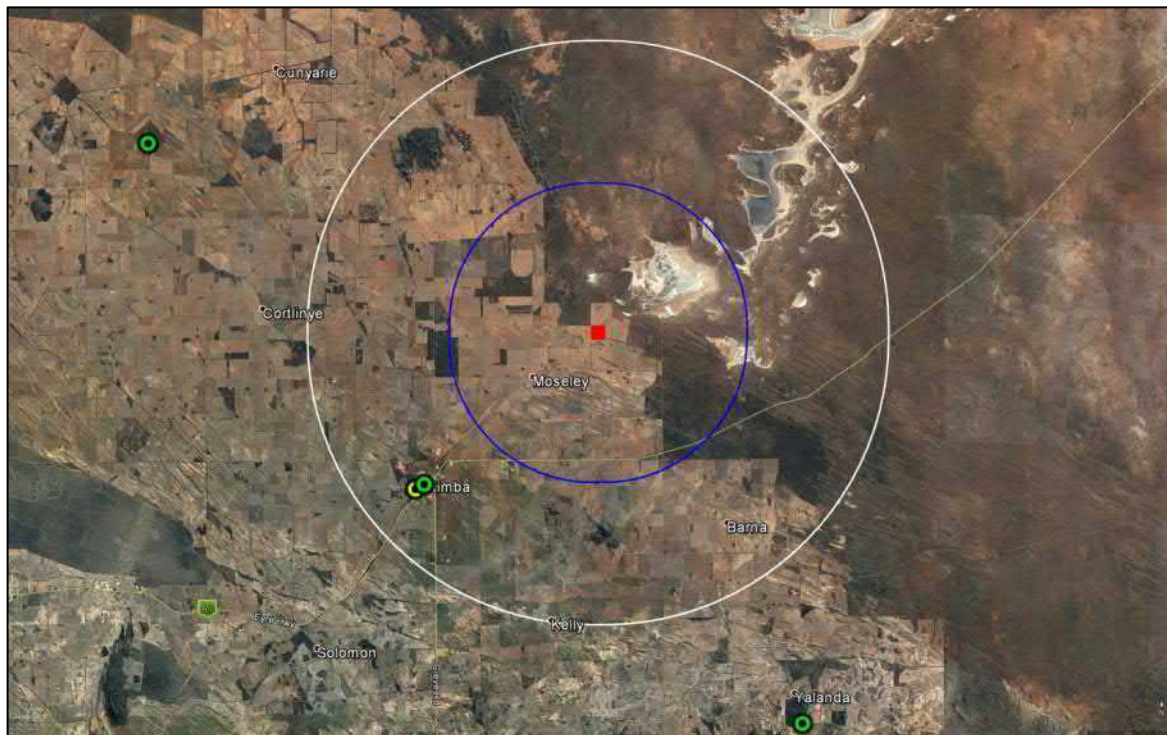
**Figure 9** The landscape surrounding the Lyndhurst 100ha site and expanded Study Area (show in red fill)

A 10km buffer of the site is shown in blue outline and a 20km buffer is shown in white outline. The yellow circle shows the location of the BOM weather station from which weather data was obtained and analysed (see Section 2.4.2.3). Green circles identify the locations of the nearest CFS brigades (see Section 2.4.2.4.4).

CFS incident data for local brigades (within approximately 20-30km of the site 'as the crow flies') was examined for the occurrence of incidents in the landscape around the site that did, or could, generate a bushfire with the potential to threaten the site. Figure 9 and Table 22 show the three CFA brigades located around the Lyndhurst site.

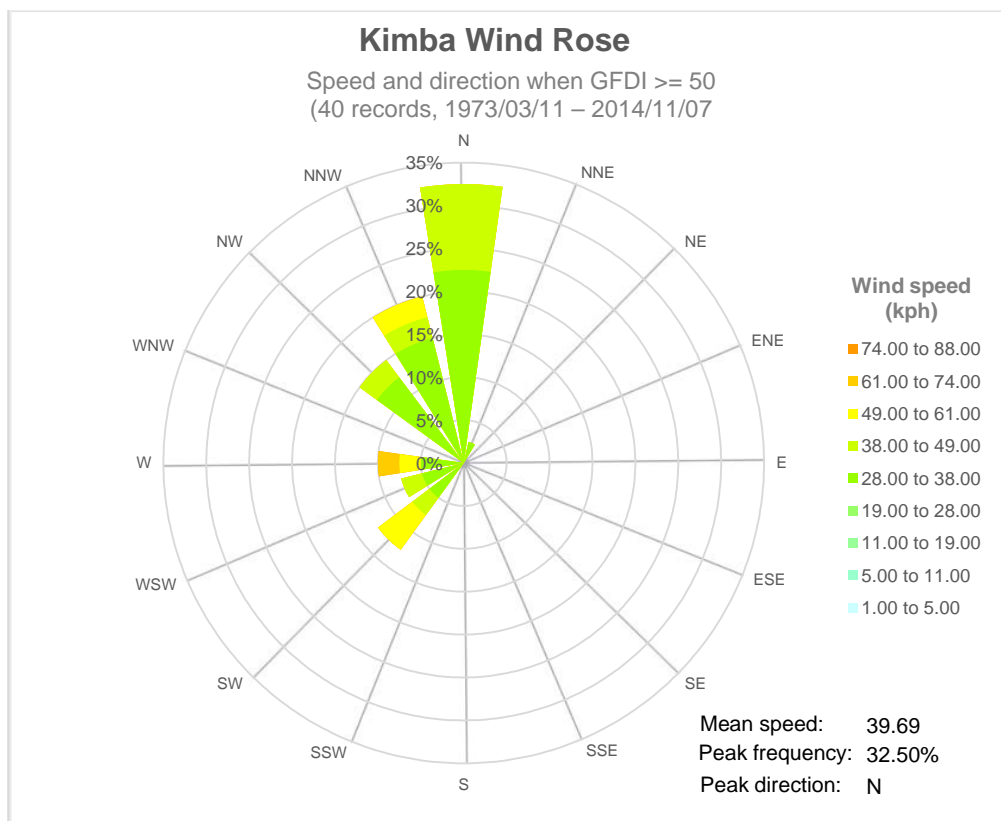
**Figure 11 Kimba wind rose for 3pm records during the fire season months when calculated GFDI  $\geq 50$ .**

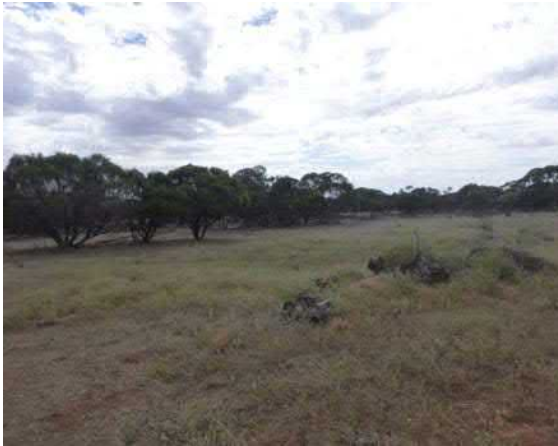
**Low lying area to the south of the site (mapped as H2 soil subgroup) where ponded water has previously been observed.**

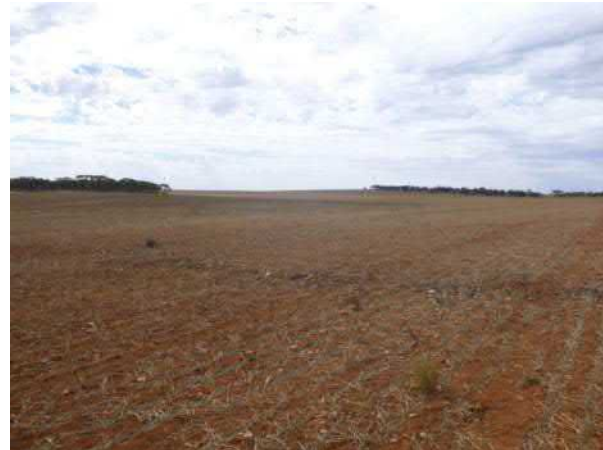
**Majority of site showing red-brown soils (D3 soil subgroup) with nodular calcrete. Vegetated dunes in the distance.**

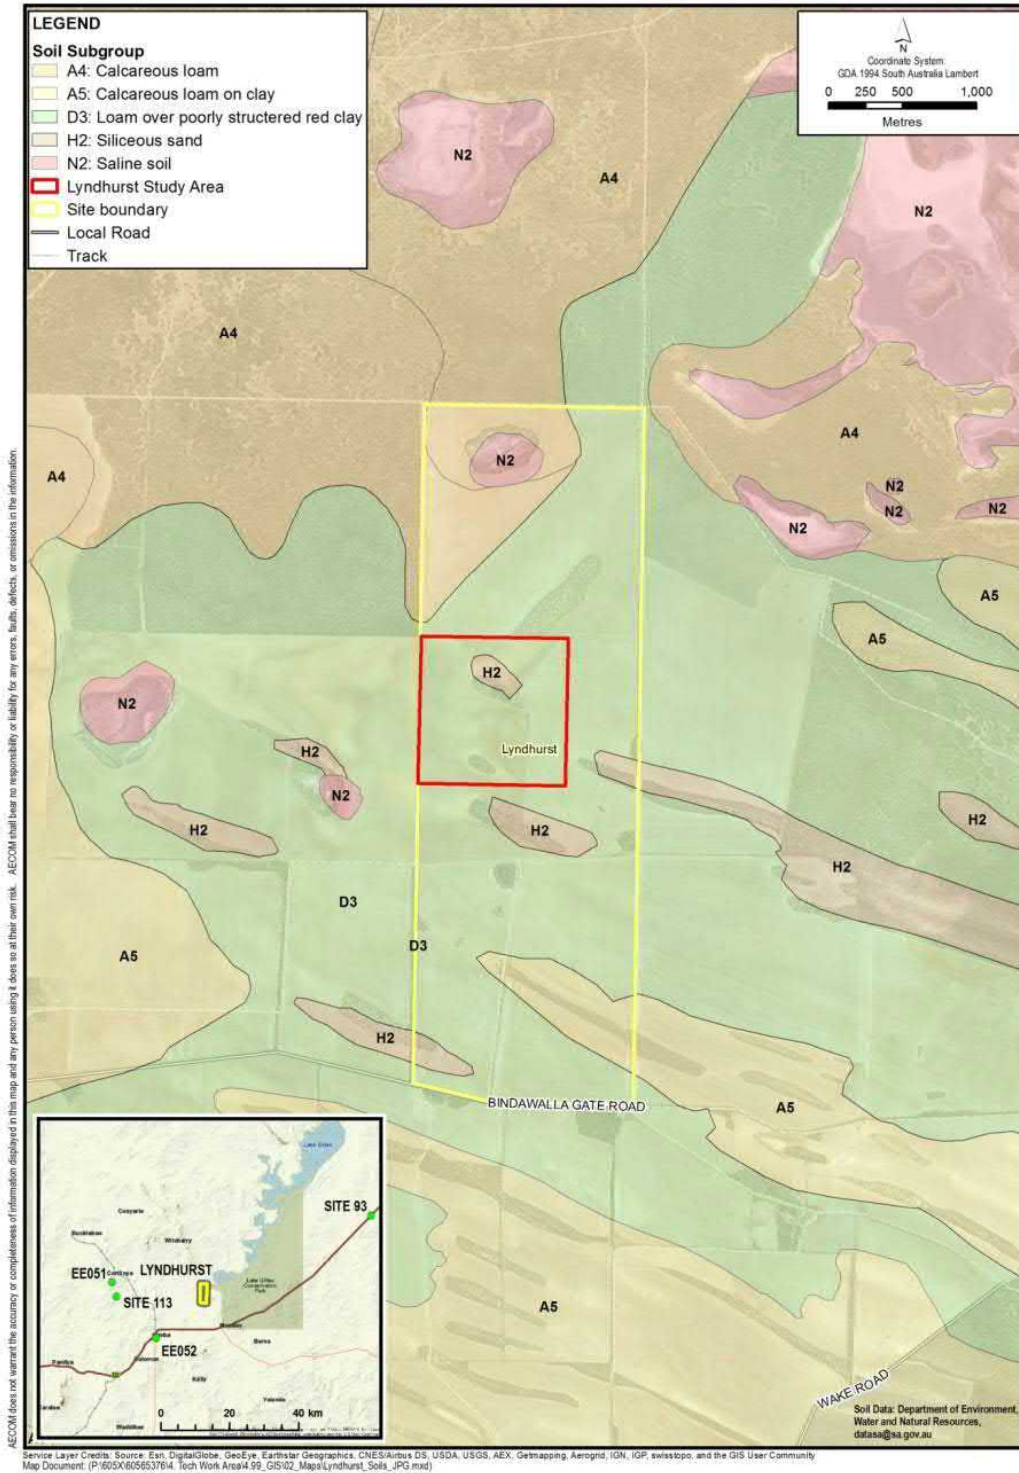
Figure 16 Soil distribution map for Lyndhurst, mapped at landscape scale (Soil & Land Program, 2005)

ASRIS information for the surface and subsurface profile (to a depth of around 2 m) for the most spatially prevalent soil types in the site mapped at the landscape scale (without field surveys) include:

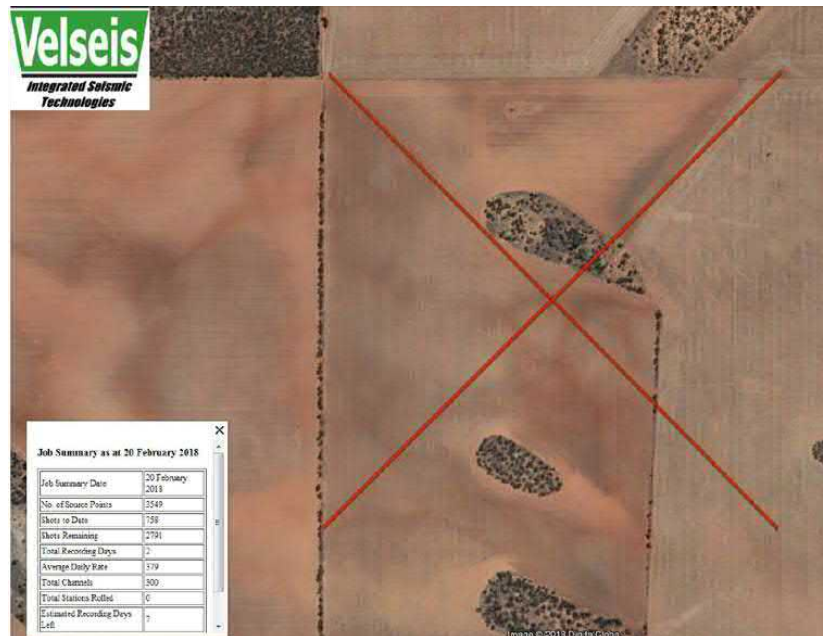
**Figure 19 Job completion summary for Lyndhurst seismic data acquisition**

Once the data was acquired Velseis output a refraction solution to provide an indication of the depth to the weathered / un-weathered boundary. Velseis then provided a preliminary interpretation of the processed data which is attached as Appendix C. It is noted that given the lack of borehole control available at the time of the survey, only more prominent potential structures have been inferred and given the complexity of the data smaller scale structures are also likely to be present.

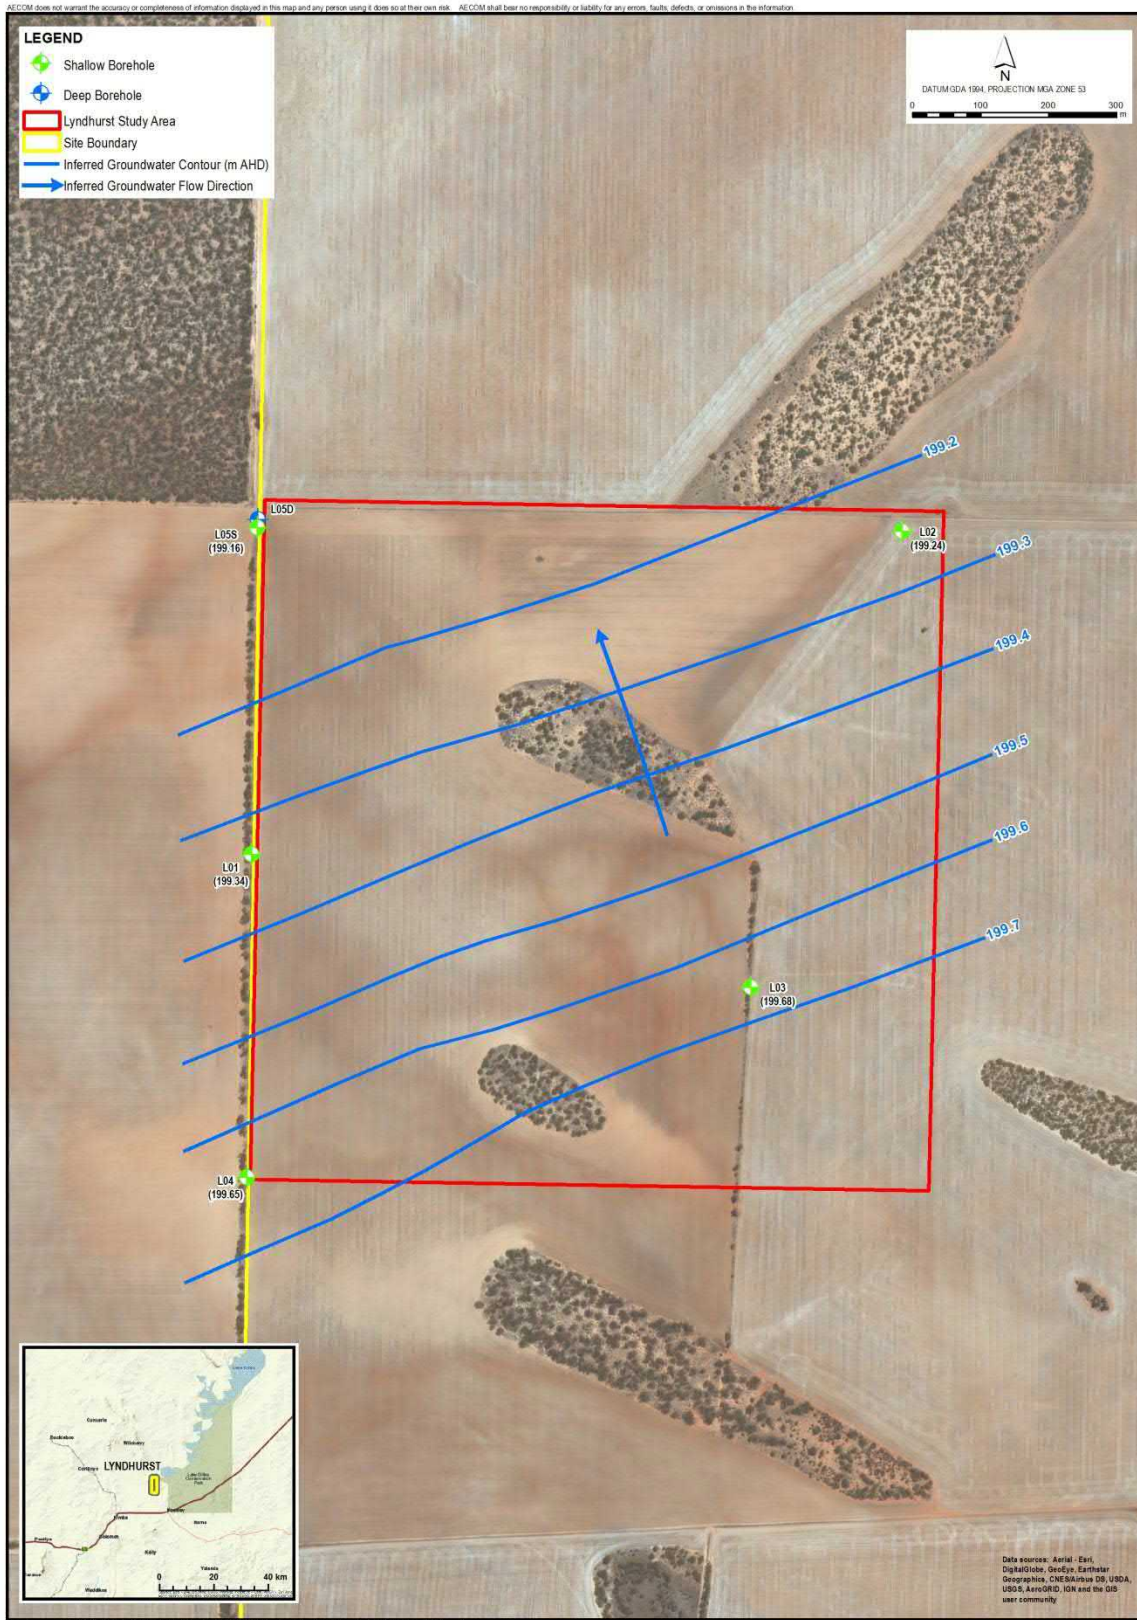
Figure 23 Interpreted Groundwater Contours and Inferred Flow Direction 22/05/18 – Watertable Aquifer Lyndhurst

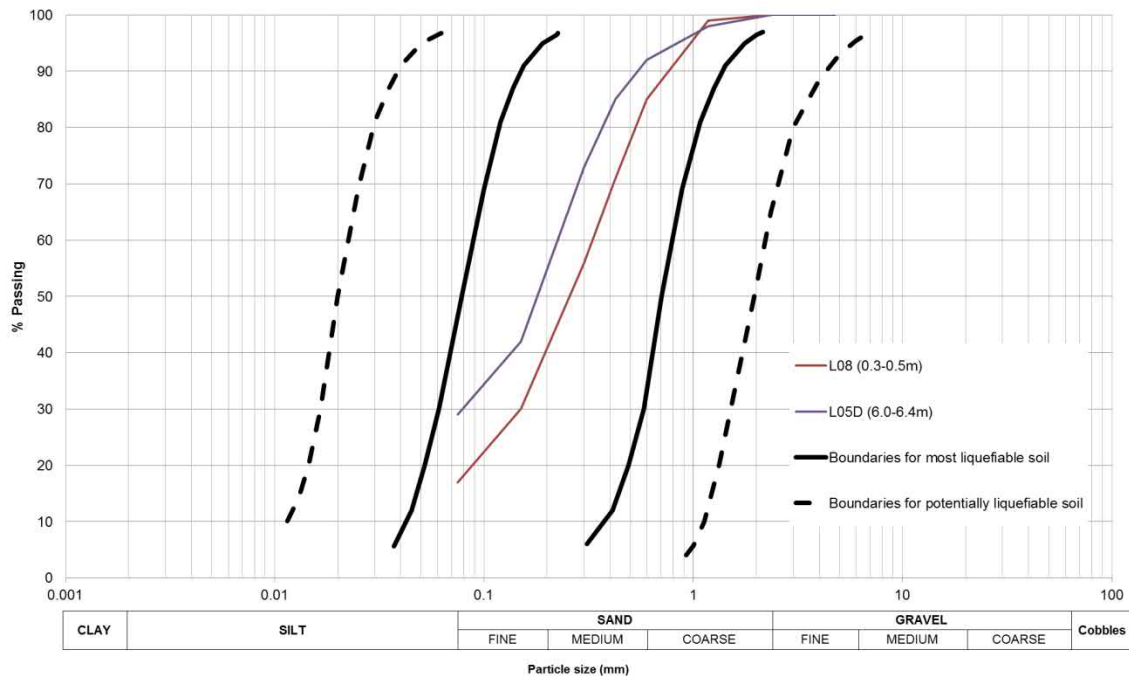
**Figure 24 Particle Size Distribution of Tested Materials**

Based on the above figure, the tested site materials can be characterised as liquefiable soil based on particle size distribution.

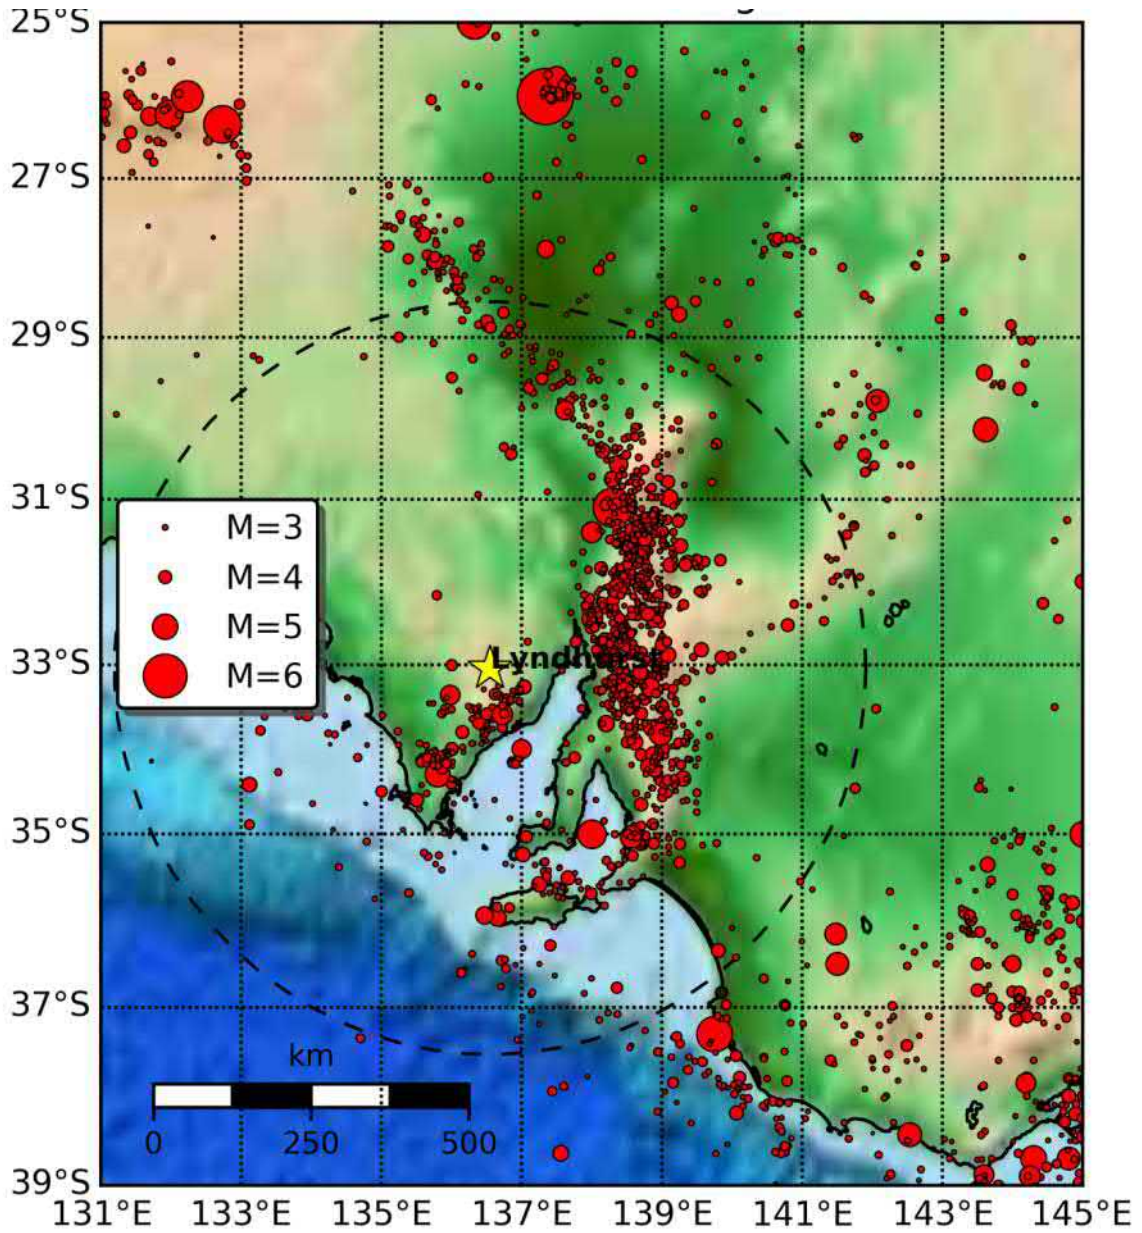
Figure 27 Historical seismicity within about 300 km of the site locations, shown by the yellow stars, based on the Geoscience Australia (2018) revised earthquake catalogue.

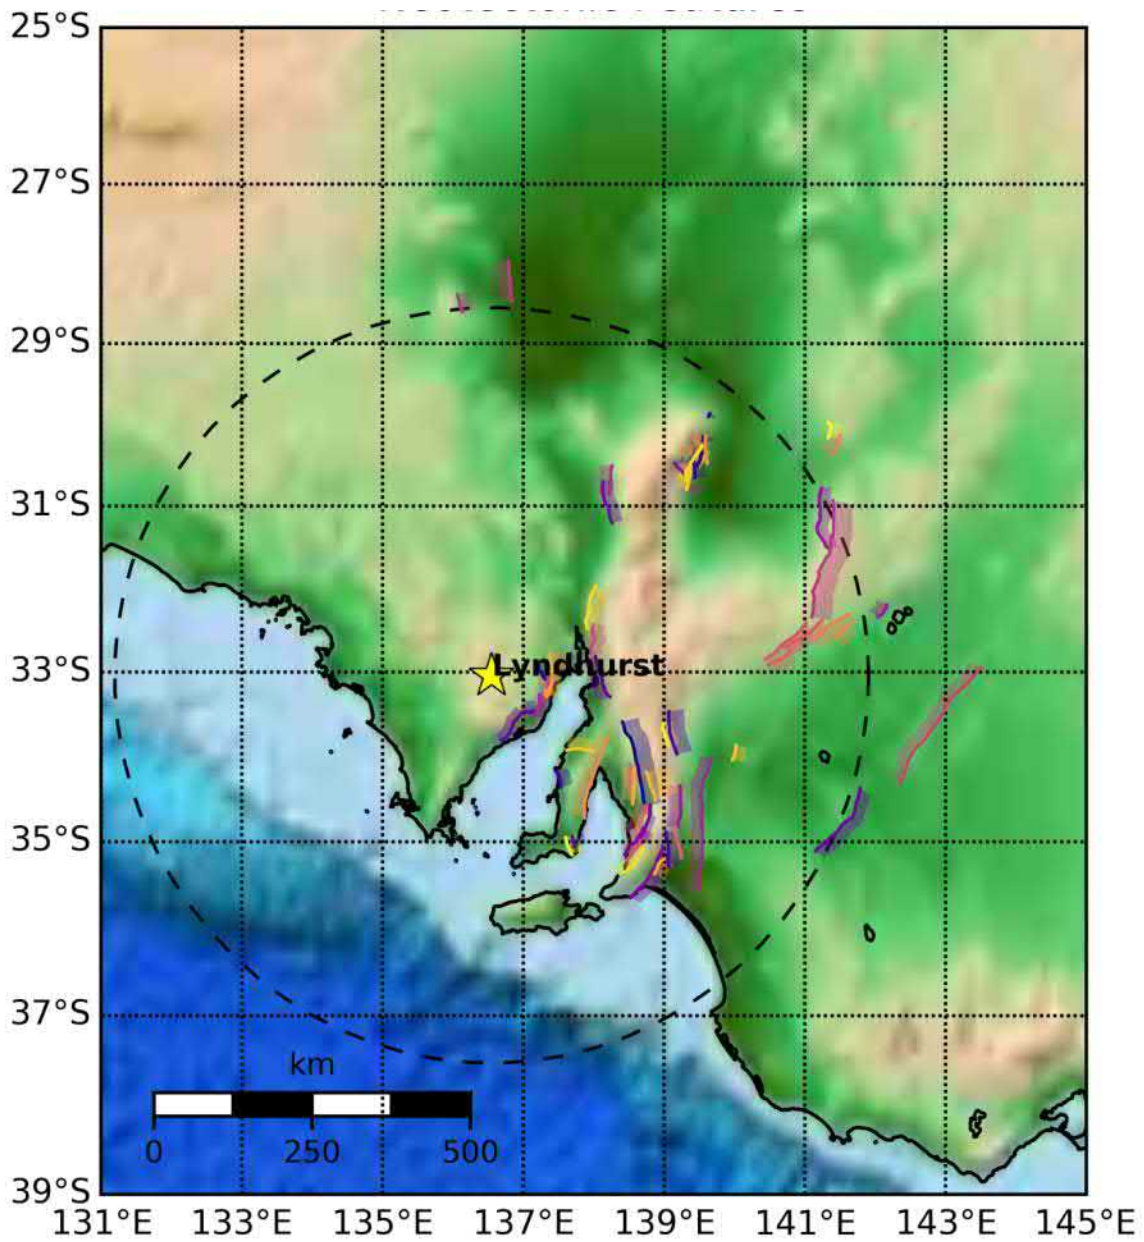
**Figure 28 Neotectonic features in the study region based on Clark et al. (2011).**

The top edges of the faults are shown by dark lines and their surface projections are shown by the coloured bands.

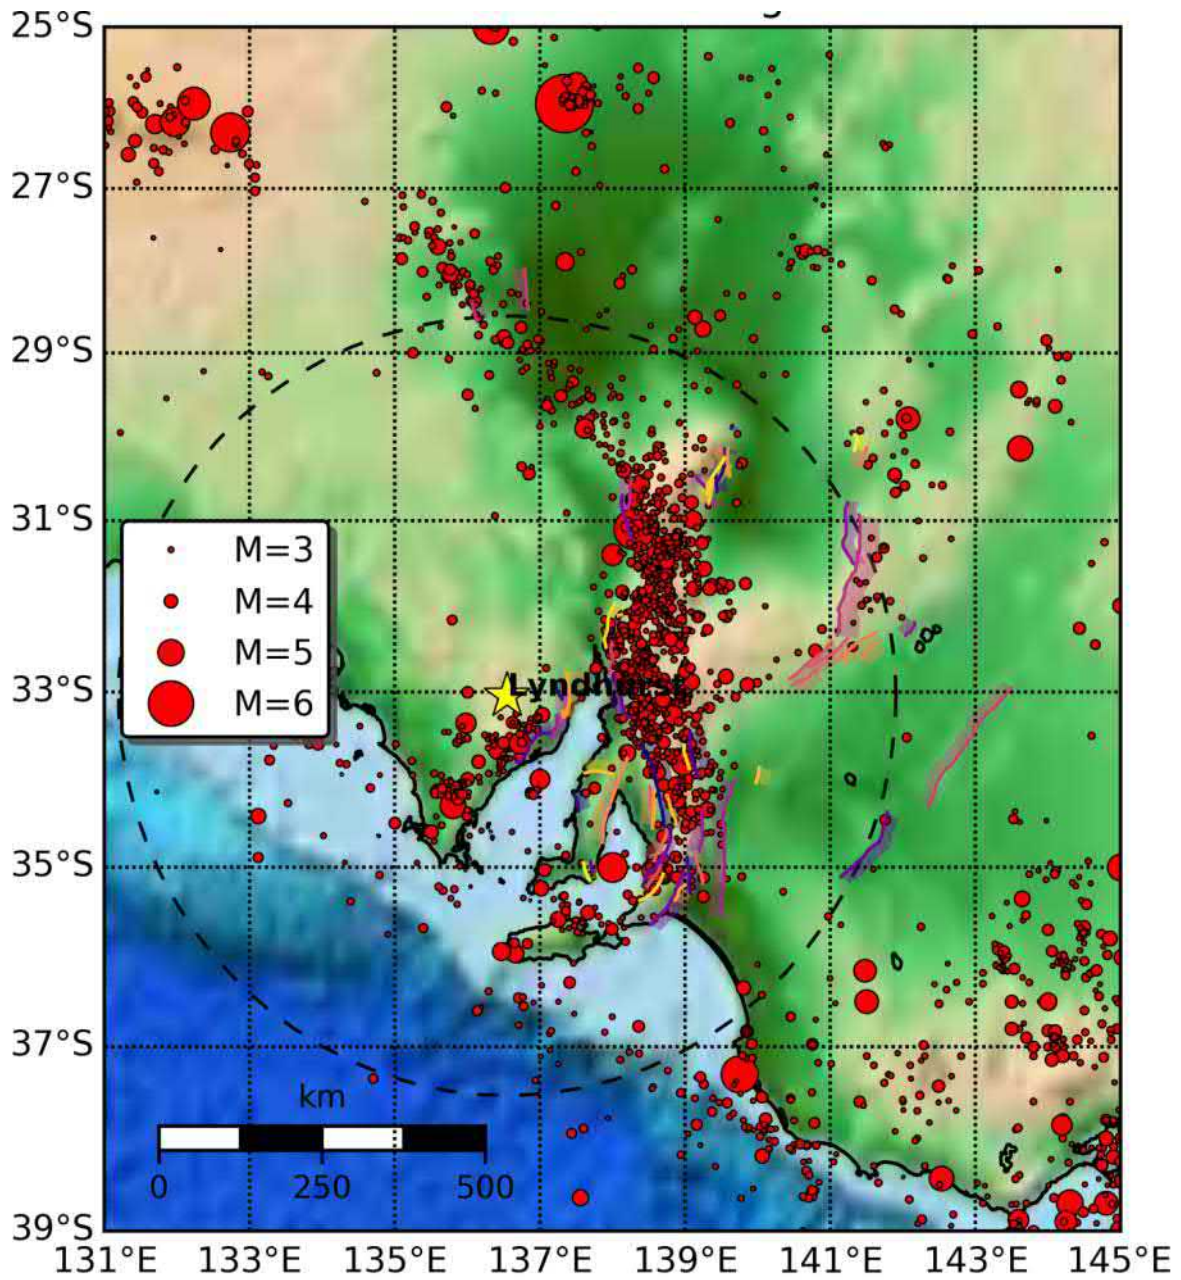
Figure 30 Neotectonic features and historical earthquakes for the study region based on Clark et al. (2011) and Geoscience Australia (2018) respectively.
