**NATIONAL  
RADIOACTIVE  
WASTE MANAGEMENT  
FACILITY**

## Site Characterisation Technical Report - Lyndhurst

Client: Commonwealth Department of Industry, Innovation and Science

**AECOM Australia Pty Ltd**

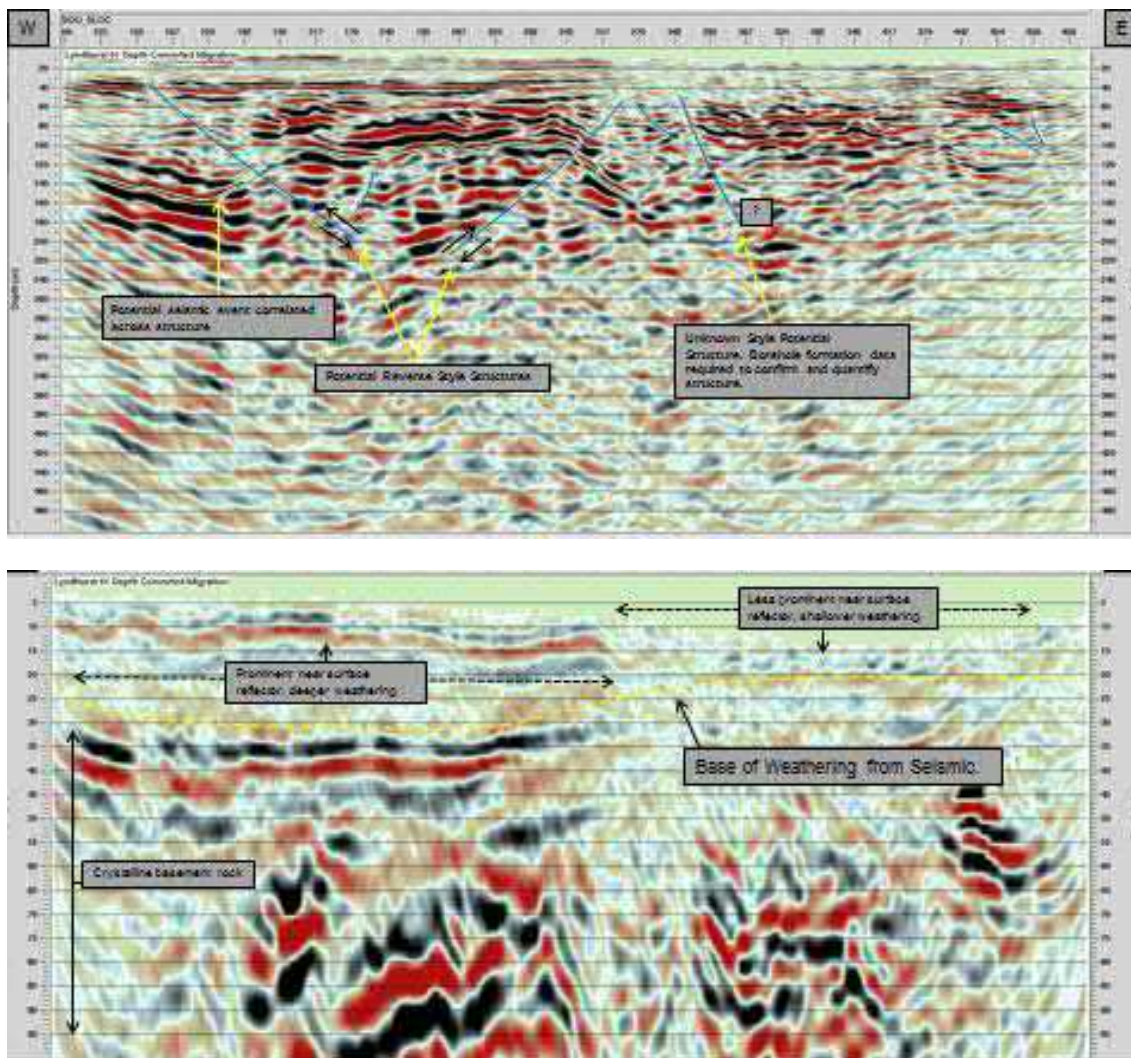
Figure 35 Lyndhurst 01 Depth Converted Migrated Stack Interpreted Structure (top) and Interpreted Section at Near Surface (bottom). Source: Velseis.

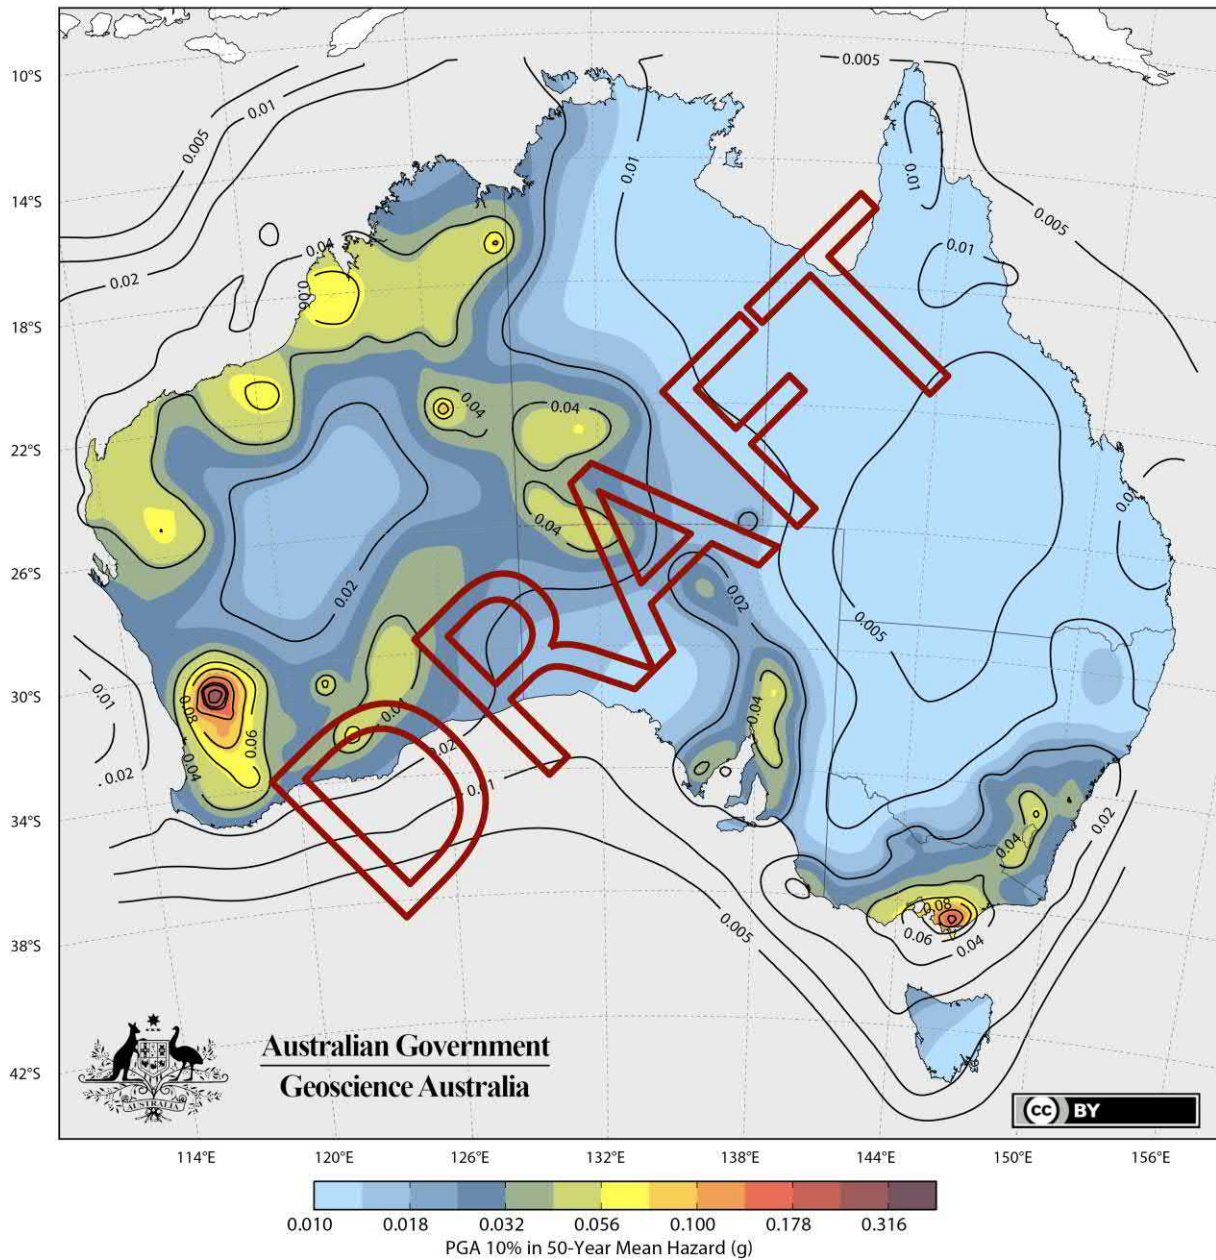
A provisional seismic hazard map of Australia is shown in Figure 36. The map shows peak acceleration having a 10% probability of exceedance in 50 years for site class B<sub>e</sub>. The hazard value at the Lyndhurst site is approximately 2.5%g, which is well below the damage threshold for ordinary structures.

Note: values from the NSHA18 within this map are in draft form only and the hazard contours are likely to change prior to the completion of the final model by June 2018. Source: Allen et al. (2017).

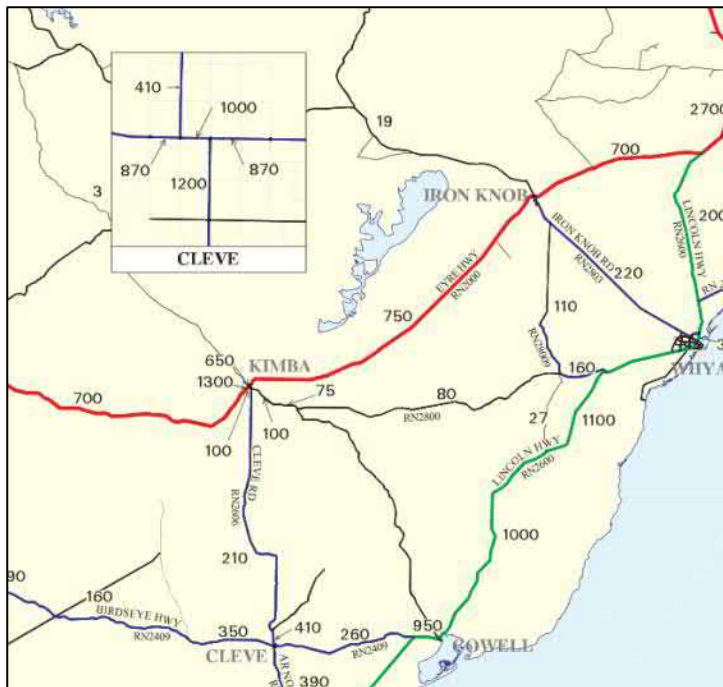
**Figure 38 Annual Average Daily Traffic Estimate 24 hour two way flows (Department of Planning, Transport and Infrastructure, 2015)**

The Eyre Highway is a two-way, sealed and marked road with a designated speed limit of 110 km/h. Annual Average Daily Traffic (AADT) estimates are provided for the state-managed arterial roads in the vicinity of the site, as shown in Figure 38. The Eyre Highway has a low estimated AADT, with traffic flows of 750 vehicles /day along the section between Iron Knob and Kimba.

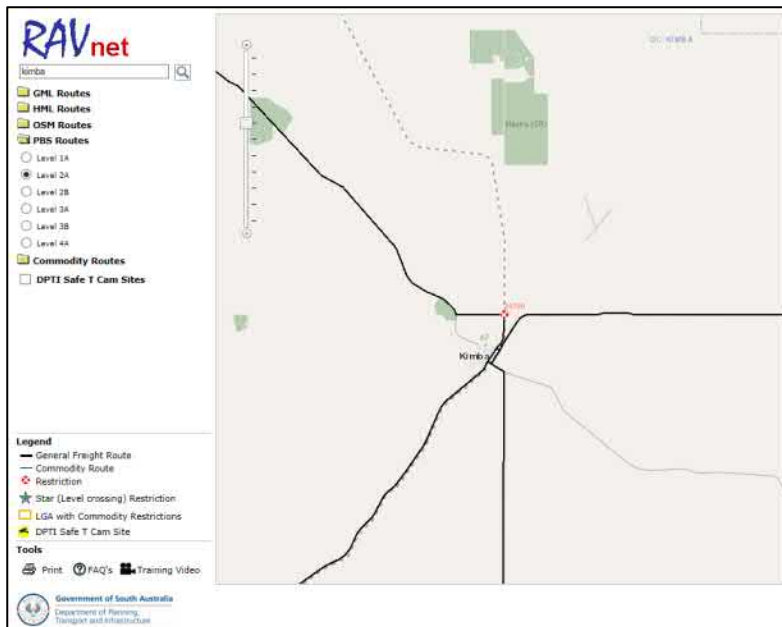
**Figure 39 Approved restricted access vehicle routes approved under PBS Level 2A – 26m B-double (Department of Planning, Transport and Infrastructure, 2018)**

Figure 39 indicates the access routes for the PBS category of level 2B vehicles, such as 26m B-double configurations which would be the largest type of vehicles used for most of the construction and operational activities (with the exception of the over-weight loads transporting the TN81 Containers which occurs very infrequently). Eyre Highway is the only road in the vicinity of the site that is classified as a PBS approved route.

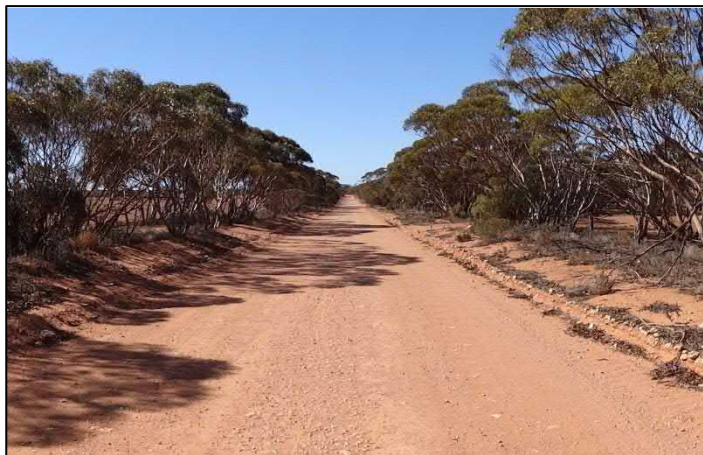
**Figure 40 Bindawalla Gate Road**

The area surrounding the potential site has a local road network mostly consisting of unsealed, low trafficked roads. Some are all-weather roads however may be less appropriate for carrying heavy loads during the winter months as a result of rainfall. The Lyndhurst site is bounded to the south by Bindawalla Gate Road and to the east / west by unnamed vehicle tracks (see Figure 40 below).

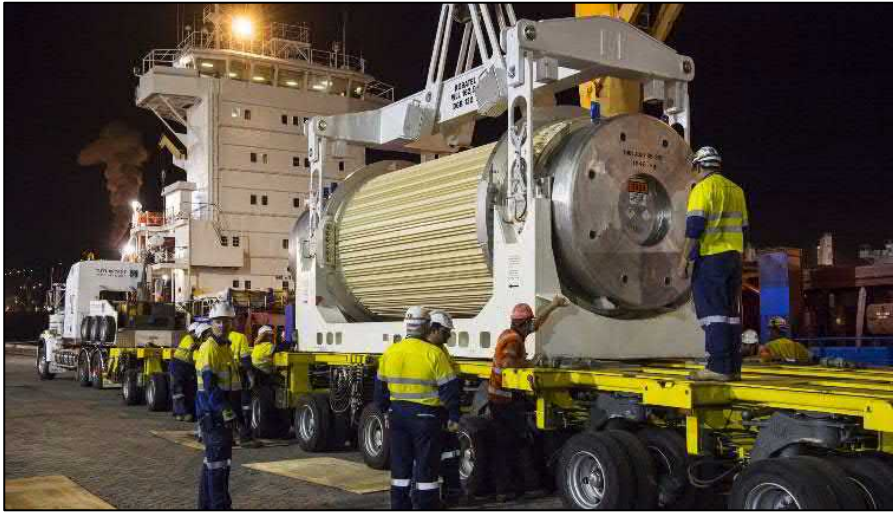
Figure 42 TN81 Container being transported (Department of Industry, Innovation and Science, 2016)

An aspect of the operation phase for the facility is the movement of TN81 Containers used to transport intermediate level waste. The TN81 Containers are 6.5 metres long, 3 metres in diameter and weigh approximately 100 tonnes when empty (Australia Nuclear Science and Technology Organisation, 2011). Therefore, the use of an over-dimensional / mass vehicle is required.

Further investigations into the type of vehicle required and appropriate transport routes will be performed as part of the Stage 2 works. As shown in Figure 42, it is likely that a prime mover and low loader combination will be necessary to transport the container over the road network.

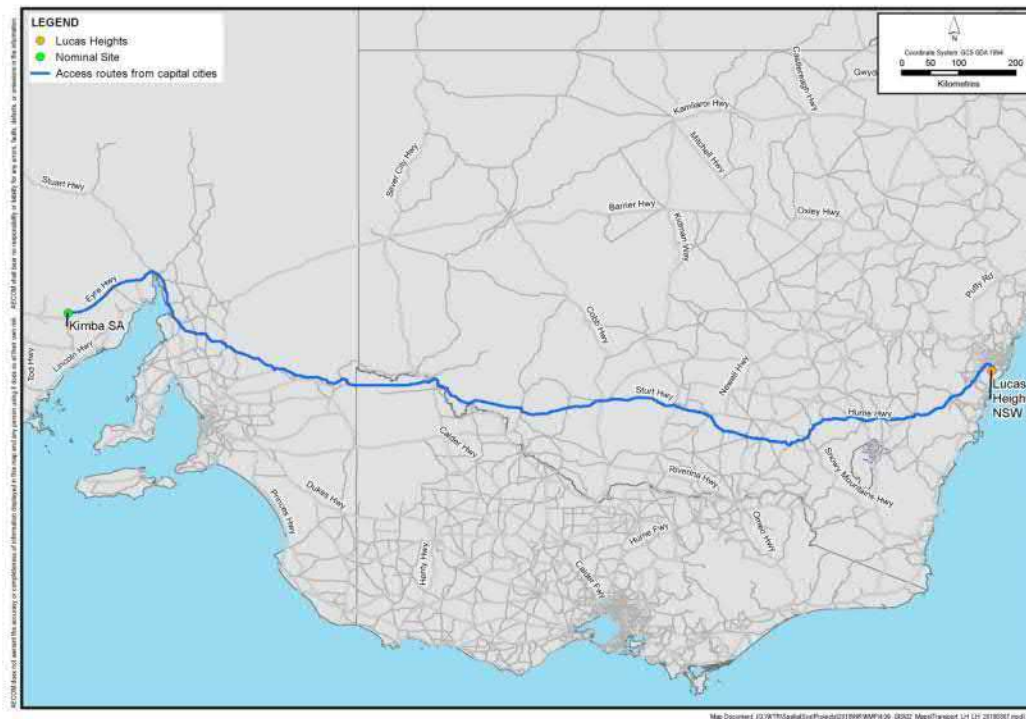
Figure 44 Access routes from Lucas Heights

1. Hume Highway (M31)
2. Sturt Highway (A20)
3. Goyder Highway (B64)
4. Clare Highway (B64)
5. Princes Highway (A1)
6. Eyre Highway (A1)

Further investigations will need to consider the local road network through key towns and cities along the proposed route to determine if there are approved heavy vehicle routes that will allow shipments to bypass these towns. Future investigations will further narrow down this route to minimise the number of towns / cities that are travelled through.

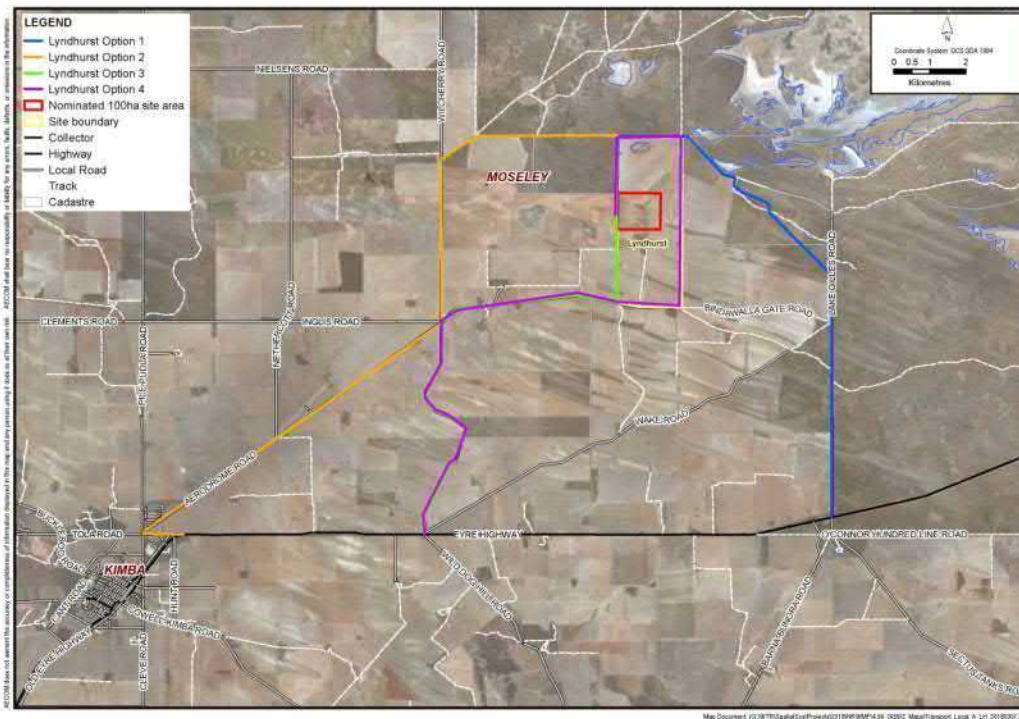
Figure 45 Local access routes

As can be seen in Figure 45, there is not a substantial difference in length for each of the potential local access routes. Key differentiating factors are likely to be the proximity to the township of Kimba and the upgrade requirements for each route. Required upgrades for the chosen access route will be determined during later design stages. Access routes may also be adjusted to minimise potential disruption to the local community. It should also be noted that if a road is upgraded to a higher standard (i.e. sealed), locals may use this road in preference to the surrounding unsealed roads. This would benefit the local community by improving local transport infrastructure and reducing the maintenance requirements compared to the existing roads.

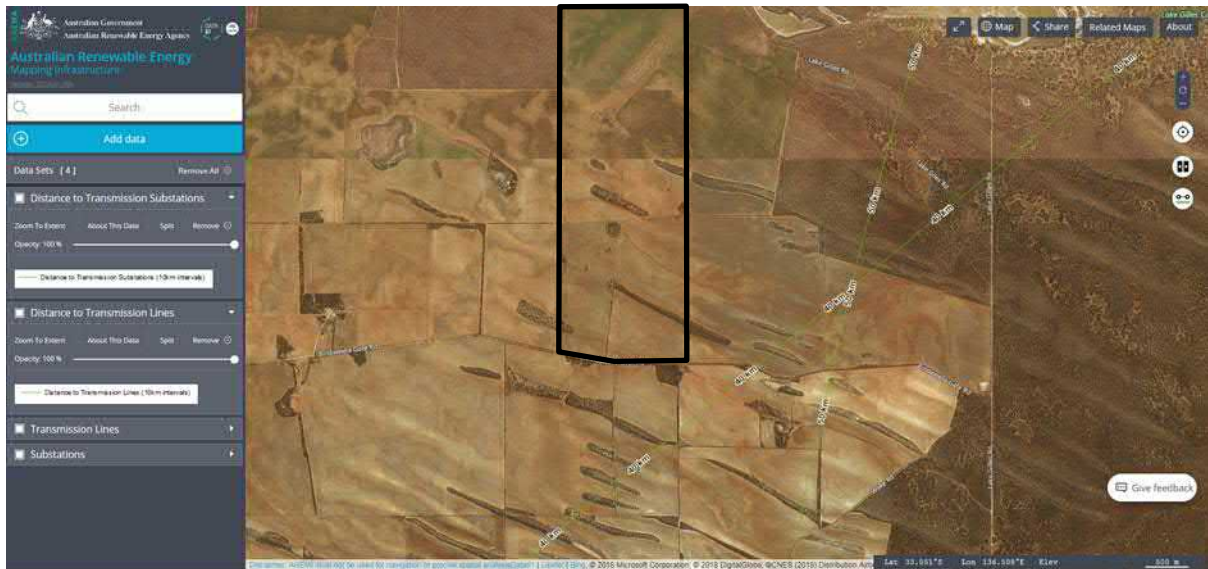
Figure 48 AREMI – Site Map

The Lyndhurst site is approximately 55km from the closest transmission substation (Middleback Tee) and approximately 45km from any transmission line (132kV Cultana to Yadnarie). This can be seen in the image below from AREMI showing in green both the distances from the 132kV transmission line and the transmission substation.

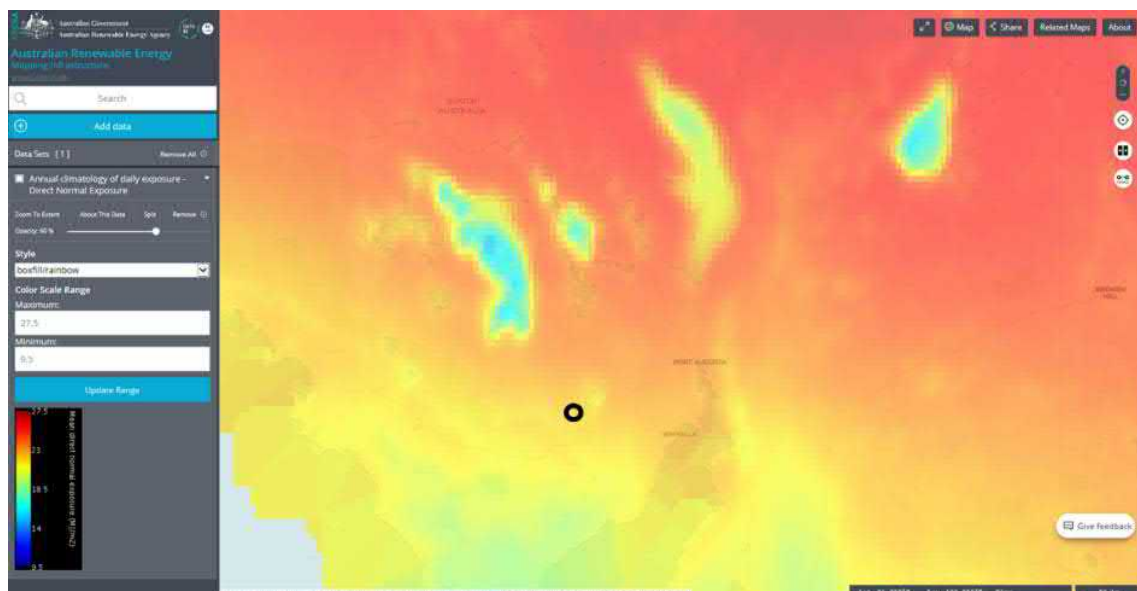
Figure 52 Solar Resource in Lyndhurst Region [1]

The area of moderate/high exposure makes it worthwhile to consider the site as offering potential for installing solar as a generation source. However, considerations for solar PV also need to include temperature and soiling of the panels.

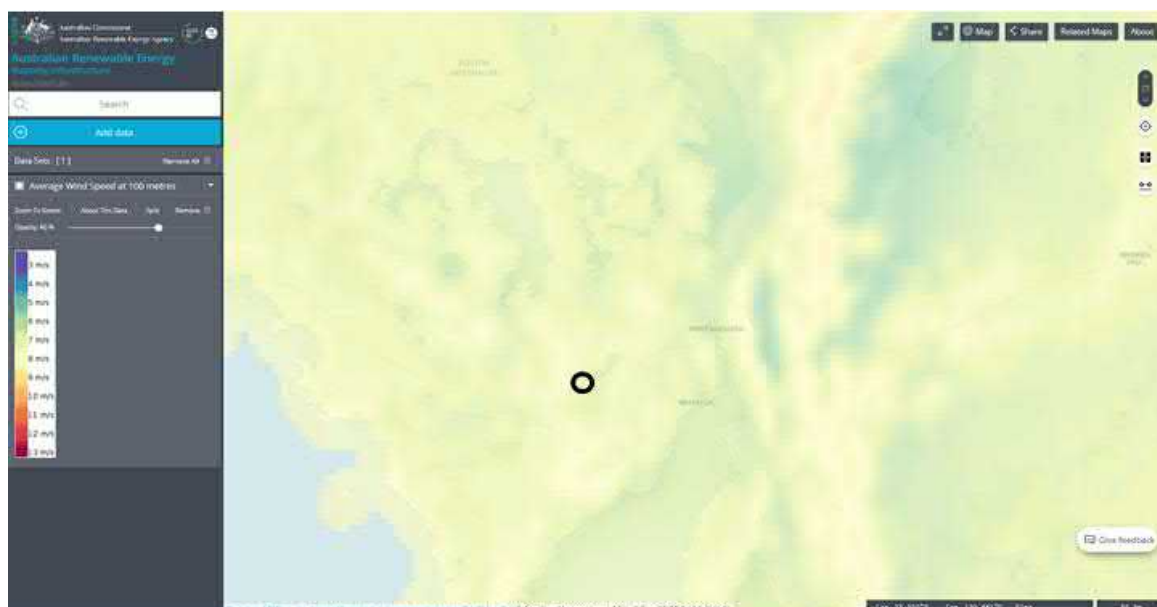
Figure 53 Wind resource at Lyndhurst sites [1]

The area for Lyndhurst shows a moderate wind resource area as outlined in Figure 53 below (Lyndhurst is the black circle). Lyndhurst is in a region of yellow colour (moderate). This resource is typical in the region surrounding Lyndhurst. Similarly to solar PV, some turbines derate at high temperatures and some stop operating at temperatures between 40°C and 45°C. This region reaches these temperatures and must be considered for the annual output.

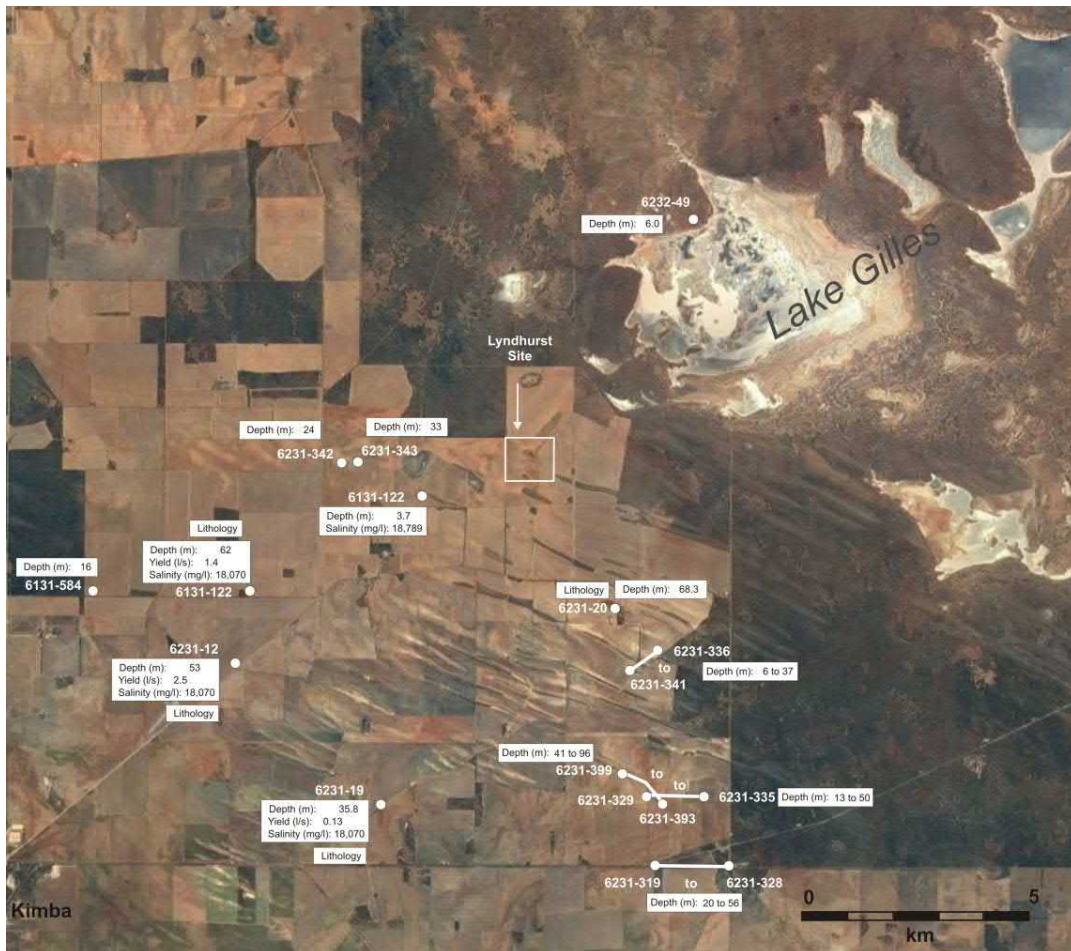
**Figure 55 Registered Groundwater Bores & Summary Data – 10 km Radius of Site (source WaterConnect)**

Figure 55 (main text) identifies the registered wells within a 10 km radius of the site including Unit No. 6131-105 located approximately 5 km south.

Well detail summary information from the bore search is attached as a table with the figure below showing available well depth and salinity information for wells in the general vicinity of the site.

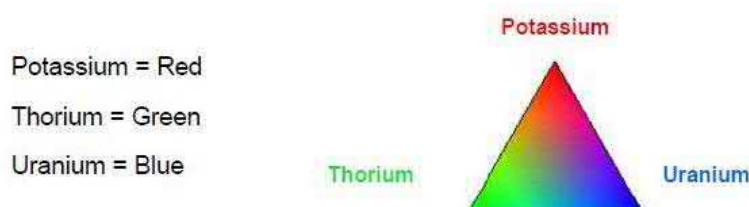
A composite image of all three elements is termed a Ternary image and may range from black (low) to white (high). In the ternary display the ternary ratio provides the relative proportion of potassium, thorium and uranium by assigning the colours red, green and blue to each channel (element).

The relative proportion is useful in mapping the variations in the surface materials and shows a strong correlation to geology and soils.

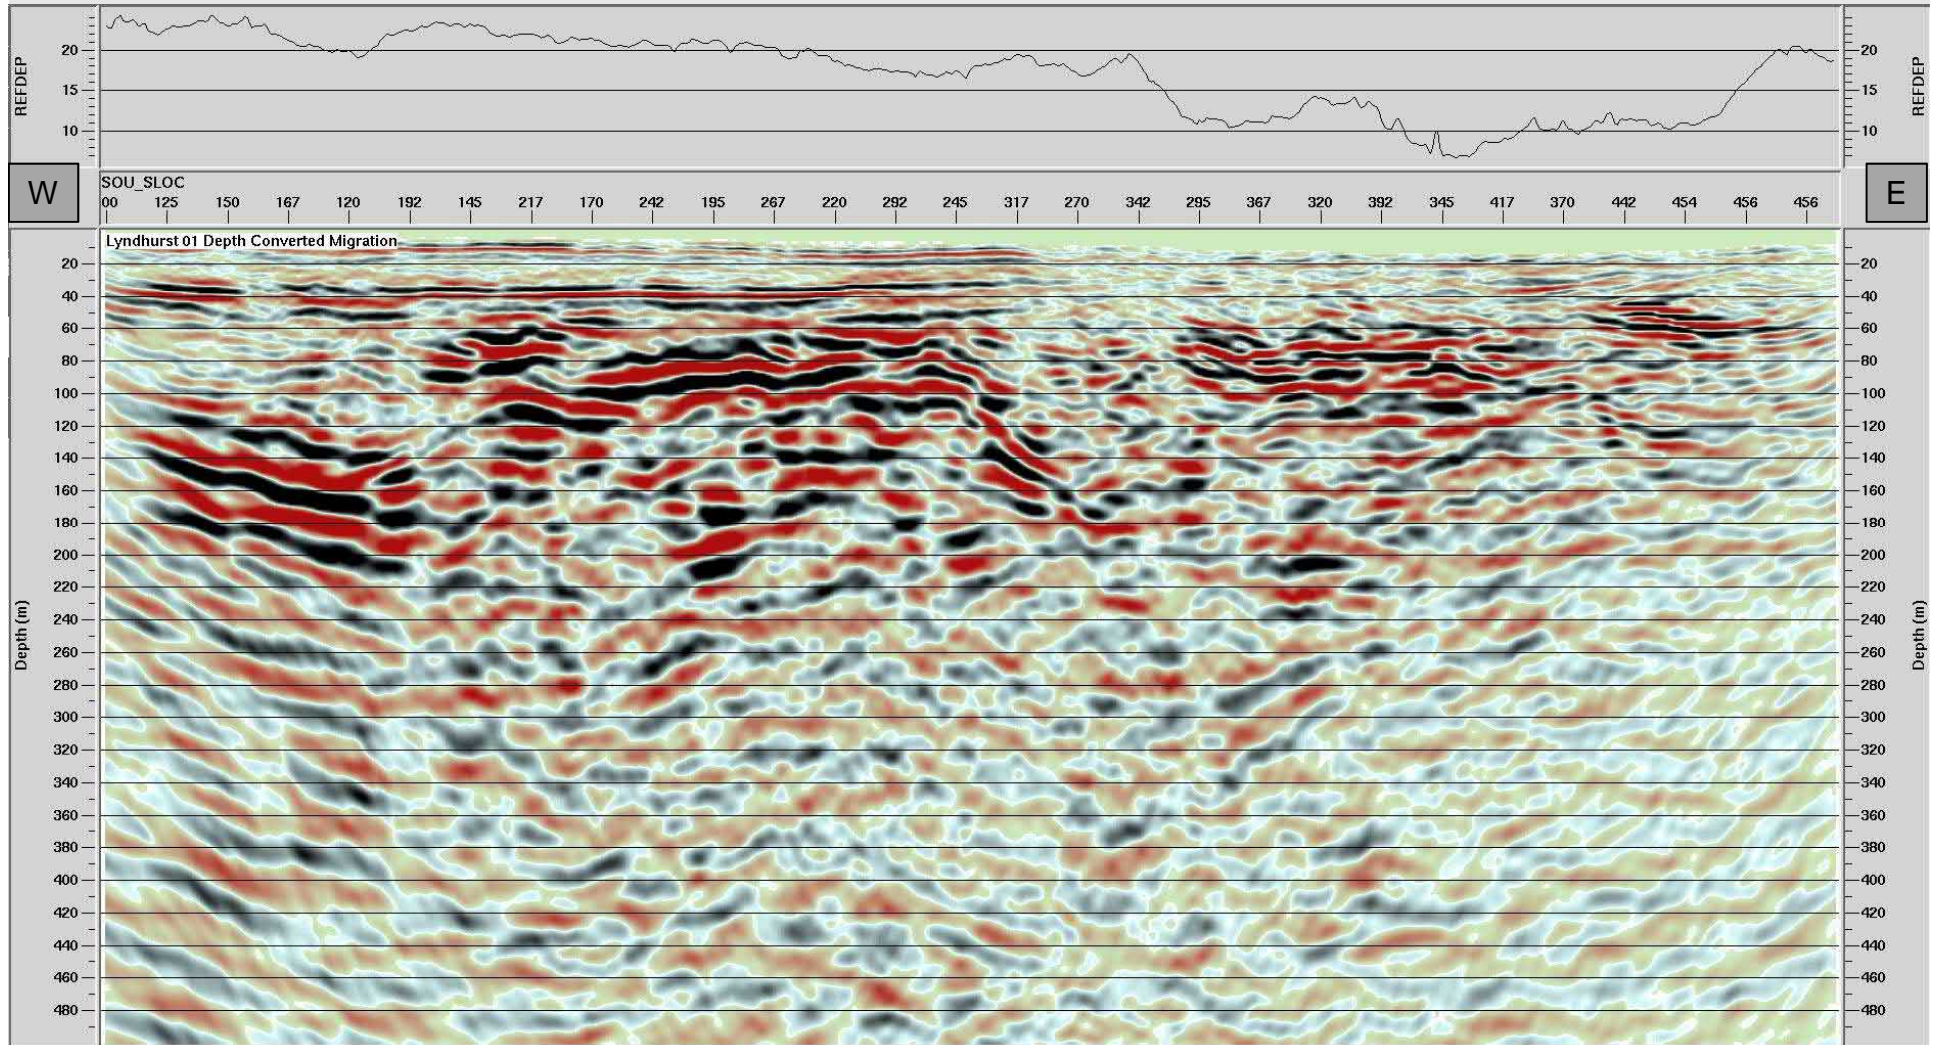
# Lyndhurst 01 Depth Converted Migrated Stack Interpreted Structure

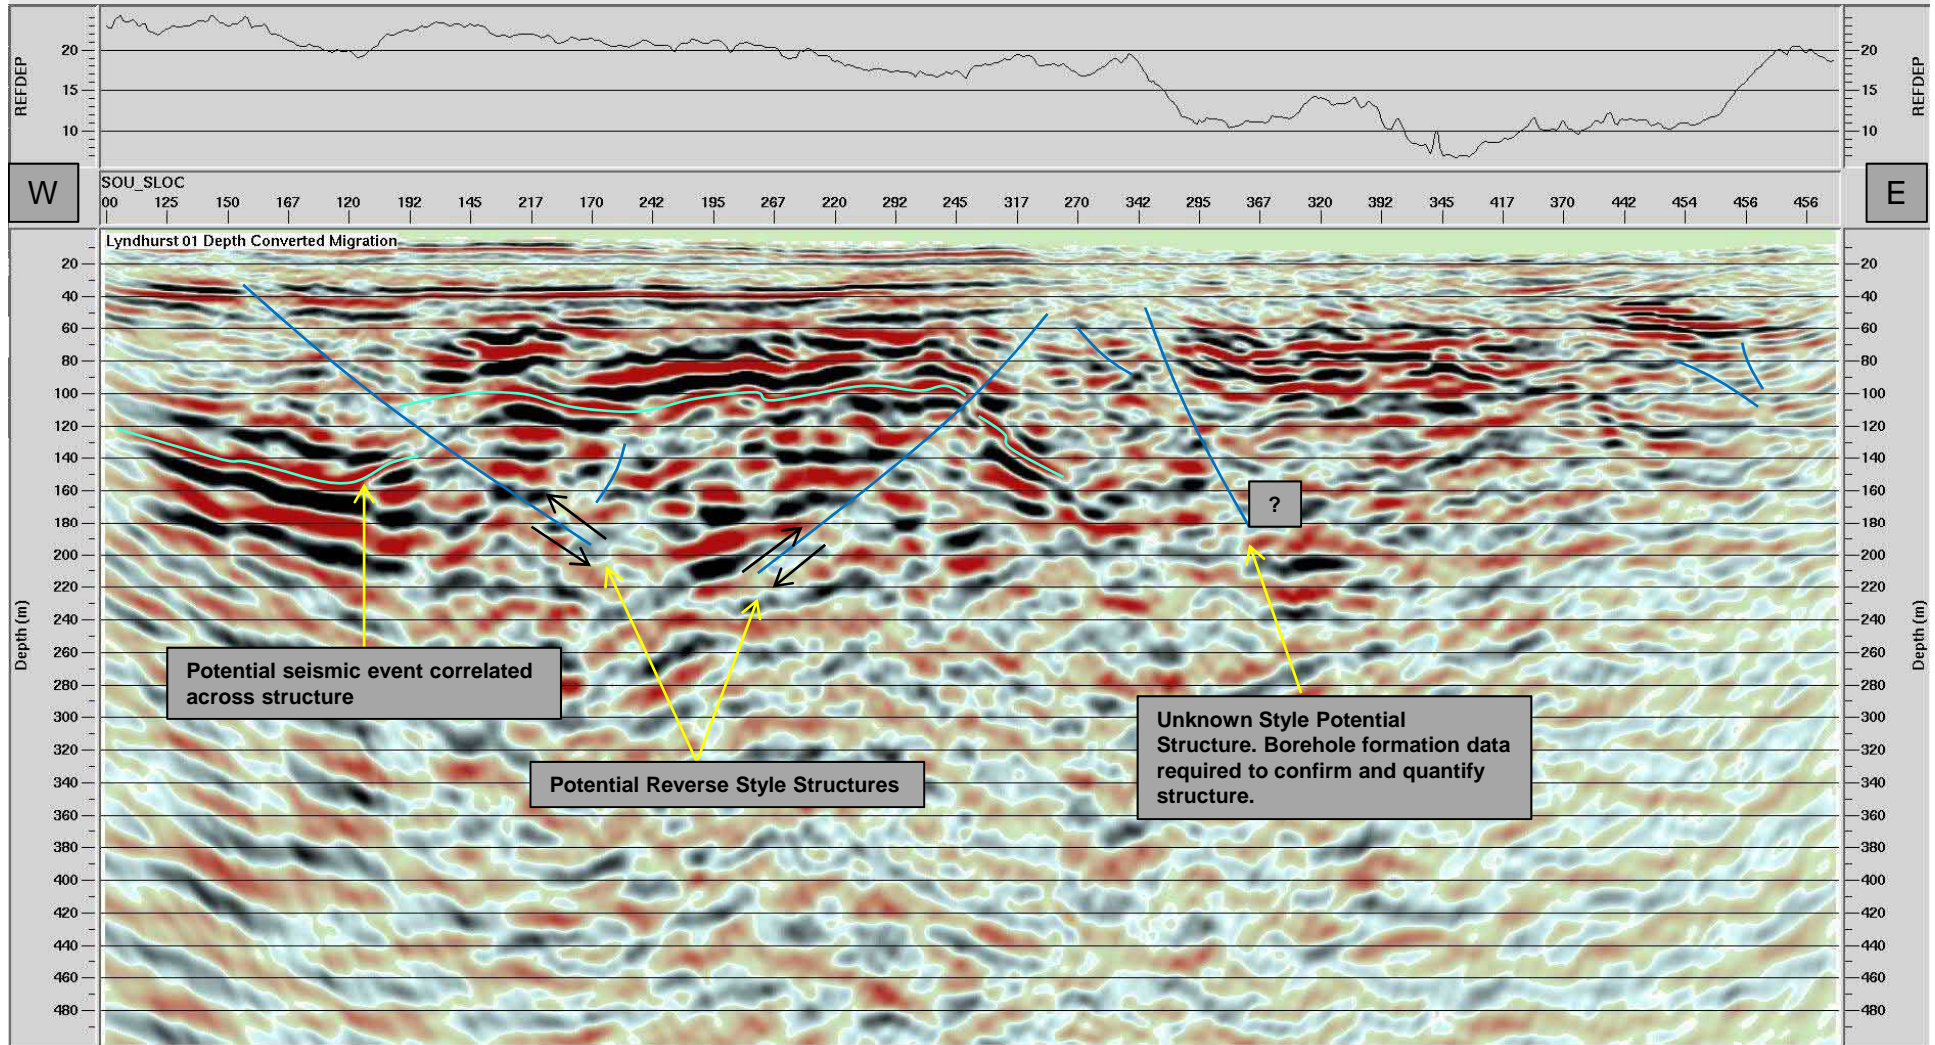
# Lyndhurst 01 Depth Converted Migrated Stack Interpreted Section at near surface

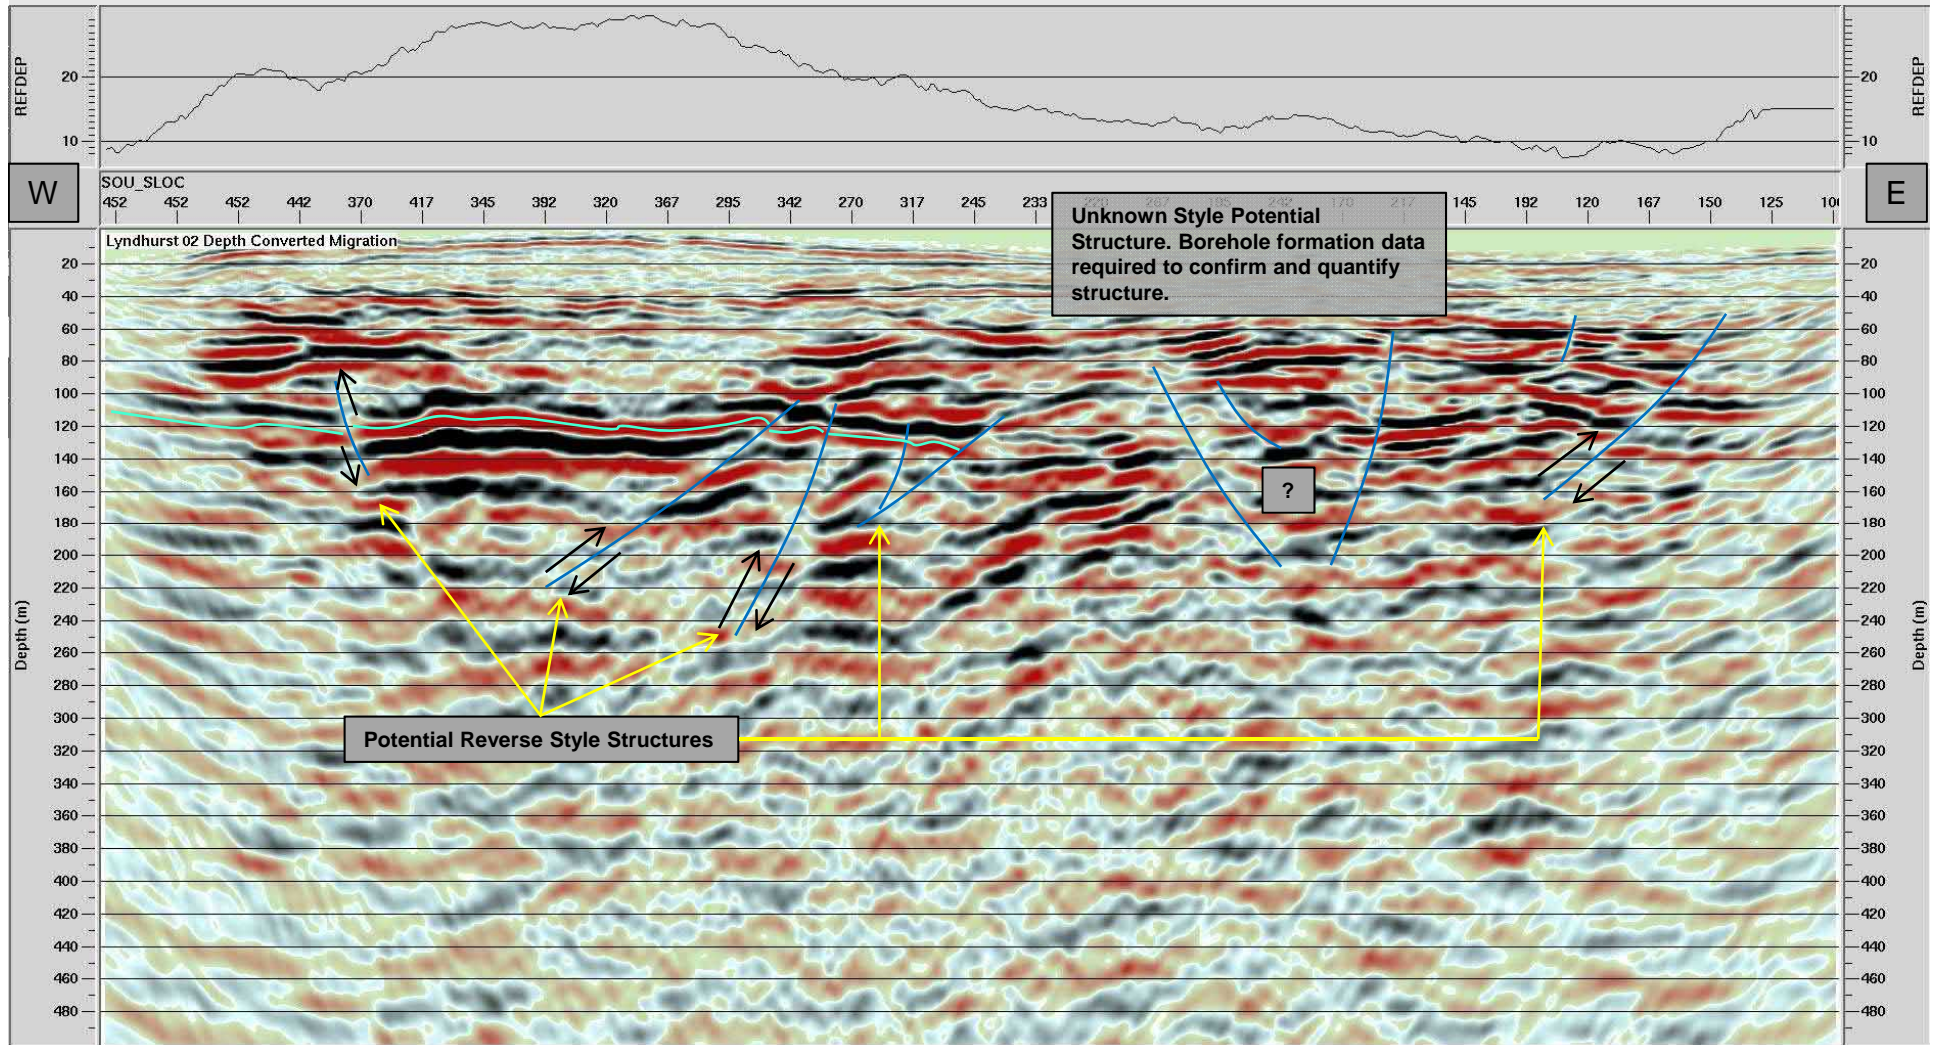
# Lyndhurst 02 Depth Converted Migrated Stack Interpreted Section at near surface
