Project name: HMAS Watsons Redevelopment Project
Address: 1 Watsons Road, Watsons Bay

Gap Bluff Precinct and the South Head, Camp Cove and Green Point Precinct Development

Traffic Advisory Report

Watsons Bay Association
Date: 6 November 2015

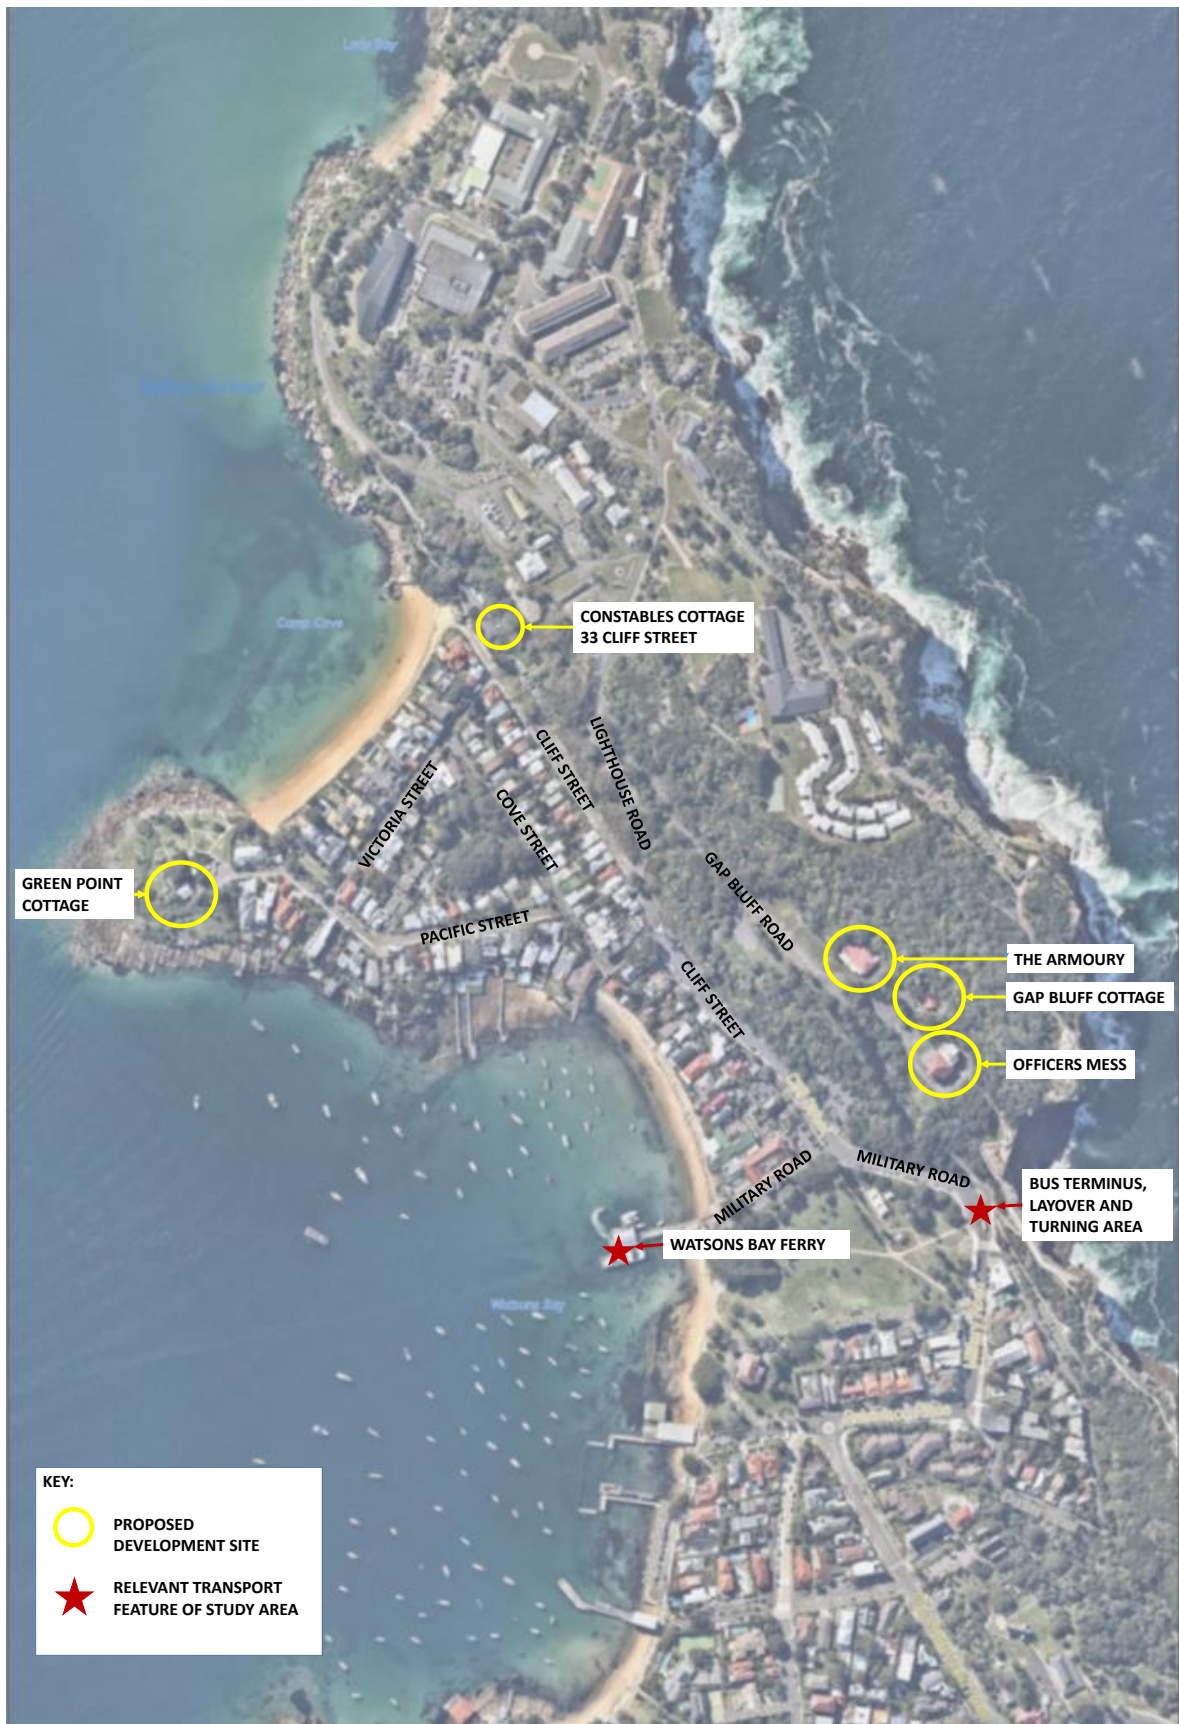
Figure 2-1: Location of proposed development

Figure 2-1 illustrates the location of the proposed development.

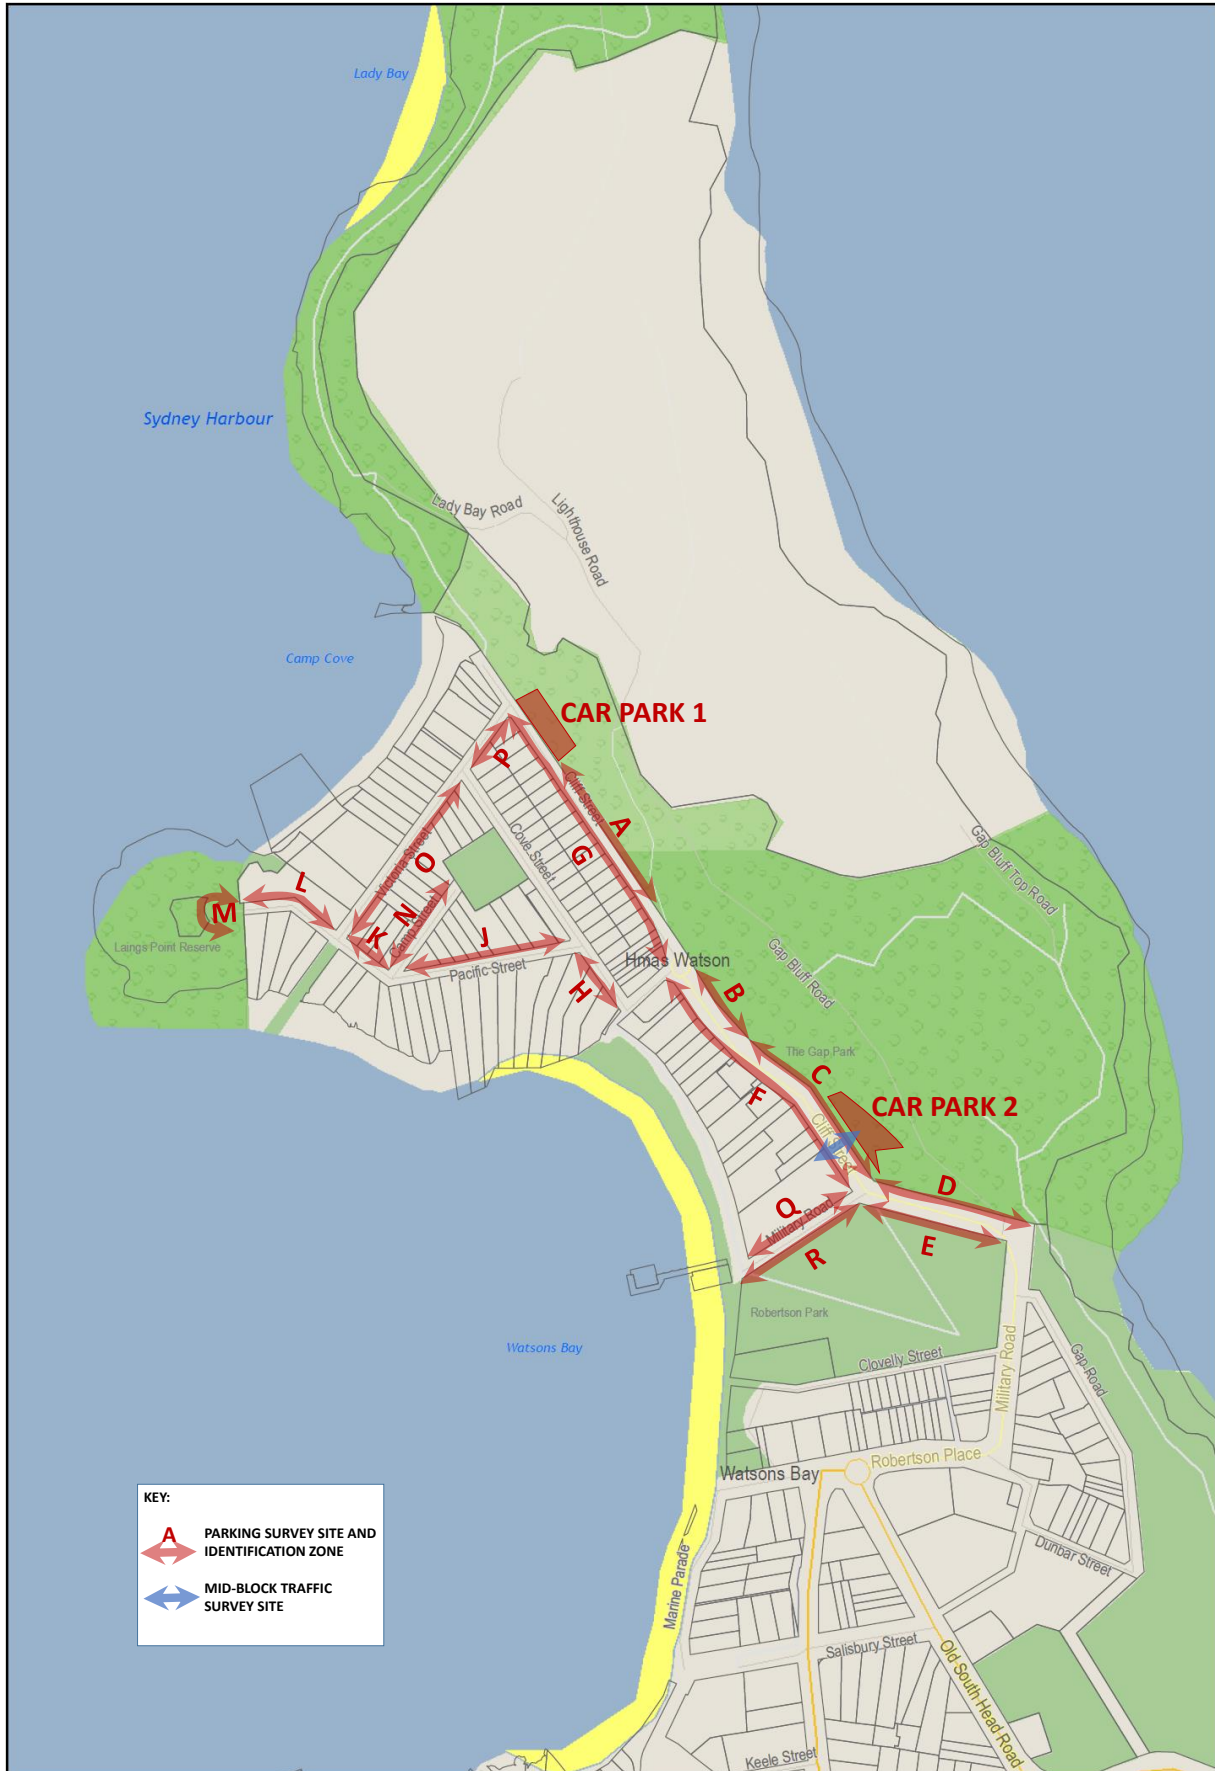
Figure 4-1: Parking and traffic survey locations

Figure 4-1 illustrates the parking survey zones and location of the mid-block traffic and speed survey commissioned for the purpose of this analysis.

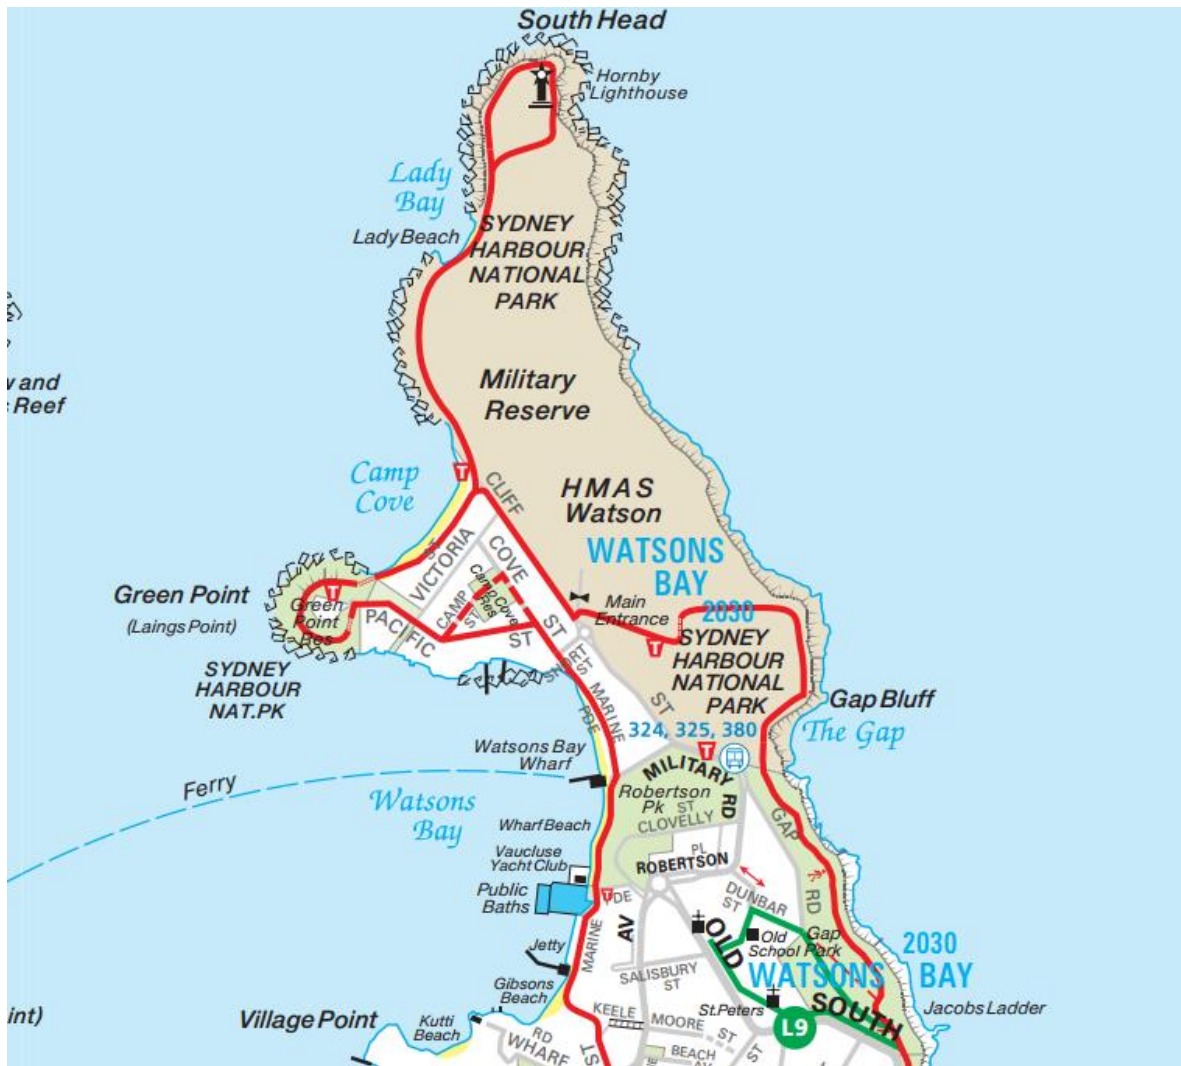
Figure 4-2: Sydney Harbour Bridge to South Head coastal walk (Walking Coastal Sydney, Sydney Coastal Councils Group)

It is further noted that Gap Bluff Road forms part of the Sydney Harbour Bridge to South Head coastal walk and is a major attractor for pedestrians to the area. Increased vehicular traffic to the region and internal circulation could compromise pedestrian safety, particularly during the spring-summer period during which there is high volume of coastal walkers. Figure 4-2 illustrates the Sydney Harbour Bridge to South Head coast walk network within the locality of the subject site.

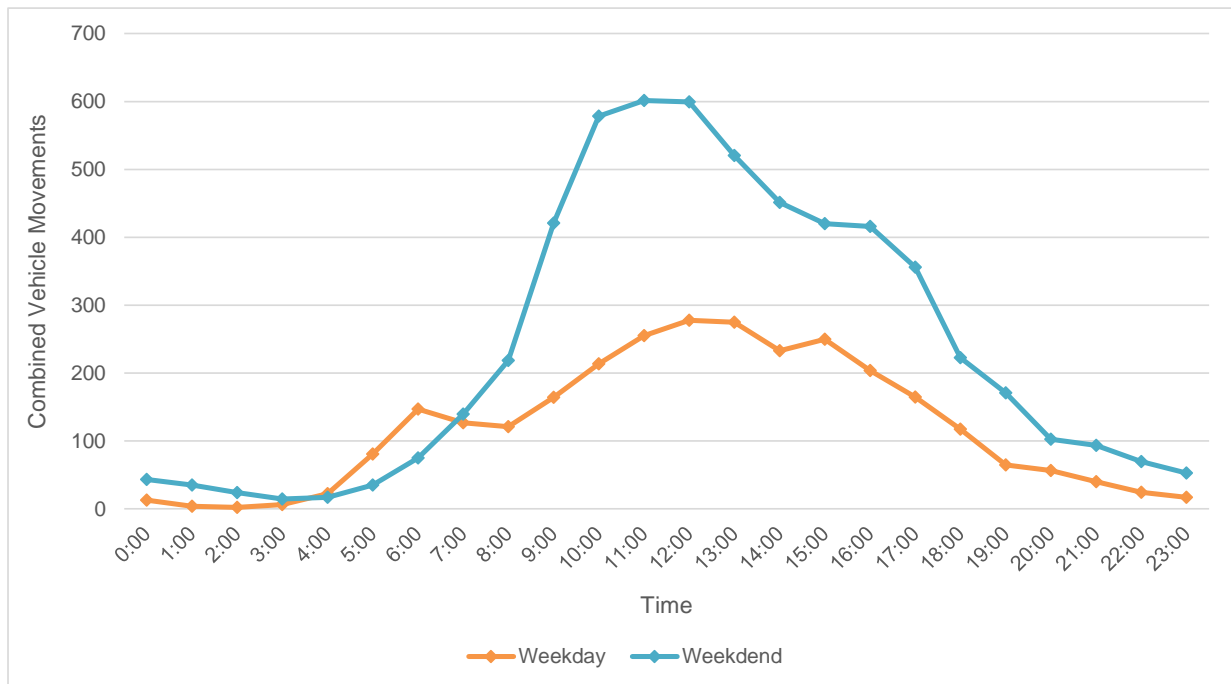
Figure 4-3: Traffic volume data, Cliff Street

- During the weekend peak period (3 to 5 October) the hourly traffic volumes reached up to 734 vehicles per hour (both directions combined). The RMS Guide to Traffic Generating Developments stipulates a maximum peak hour volume of 500 vehicles on collector roads. Hence, the traffic conditions on Cliff Street exceed the environmental capacity threshold.

Figure 4-3 shows the average northbound and southbound traffic volumes for the seven-day period beginning Thursday 1 October, 2015. Appendix B contains the full data set of traffic volumes along Cliff Street.

As seen in Figure 4-3, the average weekday and weekend traffic volumes have increased considerably in comparison to the April period. The weekend average peak period traffic volumes have increased by approximately 63%, which coincides with the high parking saturation experienced in the area.

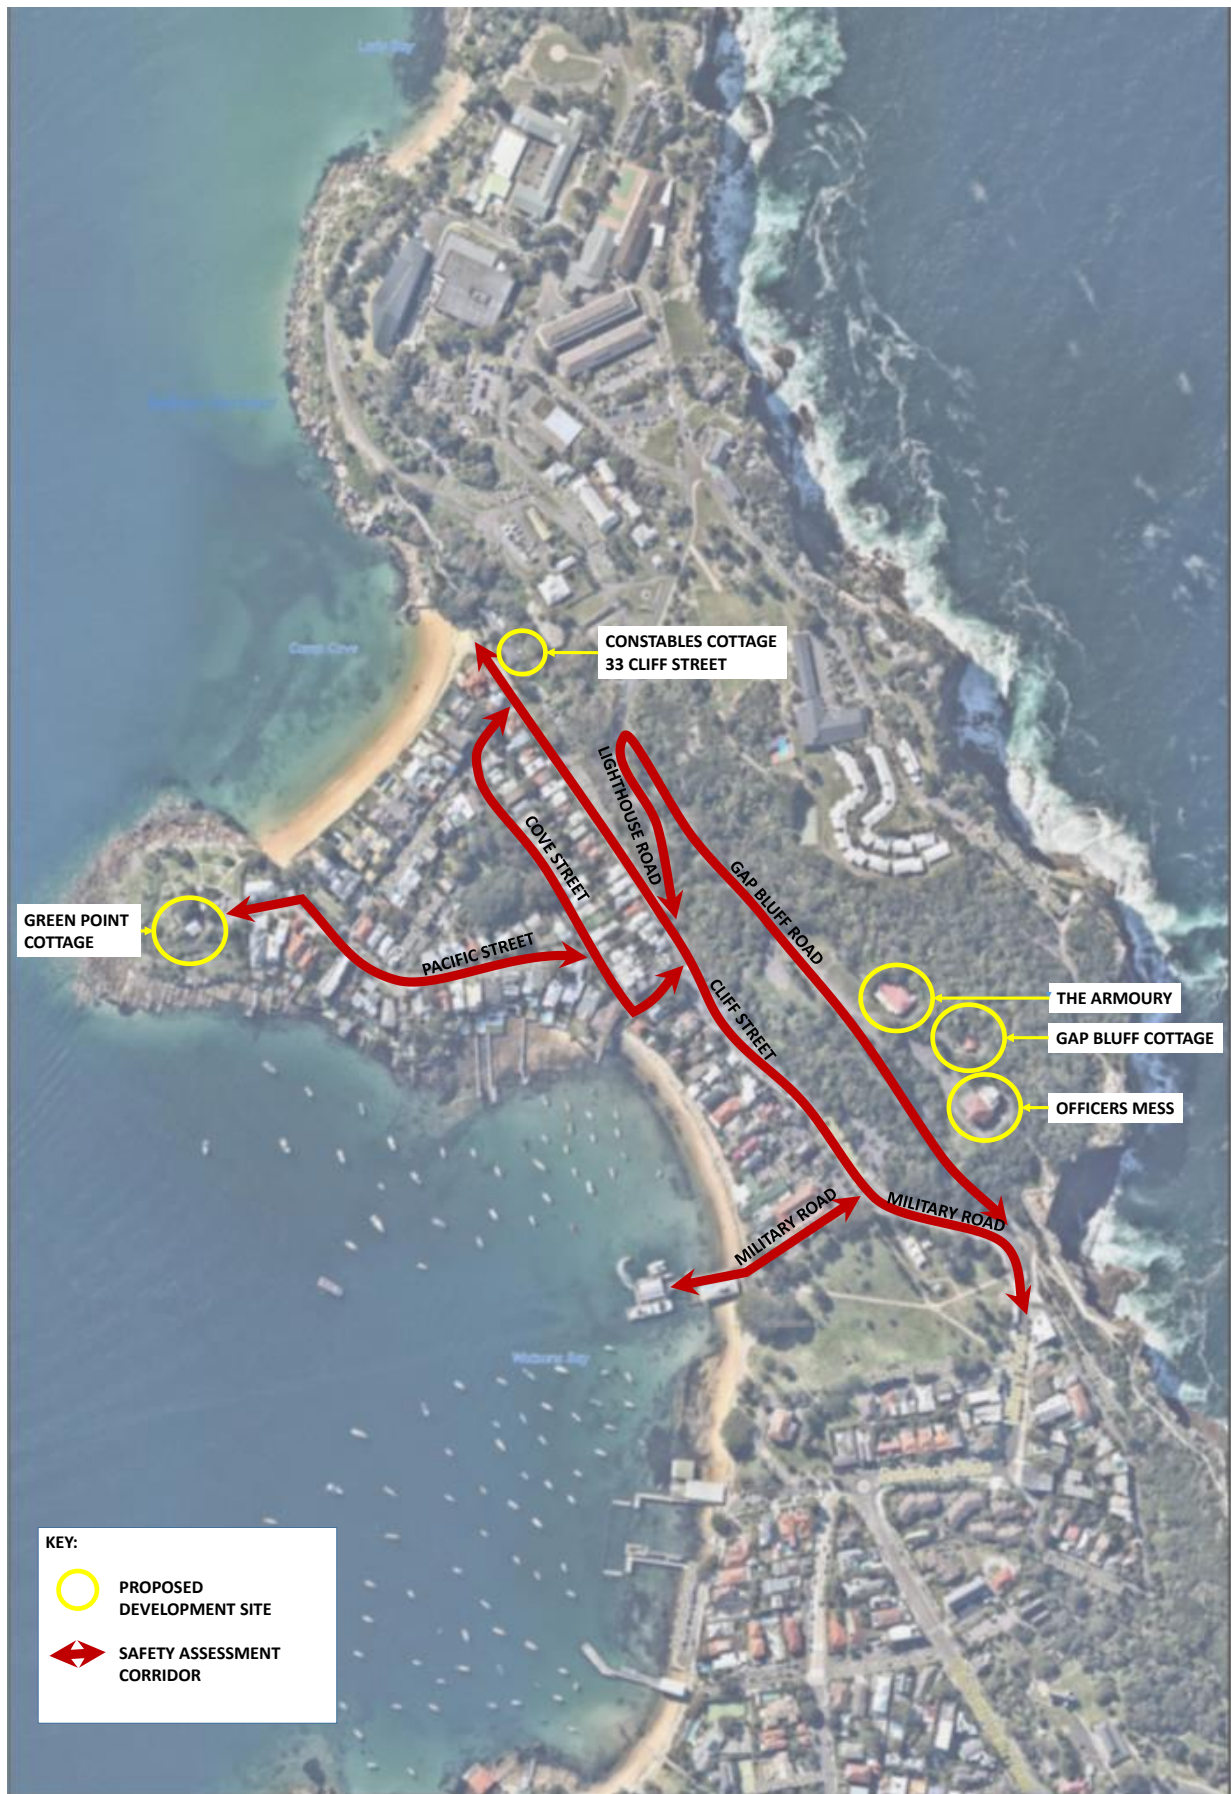
Figure 5-1: Safety assessment area

The safety assessment area focussed on the key vehicular and pedestrian routes likely to be used to access the proposed development sites. Table 5-1 illustrates the safety assessment area and key corridors investigated.

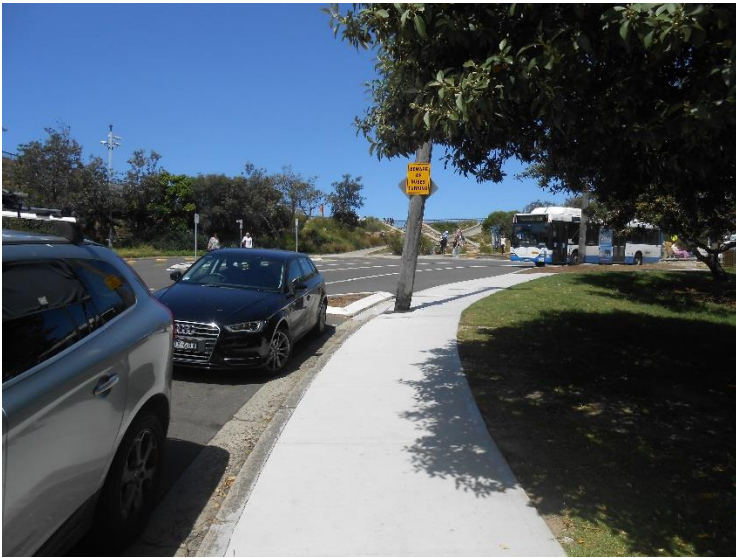
Item	Description	Risk rating	Photo reference
1	<p>There is a footpath located on the north western side of Military Road, between the Watsons Bay ferry wharf and Cliff Street and the bus terminus on Military Road. This footpath has a continuous uphill grade in the north eastern direction, which appears to be greater than the maximum grade for this length, which could result in mobility impaired pedestrians being unable to walk the length of the path without resting. When travelling in the downhill direction, pedestrians in wheelchairs or prams could lose control and enter the road carriageway.</p> <p>The alternative pedestrian access from the ferry terminal to Military Road through Robertson Park also comprises a continual uphill grade towards Military Road.</p>	Medium

<p>Footpath on southern side of Military Road, continuous uphill grade travelling in eastbound direction</p>

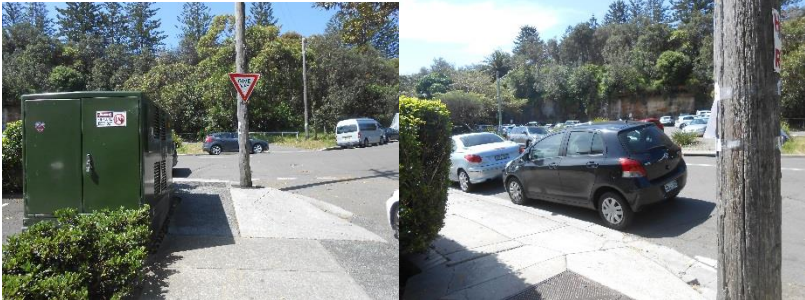
Item	Description	Risk rating	Photo reference
2	To access the footpath on the southern side of Military Road, pedestrians are required to cross at a location with poor sight distance to oncoming traffic, travelling southbound on Cliff Street. The sight distance at this location is obstructed by an electrical supply box, a hedge, vehicles parked kerbside and an electrical pole. This could result in drivers not seeing pedestrians and pedestrian not seeing vehicles creating potential conflicts.	Intolerable

<p>Obstructions to sight distance for pedestrian crossing at intersection of Military Road and Cliff Street</p>
3	There is no direct pedestrian crossing between the footpath along Military Road and the proposed site access at Gap Bluff Road. This could result in pedestrians crossing Cliff Street and Military Road at unsafe locations and being hit by vehicles. This issue is exacerbated by the poor visibility to oncoming traffic because of kerbside parked vehicles and buses parked in the layover area on Military Road. During the site investigation, pedestrians were observed to cross at this location to access Gap Bluff Road. Pedestrians were also observed to be walking along Military Road on the western side within the traffic lanes.	Intolerable

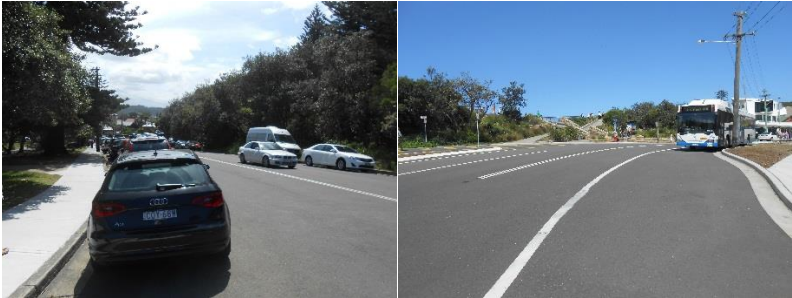
<p>Parked cars and buses obstructing potential informal crossing location for pedestrians accessing Gap Bluff Road from the footpath on Military Road</p>

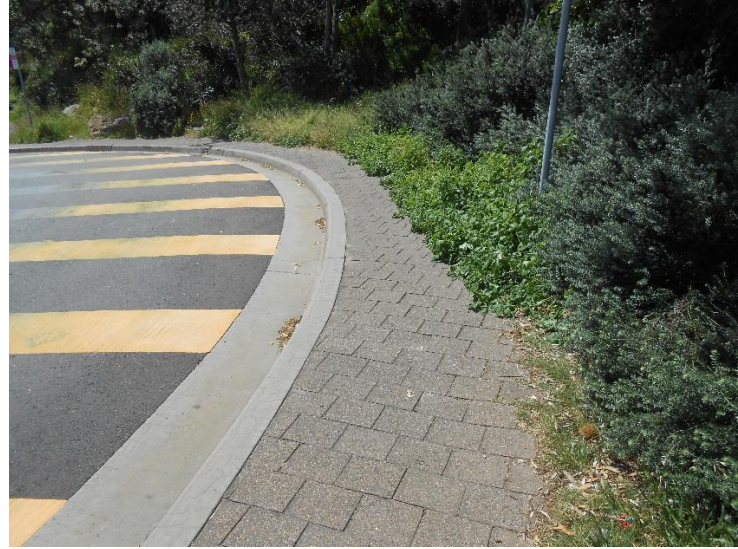
Item	Description	Risk rating	Photo reference
4	<p>The footpath on the eastern side of the bus turning area is narrow and obstructed by vegetation. This footpath does not provide adequate access for mobility and visually impaired pedestrians from the bus stop to the proposed site access at Gap Bluff Road. This could result in pedestrians walking on the bus turning area, creating potential conflicts with turning buses.</p> <p>During the site investigation a number of pedestrians were observed to be walking within the bus turning facility.</p>	High

<p>Footpath on eastern side of bus turning area narrow and obstructed by vegetation</p>
5	<p>There is poor pedestrian access at the Gap Bluff Road entrance on the southern end of the study area, with a narrow footpath on the eastern side, which is obstructed by the sandstone pillar and an informal pedestrian route on the western side comprising loose rock and dirt. This presents potential pedestrian trip hazards and inadequate access for mobility and visually impaired pedestrians.</p>	Medium

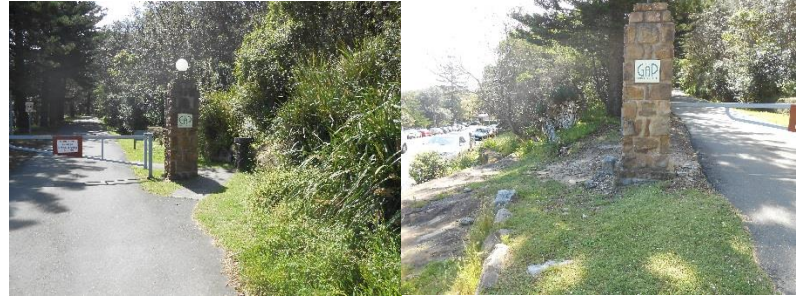
<p>Poor pedestrian access at Gap Bluff Road entrance, southern end of study area</p>

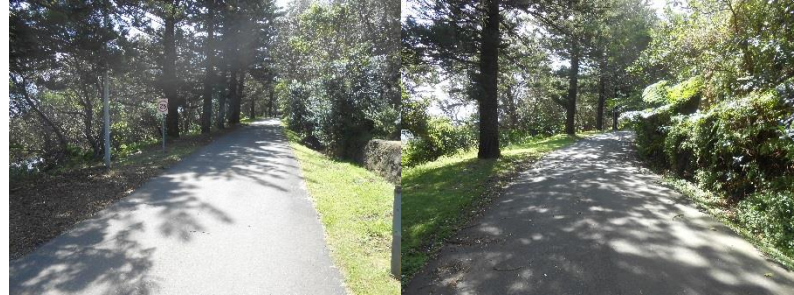
Item	Description	Risk rating	Photo reference
6	Gap Bluff Road is steep and signposted at 25 km/h, which is considered too fast for a shared pedestrian / vehicle zone (10 kilometres per hour). In addition, the curved alignment in combination with obstructions such as rock cuttings and vegetation is likely to result in poor visibility between pedestrians using the road and oncoming traffic. Additionally, the grade of Gap Bluff Road appears to be greater than six per cent for the majority of its length, with limited passing opportunities. This grade is considered unsuitable for buses and could result in drivers becoming impatient with slower vehicles travelling uphill and performing hazardous manoeuvres to overtake vehicles.	High

<p>Gap Bluff Road, steep vertical alignment and curved horizontal alignment in combination with rock cuttings and vegetation hindering sight distance</p>
7	The camber of Gap Bluff Road at the proposed car park access to the development site is steep, which is combined with the location of a drainage channel and pit. This could result in vehicles losing control at this location and driving into the drainage channel and pit.	Low

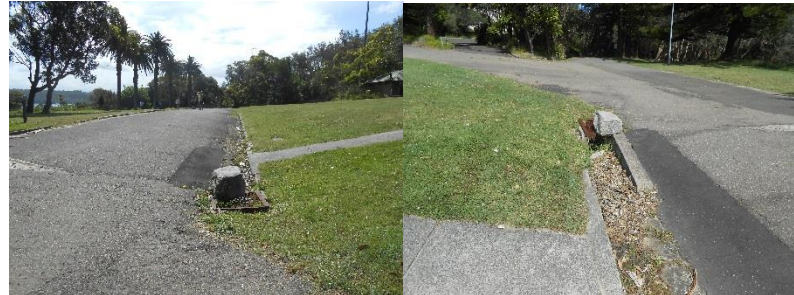
<p>Steep road profile and drainage channel and pit, adjacent to Officers Mess site entrance</p>

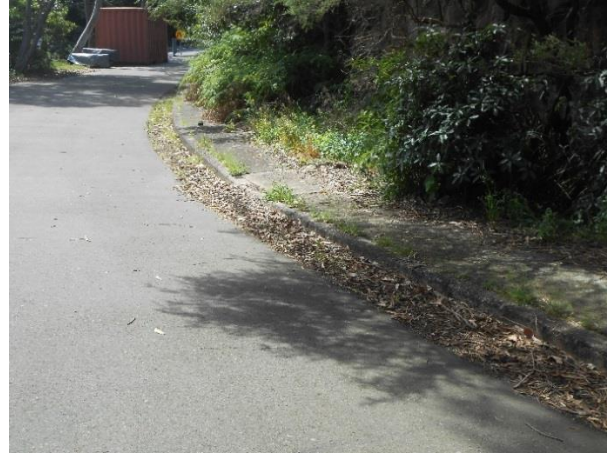
Item	Description	Risk rating	Photo reference
8	<p>The narrow footpath located on the eastern side of Gap Bluff Road on its northern end was observed to be covered in debris, which presents trip and slip hazards for pedestrians. The narrow path is also likely to result in pedestrians walking within the traffic lanes, creating potential vehicular / pedestrian conflicts.</p> <p>Additionally, the gutter was full of debris at the time of the site investigation, which could result in poor drainage and vehicle skids / loss of control.</p>	Medium

<p>Narrow footpath obstructed by vegetation and debris on Gap Bluff Road</p>
9	<p>There is no formal pedestrian connection between the existing footpath on Gap Bluff Road and the pedestrian crossing located on Lighthouse Road. Pedestrians are currently required to cross Gap Bluff Road and walk on the uneven and steep surface between Gap Bluff Road and Lighthouse Road to access the pedestrian crossing. This surface comprises loose gravel and dirt, which presents a slip / trip hazard. This informal path is unsuitable for mobility and visually impaired pedestrians.</p>	High	  <p>Lack of formal pedestrian access from Gap Bluff Road footpath to pedestrians crossing on Lighthouse Road</p>

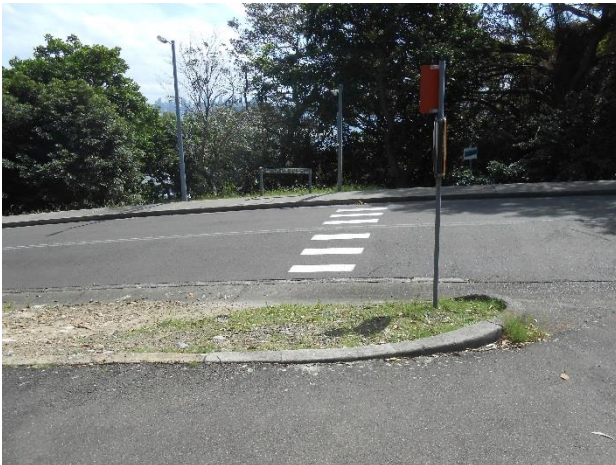
Item	Description	Risk rating	Photo reference
10	The existing pedestrian crossing on Lighthouse Road is non-standard. The crossing is too narrow and there is not kerb ramp located on the western end of the pedestrian crossing. In addition, the visibility for drivers approaching from the south of Lighthouse Road have poor visibility to the crossing and pedestrians waiting to cross on the eastern side, due to the vertical and horizontal alignment of Lighthouse Road.	High

<p>Non-standard pedestrian crossing on Lighthouse Road</p>
11	The left turn from Gap Bluff Road into Lighthouse Road has poor horizontal and vertical alignment. There is insufficient turning path for drivers to perform this manoeuvre without crossing the barrier centre line into the opposing traffic lane. This is particularly an issue for heavy vehicles and buses.	High

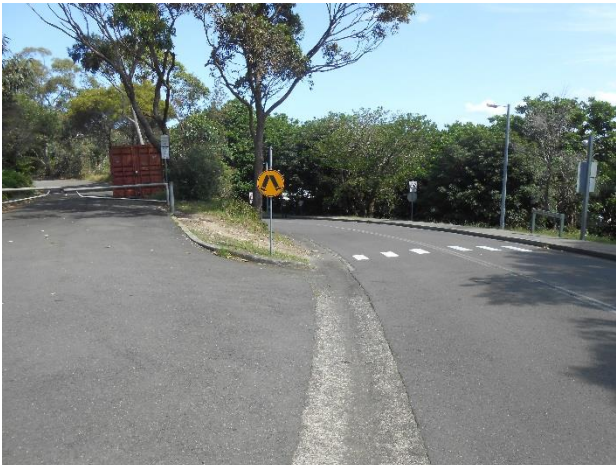
<p>Poor horizontal and vertical alignment, left turn from Gap Bluff Road into Lighthouse Road</p>

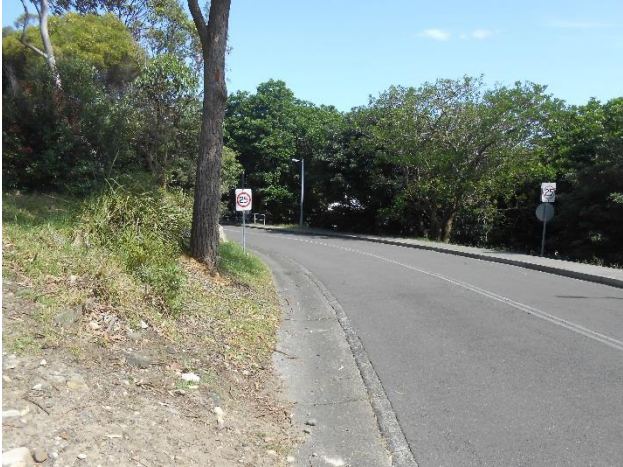
Item	Description	Risk rating	Photo reference
12	The barrier line around the curve of Lighthouse Road on its approach to the intersection with Gap Bluff Road is faded and is difficult to see, particularly at night. There are also no reflective raised pavement markers along this delineation. This could result in drivers not being able to judge the alignment of the road and losing control and encroaching on the opposing traffic lane.	High

<p>Faded barrier centreline, Lighthouse Road</p>
13	The pedestrian railing located along the western side of Lighthouse Road is non-standard and would be insufficient for containing pedestrians tripping causing them to fall over the railing and onto the steep embankment adjacent to the path.	Medium

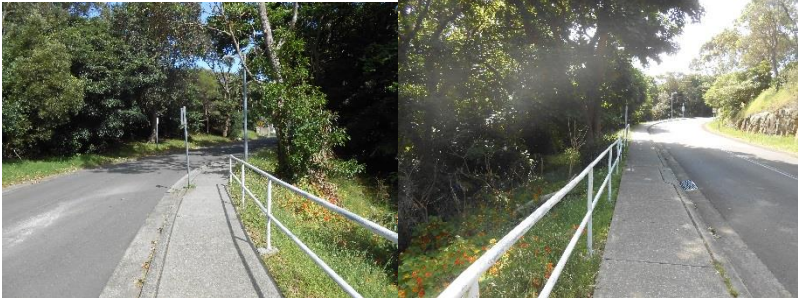
<p>Non-standard pedestrian railing along footpath on Lighthouse Road</p>

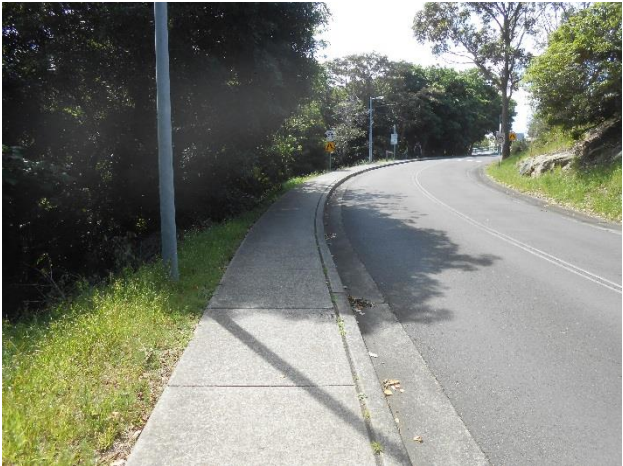
Item	Description	Risk rating	Photo reference
14	<p>The footpath along Lighthouse Road has a continuous uphill grade in the north eastern direction, which appears to be greater than the maximum grade for this length, which could result in mobility impaired pedestrians being unable to walk the length of the path without resting. When travelling in the downhill direction, pedestrians in wheelchairs or prams could lose control and enter the road carriageway.</p>	Low

<p>Steep grade footpath on Lighthouse Road, towards north</p>

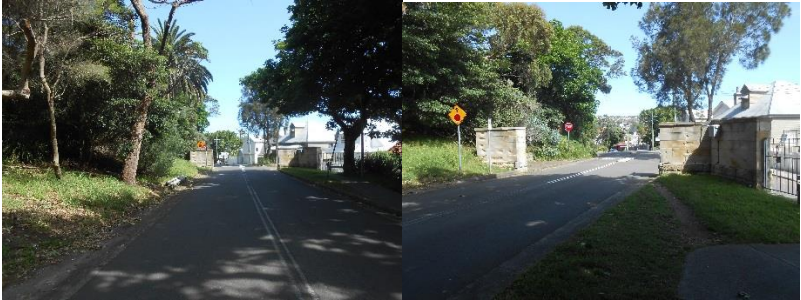
Item	Description	Risk rating	Photo reference
15	<p>The stop sign on the southbound approach of Lighthouse Road its intersection with Cliff Street is unclear and blocked by the sandstone wall. A warning sign is posted on the northern side of the sandstone wall, however, if the stop sign is not seen by drivers, the stop line is located on a crest and is unlikely to be seen by approaching vehicles. This could result in vehicles driving through the intersection without stopping and causing potential vehicular conflicts.</p> <p>This issue is exacerbated by the poor sight distance to vehicles on the southbound approach from Cliff Street's one-way section, which is hindered by the sandstone wall.</p>	High

<p>Poor visibility to stop sign and traffic approaching southbound from Cliff Street</p>

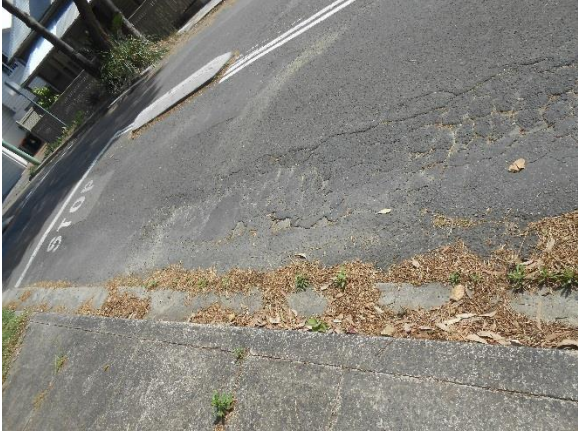
Item	Description	Risk rating	Photo reference
16	<p>The pavement on Lighthouse Road on the approach to its intersection with Cliff Street is in poor condition with debris in the gutter. This could result in vehicles skidding at this location and losing on approach to the intersection.</p>	Low

<p>Pavement in poor condition on Lighthouse Road at intersection with Cliff Street</p>
17	<p>The left turn from the Cliff Street southbound approach into Lighthouse Road has insufficient radius to perform the manoeuvre without encroaching into the opposing traffic lane, creating potential vehicular conflicts.</p> <p>This issue is of particular concern for drivers who are visiting the area and are unfamiliar with the road network.</p>	High

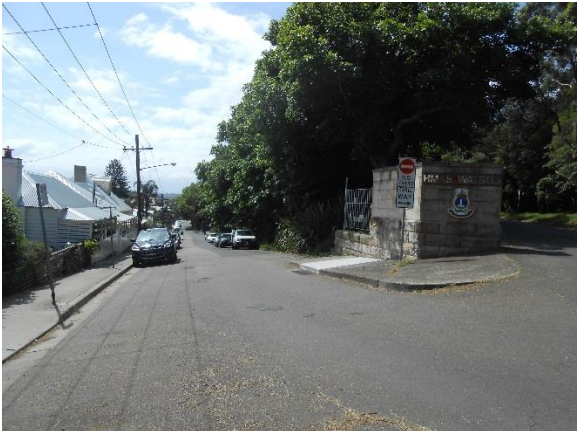
<p>Tight curve radius for traffic turning left from Cliff Street into Lighthouse Road</p>

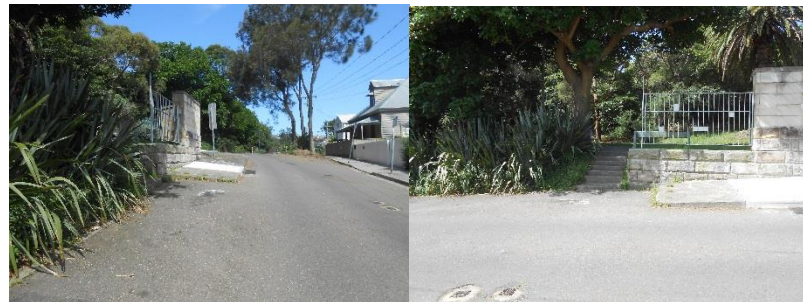
<p>Poor sight distance for southbound traffic on Cliff Street to pedestrian stairs between Lighthouse Road and Cliff Street</p>

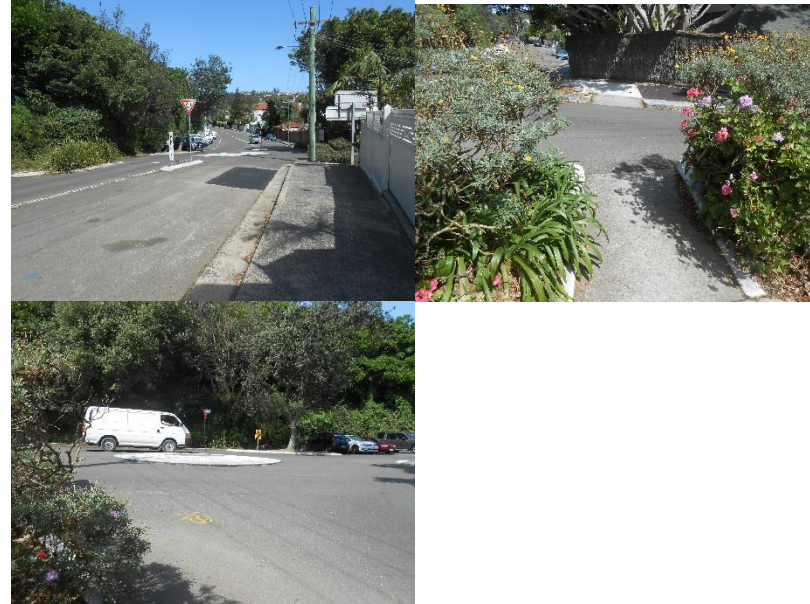
Item	Description	Risk rating	Photo reference
22	Sight distance from the southbound Cliff Street approach to pedestrians crossing Cove Street is poor and is obstructed by property fencing and a planted kerb build-out. Drivers would not be able to see pedestrians crossing at this location until they are in the roundabout's circulating lane. This could result in vehicular and pedestrian conflicts at this location.	High

<p>Poor sight distance from southbound traffic on Cliff Street to pedestrians crossing Cove Street</p>

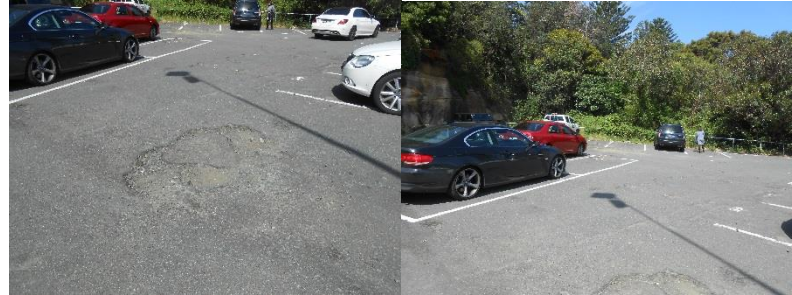
Item	Description	Risk rating	Photo reference
24	<p>The off-street car park located on Cliff Street, opposite Watsons Bay Hotel comprises a poor layout, with a poor circulating arrangement, a number of parking spaces that are difficult to access and pavement that is in poor condition. These issues could result in vehicles hitting parked vehicles to enter an exit parking spaces, vehicular conflicts associated with the poor circulating arrangement and slip and trip hazards for pedestrians accessing their vehicles as a result of the poor pavement conditions.</p> <p>The issue of poor layout is likely to be exacerbated by the car park being over-capacity</p>	Medium

<p>Poor pavement conditions, layout and circulating arrangement of off-street car park on Cliff Street</p>

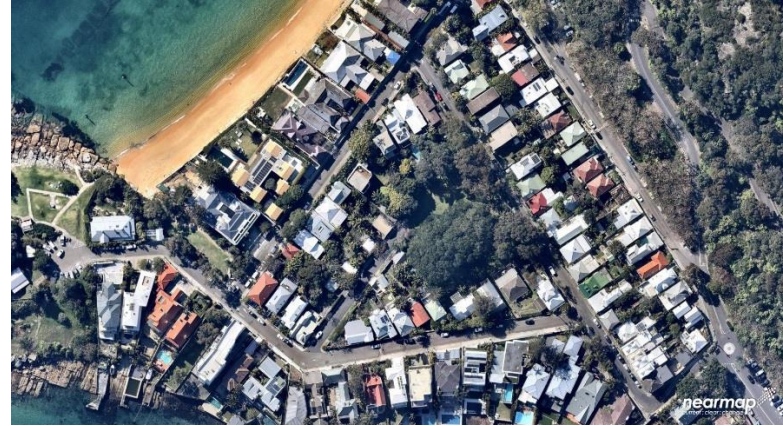
Item	Description	Risk rating	Photo reference
25	<p>The road network within Watsons Bay is very narrow with kerbside parking allowed on the majority of the corridors, particularly along sections of Cliff Street, Pacific Street and Cove Street. During periods of congestion and vehicles waiting to park on the kerbside, there are limited opportunities for overtaking and passing. This could result in drivers becoming impatient and performing hazardous manoeuvres to pass vehicles waiting to park or queued traffic.</p> <p>This issue is of particular concern for emergency vehicle access with the corridor constrained by property boundaries close to the carriageway, which restricts emergency vehicles from mounting the kerb to pass traffic.</p>	Low

<p>Narrow road network around Watsons Bay</p>
