Senate Committee Enquiry – Primary Schools for the Twenty First Century

Subject : Schools - Education Revolution – Stimulus – Balance of Grant Monies

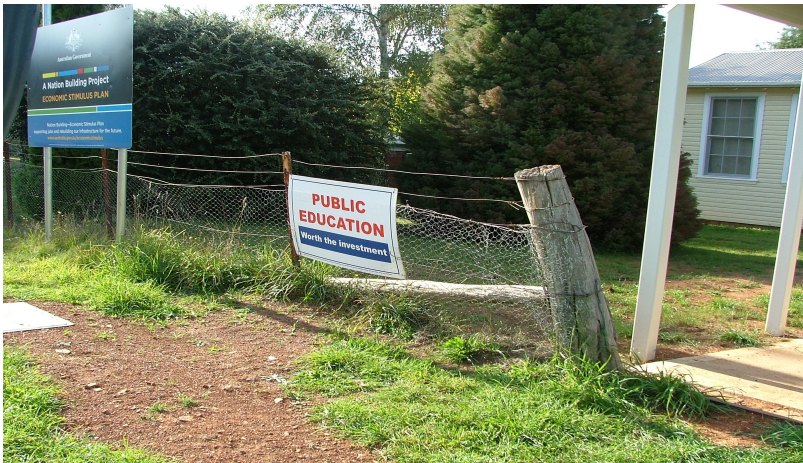
The Main Entrance to the school, showing the construction of the fence and the disconnected strainer. Approximately 80 meters of fence is in the same or worse condition, and should be replaced. Vehicle and pedestrian gates are needed to facilitate entry to the playground area for emergency vehicles - ambulance or fire brigade for example. Emergency services would have to knock down a portion of the rickety fence to gain access to the playground. A gate can't be attached to that post!

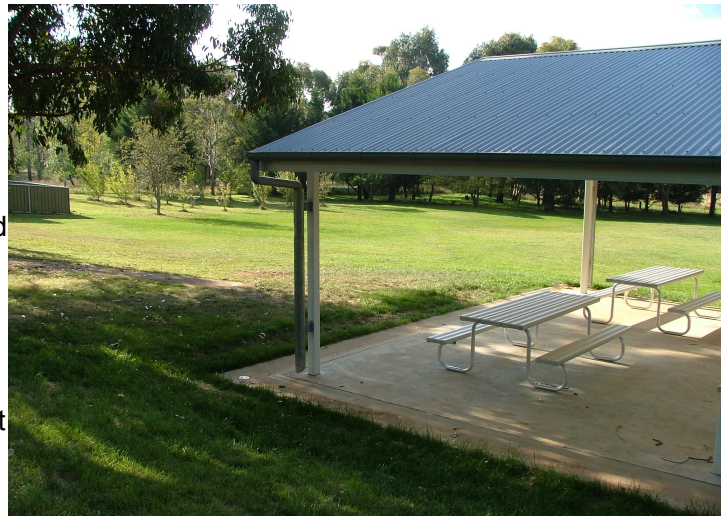
The south west corner of the COLA. The rain water discharges to an extremely shallow spoon drain with 2 shower-size inlets to an underground drain. The catchment area on the uphill side of the COLA is without any drainage, and in the event of heavy rain the road drains indirectly onto the COLA floor and will flood it. In the normal winter weather of nightly frost this will resemble a skating rink, and render the COLA unusable and dangerous for our children. The roadway (Avoca Street) above has no gutter formed, and is not kerbed. Clearly no one has thought about drainage or frost or wind at the 1210m elevation of Black Springs Public School.

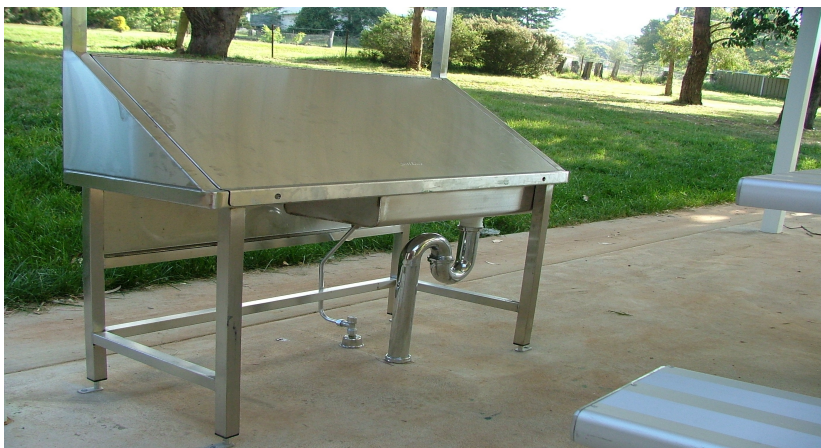
The stainless steel sink is a thoughtful inclusion in the COLA, however during the summer it is unlikely to have water available should no extra tanks or rainfall be available.

You will note that there is no lagging provided to the water inlet or to the drain from the sink. From mid May until October the sink will not be in use owing to frozen inlet and/or outlet pipes. Soil is frozen to 200mm in winter.

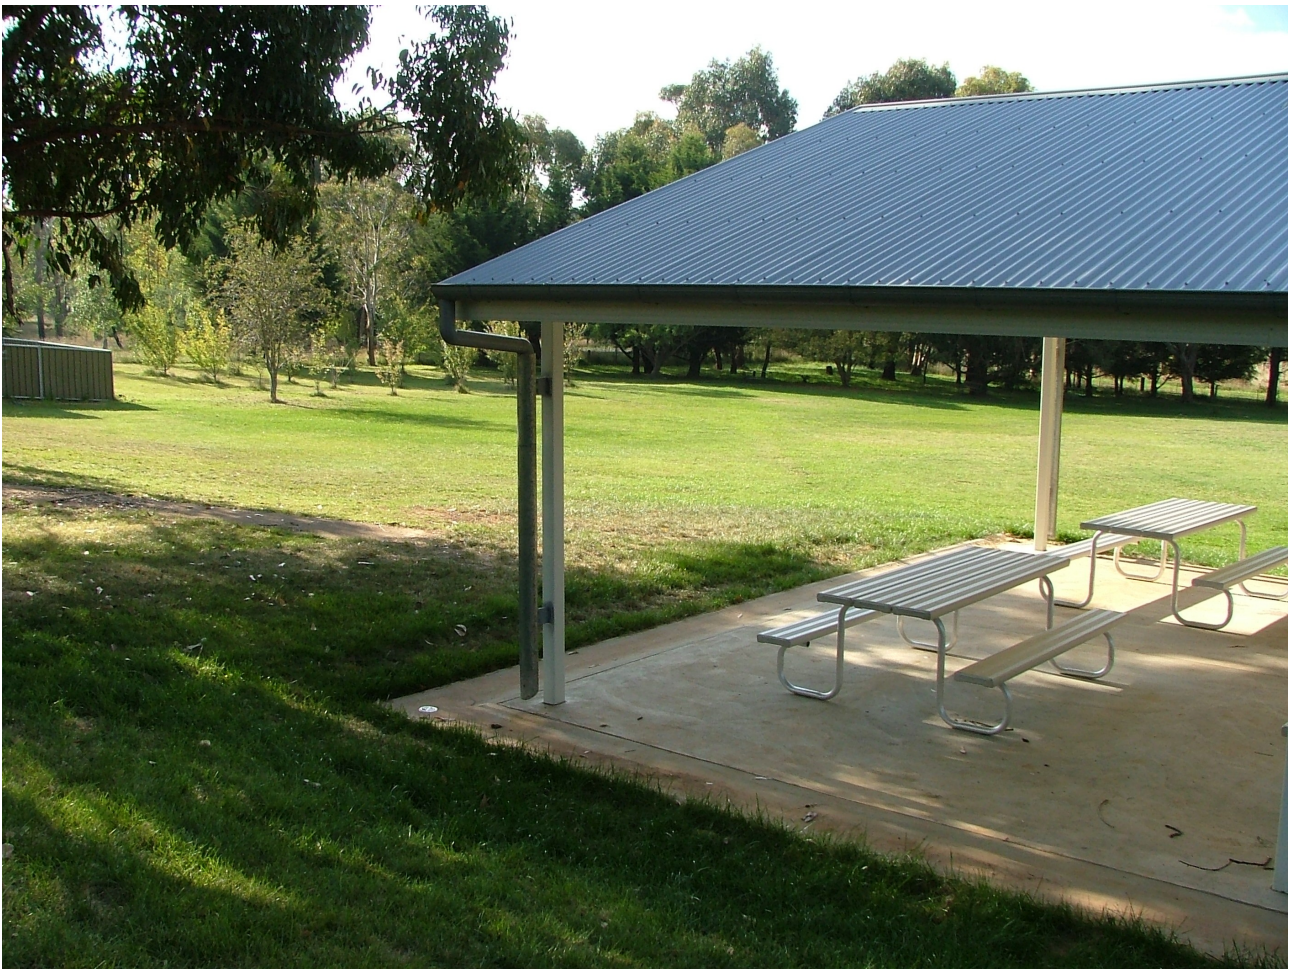
This our new COLA. It is nearly as big as the double carport and lock-up garage just built nearby, which cost under \$16,000.

The roof drains do not connect to water tanks which is a pity as any rain will be wasted.

The seats are very cold to sit on after a frost, and we won't be able to use it when it snows, or when it rains heavily as the floor floods from the road drainage.

The sink is a good idea, but the pipes are not lagged and will freeze and burst in winter.

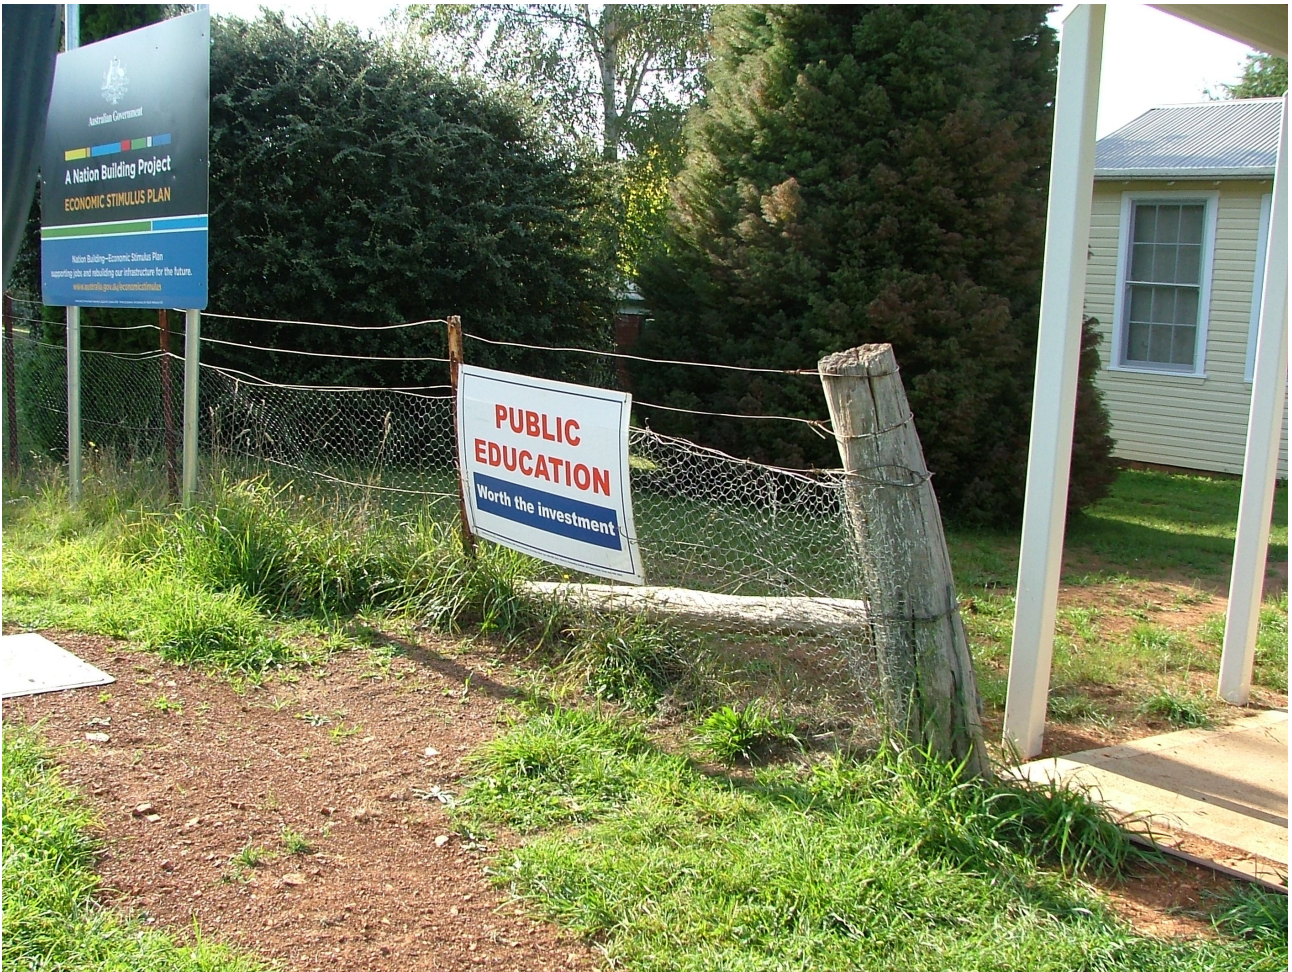
This is the main entrance to our little school. It shows our new path and covered walkway to the front door.

We would like to have a gate to keep out stray dogs, but the post is too rotten, and it would be nice to have a new fence with a big gate so that the fire brigade and ambulance could get to the playground and buildings from the other side.
