Comparison of the noise levels measured in the vicinity of a wind farm for shutdown and operational conditions

Kristy HANSEN¹; Branko ZAJAMŠEK¹; Colin HANSEN¹

¹ University of Adelaide, Australia

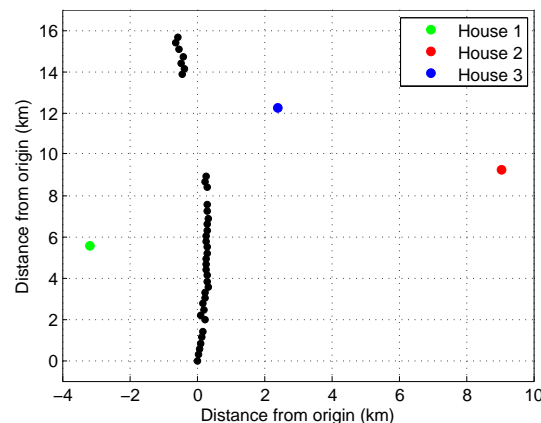
The location of the residences relative to the wind farm is shown in Figure 1. House 1 is situated 3.5 km from the nearest wind turbine, which is near the centre of the main turbine group. The downwind direction from the closest wind turbine to the residence is 88° . It is estimated that this residence was built in the early 1900's. The walls are constructed of 350 mm thick stone/cement brick, the windows are a small-medium, single-pane, wood-framed sash design and the roof is constructed from corrugated sheet steel. The ceiling consists of plaster panels and the ceiling space has recycled paper insulation. This house was unoccupied for the duration of the measurements. House 2 is 8.7 km from the nearest wind turbine which is the northernmost turbine of the main group. The downwind direction from the closest wind turbine to the residence is 268° . For the indoor measurements, a small cottage was used which is separated from the main residence by about 10 m. The walls of the cottage are constructed of stone and the roof consists of corrugated sheet steel. The ceiling is constructed of wooden panels and there are two medium-sized windows, one of which faces towards the wind farm. House 3 is 3.3 km from the nearest wind turbine, which is the southernmost turbine in the smaller northern group. The downwind direction from the closest wind turbine to the residence is 300° . The walls of this residence are constructed of concrete and the roof consists of corrugated sheet steel. The indoor instrumentation was located in the room closest to the wind farm, which has one medium-sized window facing the wind farm. The house was occupied during the measurement period but the results presented in this paper were collected between 12 am and 5 am for this residence, during which time indoor disturbances were expected to be minimal.

Figure 1 – Layout of residences relative to the Waterloo wind farm.

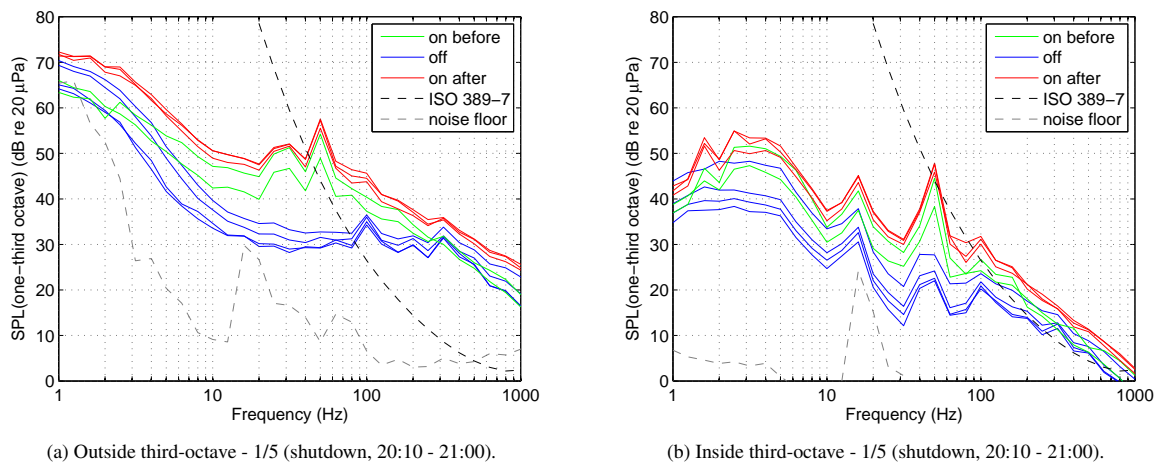
The unweighted 10-minute averaged third-octave spectra for the shutdown and operational cases are shown in Figure 2 and Figure 3. The curve labelled “ISO 389-7” corresponds to the generally accepted threshold of hearing for normal ears subjected to steady tonal noise. The outdoor and indoor noise levels measured during the shutdown cases were consistently lower than those measured when the wind farm was operating. This can be observed for the entire frequency range from 1 Hz to 1000 Hz. Comparison between Figure 2 (a) and (b) and Figure 3 (a) and (b) reveals that the increased noise levels can also be observed for operational conditions selected based on matching wind speed conditions.

The most significant difference in the spectra occurs for the 50 Hz third-octave band, where the sound pressure level difference between shutdown and operational cases can be more than 25 dB for both outdoor and indoor measurements. The high sound pressure level in this third-octave band observed during operational conditions cannot be attributed to electrical noise as it is not present when the wind farm is shut down. In comparison to the SA EPA study (7) results, the difference between shutdown and operational levels in this third-octave band is much larger, where the outdoor operational levels in the 50 Hz third-octave band, measured at the same residence by the EPA, were closer to 45 dB (instead of the 58 dB shown in Figure 2 (a)) and the shutdown levels are similar to those shown in Figure 2 (a) and Figure 3 (a) giving a difference of approximately 15 dB. The indoor levels for this residence reported by the SA EPA (7) were also much lower than those presented in Figure 2 (b) and Figure 3 (b) and were close to 30 dB. Contrary to the EPA report (7) findings, the data in Figure 2 and Figure 3 shows that the noise in the 50 Hz third-octave band, associated with operational conditions, would be audible both indoors and outdoors to a person with normal hearing according to ISO 389-7 (12). In addition, the peak in the 50 Hz third-octave band is more than 15 dB higher than the level in the adjacent third-octave bands for the indoor results. According to guidelines specified in standards such as NZS 6808:2010 (8) and ANSI S12.9 - Part 4 (13), this would be classified as a tone and hence an adjustment to the allowable wind farm noise limits would be required. According to the SA EPA standard (14), a penalty of 5 dB(A) would need to be added to the measured noise level in the case of identified tonality. The results in this report suggest that this would lead to non-compliance at the Township residence but the EPA study (7) results indicate that the wind farm would still be compliant.

Figure 2 – Comparison of third-octave spectra for House 1 before/during/after shutdown.

The outdoor results shown in Figure 2 (a) and Figure 3 (a) also indicate that the sound pressure level in

the third-octave bands from 25 Hz to 40 Hz is higher when the wind farm is operating. On the other hand, the indoor results shown in Figure 2 (b) and Figure 3 (b) do not show peaks in the sound pressure level at these frequencies. It is possible that the noise level in this third-octave band varies with room position due to the presence of room resonances and thus the average results would not reflect the worst case scenario for indoor noise. The large difference in the sound pressure level indoors relative to outdoors was also shown in the SA EPA report (7) for these third-octave bands. Another characteristic that can be attributed to wind farm operation are the peaks in the infrasonic frequency range which appear to correspond to harmonics of the blade-pass frequency. Additionally, a significant peak is evident in the 16 Hz third-octave band for the indoor results. While this peak is present for both operational and shutdown conditions, the level is consistently higher when the wind farm is operating, by as much as 15 dB. It is believed that there is a structural resonance of the residence in this frequency range which is excited by both wind induced noise and wind farm noise. It has been found previously that structural resonances occur in the range of 12-30 Hz, according to data measured for several different housing structures (15).

The most significant difference between the narrow-band plots associated with shutdown and operational conditions is the general absence of tonal peaks and broadband peaks for the shutdown cases as shown in Figure 6. The 50 Hz narrowband peak in Figure 6a shows an obvious exception, but this peak is related to electrical noise associated with some aspect of the NI data acquisition system, which is confirmed by its absence in the third-octave spectra measured with the SVAN 958 sound level meter, which was presented in Figures 2a and 3a.

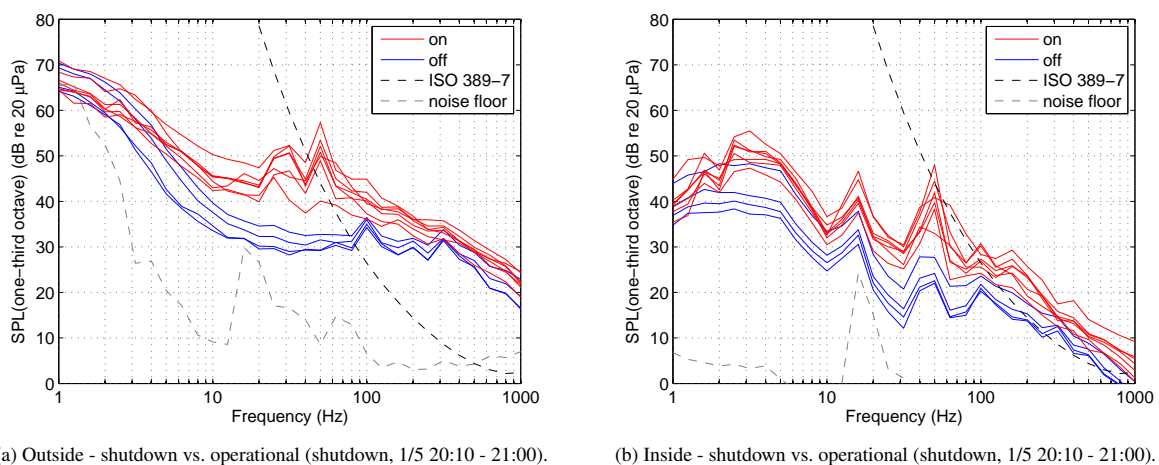
Figure 3 – Comparison of third-octave spectra for House 1 with wind conditions matching the wind farm shutdown.

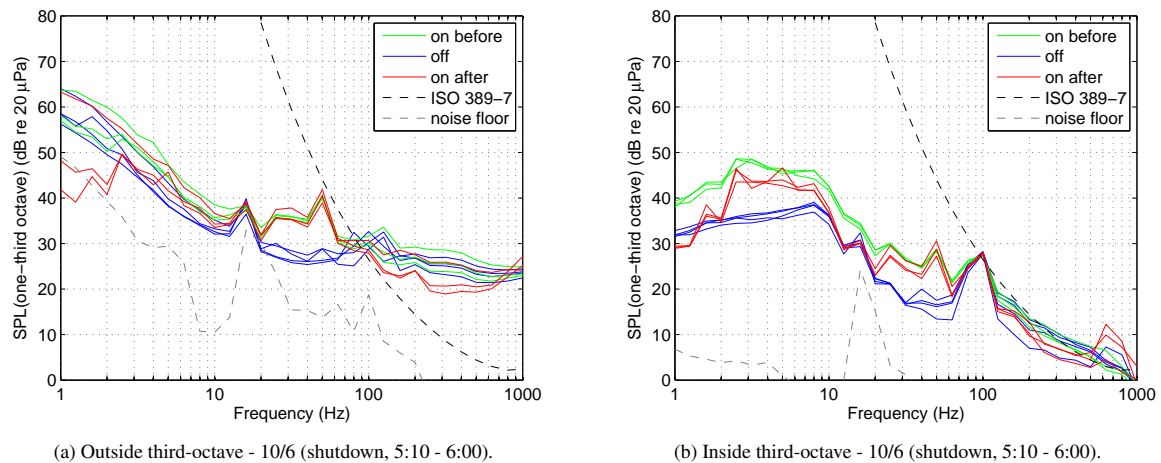
The unweighted 10-minute averaged third-octave spectra for the shutdown and operational cases are shown in Figure 4 (a) and Figure 4 (b) for the residence which is 8.7 km from the wind nearest wind turbine. The outdoor noise levels measured during the shutdown cases were consistently lower than those measured when the wind farm was operating for all the third-octave bands between 20 Hz and 63 Hz. For the indoor results, the noise levels were lower during shutdown for almost all third-octave bands below 80 Hz. The increased noise levels can also be observed for operational conditions selected based on matching wind speed conditions but the corresponding results are not shown here.

Consistent with Section 3.1.1, the most significant difference in the spectra occurs for the 50 Hz third-octave band, where the sound pressure level difference between shutdown and operational cases can be higher than 15 dB for both outdoor and indoor measurements. The plots shown in Figure 4 indicate that the outdoor noise in the 50 Hz third-octave band is close to the audibility threshold for a person with normal hearing, which is defined in ISO 389-7 (12). However, as discussed in Section 1, wind turbine noise is highly variable with time and therefore it is expected that peak noise levels would be much higher than the 10-minute average levels. Hence, noise in the 50 Hz third-octave band is likely to be audible outside and possibly inside to a person with normal hearing according to ISO 389-7 (12).

Figure 4 – Comparison of third-octave spectra for for House 2 before/during/after shutdown.

The outdoor and indoor results shown in Figure 4 (a) and Figure 4 (b) also indicate that the sound pressure levels in the third-octave bands from 25 Hz to 40 Hz are higher when the wind farm is operating as was observed in Section 3.1.1. This unduly influences the tonality assessment outlined in the NZS 6808:2010 (8) and ANSI S12.9 - Part 4 (13) standards. Another characteristic noted in Section 3.1.1 that can be attributed to wind farm operation are the peaks in the infrasonic frequency range, which appear to correspond to harmonics of the blade-pass frequency of 0.8 Hz. These peaks are more noticeable indoors where the contribution from wind-induced noise would be expected to be much lower.

The peak in the 100 Hz third-octave band is most likely attributable to a transformer, which was located nearby the residence and this explains why it was present when the wind farm was shutdown.

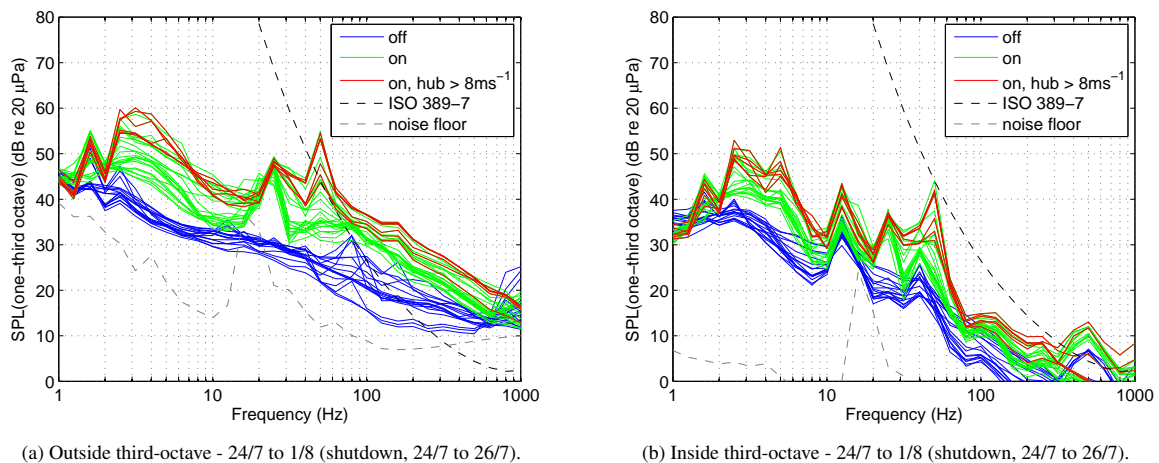
Unweighted third-octave spectra corresponding to a period during which the entire wind farm shut down due to the presence of a cable fault are shown in Figure 5 (a) and Figure 5 (b). To minimise interference from wind-induced noise and other extraneous noise sources, the measurements for comparison were selected during nighttime hours between 12 am and 5 am when the wind speed measured at 1.5 m in the vicinity of the microphones was 0 m/s. Due to wind shear, the wind speed at hub height was non-zero and for all results shown in Figure 5 (a) and Figure 5 (b), it was greater than 6.5 m/s.

As was noted in Section 3.1.1 and Section 3.1.2, the largest difference in the spectra occurs for the 50 Hz third-octave band, where the sound pressure level difference between shutdown and operational cases can be higher than 30 dB for both outdoor and indoor measurements. The plots shown in Figure 5 (a) indicate that the outdoor noise in the 50 Hz third-octave band is at least 10 dB higher than the audibility threshold for a person with normal hearing, which is defined in ISO 389-7 (12). The corresponding indoor results shown in Figure 5 (b) indicate that the noise in the 50 Hz third-octave band was extremely close to the audibility threshold (12). However, since wind turbine noise is highly variable with time, it is expected that peak noise levels would be much higher than the 10-minute average levels. Therefore, it is highly likely that noise in the 50 Hz third-octave band is audible outside and possibly inside to a person with normal hearing according to ISO 389-7 (12).

Figure 5 – Comparison of third-octave spectra for House 3 during/after cable fault.

The outdoor and indoor noise levels measured during the shutdown cases were consistently lower than those measured when the wind farm was operating for the majority of third-octave bands between 1 Hz and 1000 Hz. Moreover, the noise levels measured when the hub height wind speed was greater than 8 m/s were in general, the highest noise levels recorded, as shown by the red-coloured plots in Figure 5 (a) and Figure 5 (b). This provides evidence of a strong correlation between significant increases in low frequency noise and infrasound, and wind farm operation.

Comparison between the outdoor results presented in Section 3.1.1 indicates that the level of broadband infrasound shown in Figure 5 (a) is significantly lower for House 3 than for Houses 1 and 2 when the wind farm is switched off, due to the absence of wind-induced noise. As a result, peaks at blade-pass harmonics are much more distinct and the sound pressure level measured in adjacent third-octave bands is as much as 15 dB lower. As was observed in Section 3.1.1 and 3.1.2, higher sound pressure levels are also associated with the third-octave bands from 25 Hz to 40 Hz when the wind farm is operational, particularly when the wind speed at hub height is greater than 8 m/s. Furthermore, a distinct peak at 12.5 Hz can be identified for the indoor results only, although the associated wavelength is too large to indicate room resonance effects. Therefore, it is likely that this is a structural resonance which is related to the construction properties of this residence.

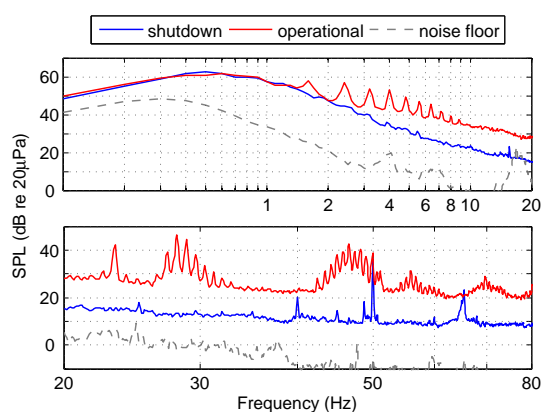
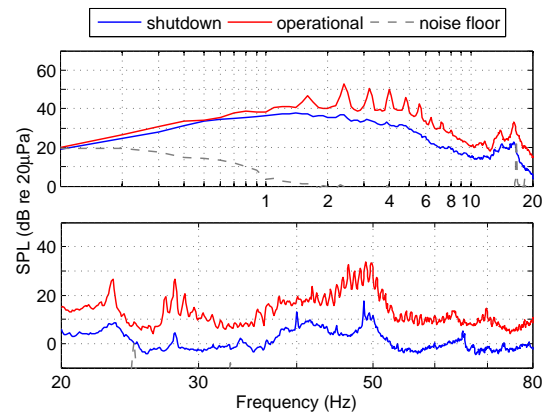
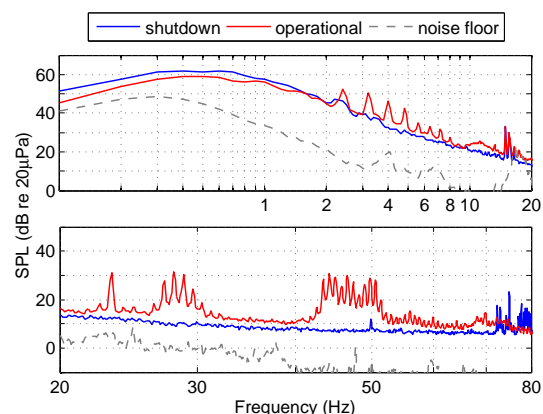
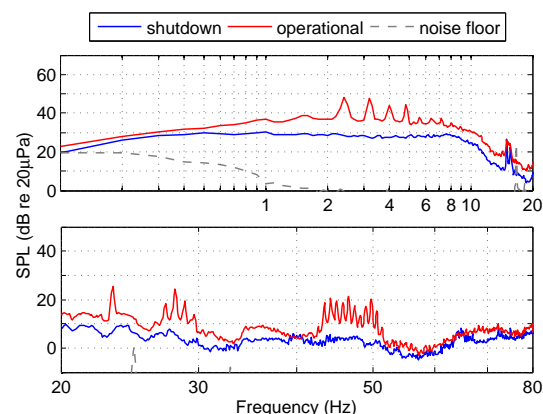
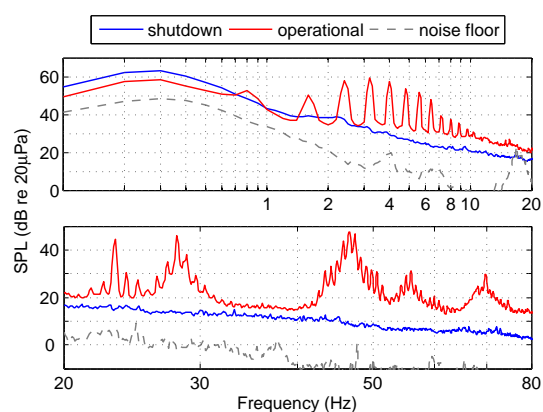
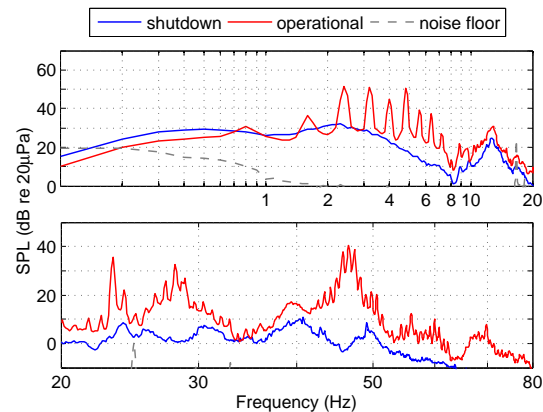
The narrow-band spectra depicted in Figure 6 show results for one 10-minute average measured during wind farm shutdown and another 10-minute average measured during wind farm operation. Identical analysis periods have been selected for the outdoor and indoor results and therefore the spectra are shown in adjacent figures. Selection of the operational periods was based on the prominence of tonal peaks and amplitude modulation for the 10-minute periods of analysis that were presented in Section 3.1. The shutdown measurements depicted in Figure 6 correspond to the lowest 10-minute sound pressure levels that were measured when the wind farm was shut down.

Figure 6 – Comparison of outdoor and indoor narrow-band spectra with local wind conditions similar to wind farm shutdown conditions

The infrasonic peaks that appear in the spectra exclusively during operational conditions are consistently harmonics of the blade-pass frequency of 0.8 Hz. This blade-pass frequency is expected for Vestas V90-3MW wind turbines, which have a nominal speed of 16.1 rpm (16). The first set of harmonics begins either at the fundamental frequency of 0.8 Hz, as shown in Figure 6e and 6f, or the second harmonic of 1.6 Hz, as indicated in Figures 6a to Figure 6d. The detectability of the fundamental peak at 0.8 Hz appears to be directly related to the amplitude of broadband infrasound present below 1 Hz. The harmonics extend to the 11th harmonic of 8.8 Hz and sometimes slightly higher.

Another consistent feature of the narrow-band spectra for operational conditions is the presence of low frequency peaks at 23.3 Hz, 28 Hz, 46.6 Hz, 56 Hz and 69.9 Hz, which are most evident in the outdoor spectra shown in Figures 6a, 6c and 6e. It appears that the fundamental frequencies of these peaks are 23.3 Hz and 28 Hz and that the other peaks are harmonics. Each of these low frequency peaks has side-bands, which are spaced at the blade-pass frequency and appear to be most numerous around the peak at 46.6 Hz, where there can be up to seven peaks on either side of the main peak. Further insight into the origin of these peaks and side-bands can be gained through determining if they are exact multiples of the blade-pass frequency. In this case it is possible that some harmonics of the blade-pass frequency are selectively amplified, perhaps as a consequence of cavity resonance between the turbine blade and tower (17). On the other hand, if the peaks and side-bands are not exact multiples of the blade-pass frequency then it is probable that the tonal peaks represent tonal noise that is amplitude modulated at the blade-pass frequency.

To determine whether the peaks and side-bands are harmonics of the blade-pass frequency, the frequency resolution of the narrow-band analysis for the measurement shown in Figure 6e was increased to 0.0017 Hz, enabling more accurate calculation of the blade-pass frequency to give 0.8033 Hz. Selected peaks are shown as well as adjacent side-bands, where applicable, in Table 4. The frequencies that correspond to an exact multiple of the blade-pass frequency are highlighted in grey. The results indicate that all except one infrasonic peak is an exact multiple of the blade-pass frequency. On the other hand, only four peaks in the low frequency range above 20 Hz appear to be exact multiples of the blade-pass frequency. Nevertheless, if the peak at 27.993 Hz is considered to be the 35th harmonic then the associated blade-pass frequency would be 0.7998 Hz, a variation of only 0.0035 Hz, which is in the same order of magnitude as the frequency resolution of the narrow-band analysis. These results indicate that the tonal peaks and sidebands could either be related to selective amplification of the blade-pass frequency harmonics which are generated according to spinning mode theory (17) or they could be associated with gearbox vibration which is transmitted to the tower and blades and re-radiated as sound. The tower and blades provide large surface areas for radiating sound and variation in gearbox loading due to changes in aerodynamic forces on the blades could account for the amplitude modulation.

The data presented for the indoor results below 6 Hz is uncalibrated and hence does not reflect the true sound pressure level for these frequencies. However, peaks at the blade-pass frequency and harmonics shown in Figures 6b to 6f indicate that the microphone is still capable of measuring (albeit with decreased accuracy) below 6 Hz.

The results show that there is little attenuation of the signal from outdoors to indoors below a frequency of 80 Hz. The tonal peaks and side-bands corresponding to operating conditions, which were observed for the outdoor measurements, are still clearly distinguishable for the indoor results. The spectra corresponding to shutdown conditions contain some small peaks that did not exist in the outdoor results. These peaks can be
