KATHERINE LANDCARE GROUP INC.

The Katherine Landcare Group has been active in the Katherine River Catchment since 1996. The Katherine River Catchment incorporates the King River sub-catchment and consequently the proposed site for the Fishers Ridge Nuclear Waste Site. The Group opposes the site selection process and the selection of the Fishers Ridge site for the proposed Nuclear Dump.

LAND DEGRADATION ASSOCIATED WITH SINKHOLE DEVELOPMENT IN THE KATHERINE REGION

Technical Report No 11/2002

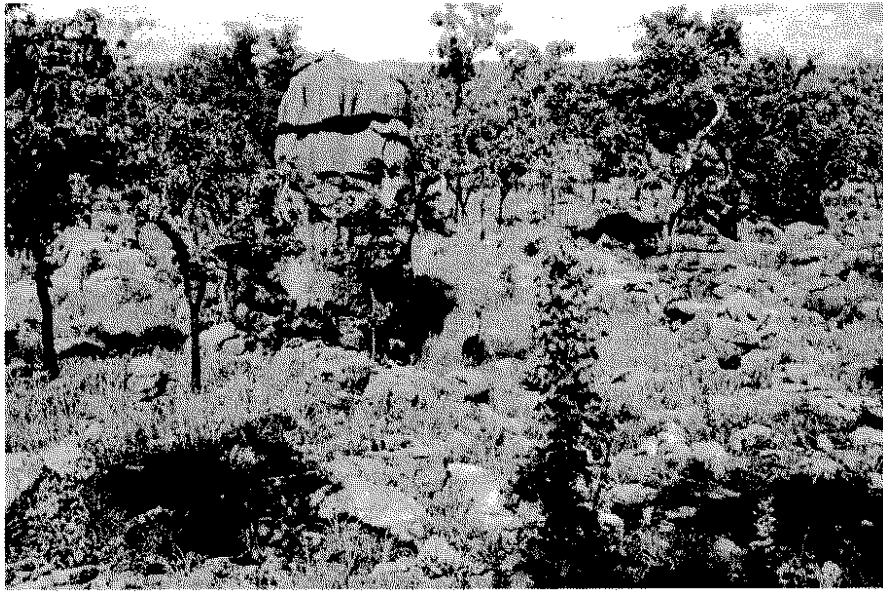
Plate 5 Pinnacle karst in Cutta Cutta Nature Park

Reliefs composed of karst pinnacles are shown in Plates 4 and Plate 5 with Plate 6 showing a limestone ridge in the Cutta Cutta cave region.

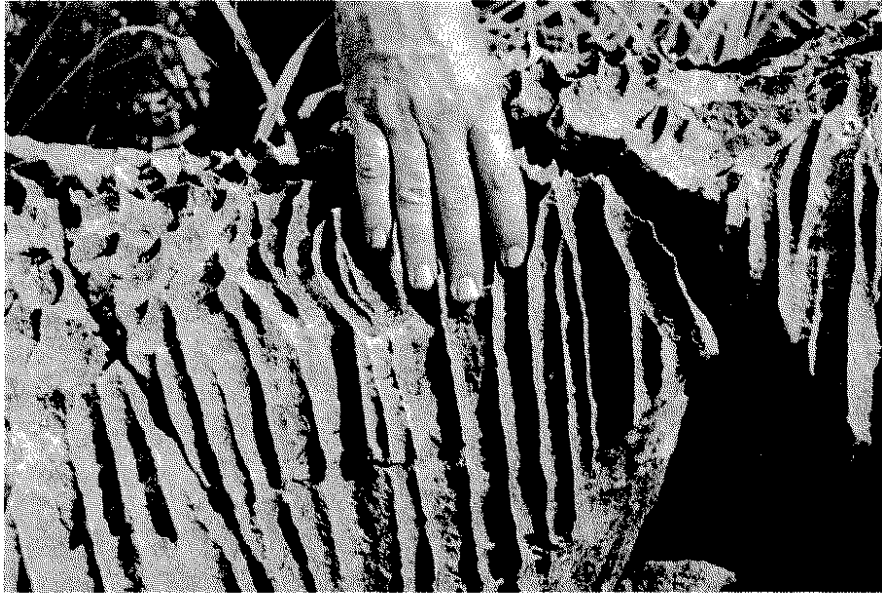
Plate 7 Rillenkarren forms on the Tindall Limestone northwest of Cutta Cutta Caves

by sharp ridges 2-3 centimetres apart. This is common in the Cutta Cutta Nature Park area and is shown in Plate 7.

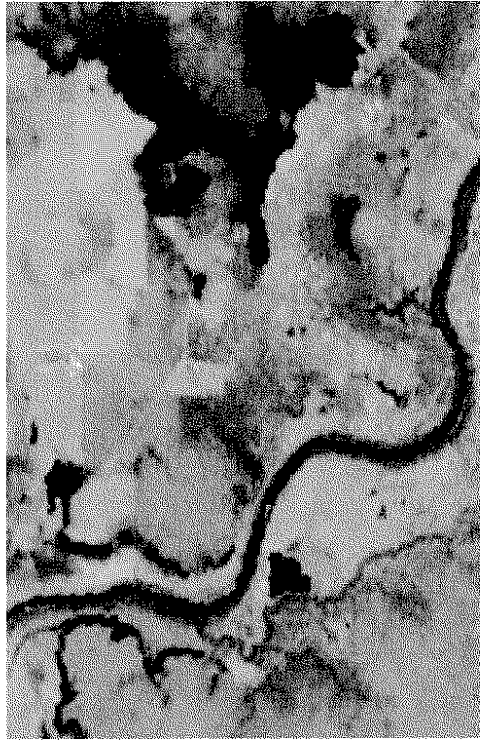
Plate 8 Satellite image showing a polje (black area, top) flooded in March 1998, located north of Katherine town between Stuart Highway, Zimin Drive and Florina Road

A satellite image of the polje known as Lake Hickey is shown in Plate 8.

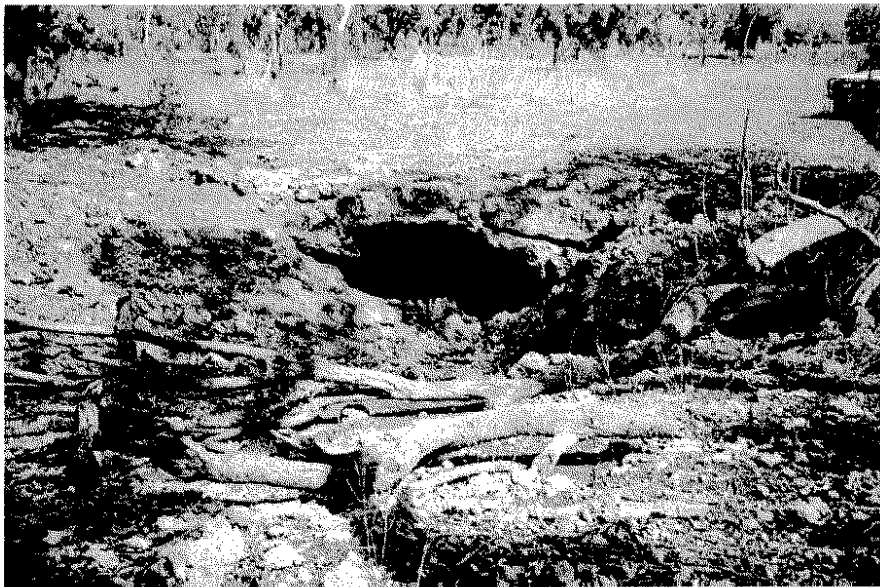
Plate 9 Example of a sinkhole formed by cave roof collapse, located north of Zimin Drive and east of Florina Road

Plate 9 shows a typical collapse sinkhole formed on a section of the bare, exposed Tindall Limestone outcrop. A typical suffosion sinkhole is shown in the photograph taken during a helicopter reconnaissance in March 2001 (Plate 10).

suffosion/collapse and solution /collapse types with slightly more in the suffosion/collapse type. Diagrams of a collapse sinkhole formation are shown in Figure 6. Only one sinkhole of this type was observed in the study area (See Plate 9).

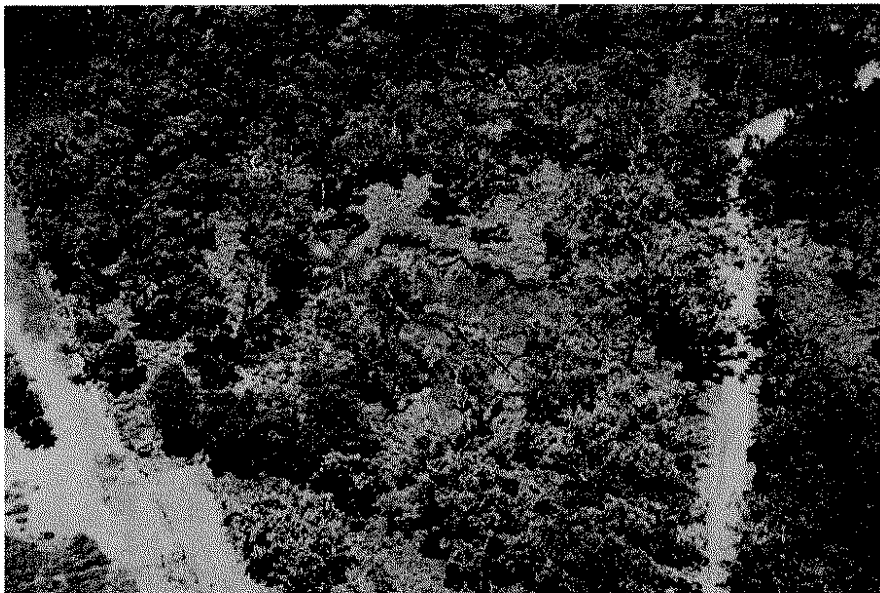
Plate 10 Example of suffosion sinkhole formed in Cutta Cutta Nature Park (AMG co-ordinate 53L 227250-8385500)

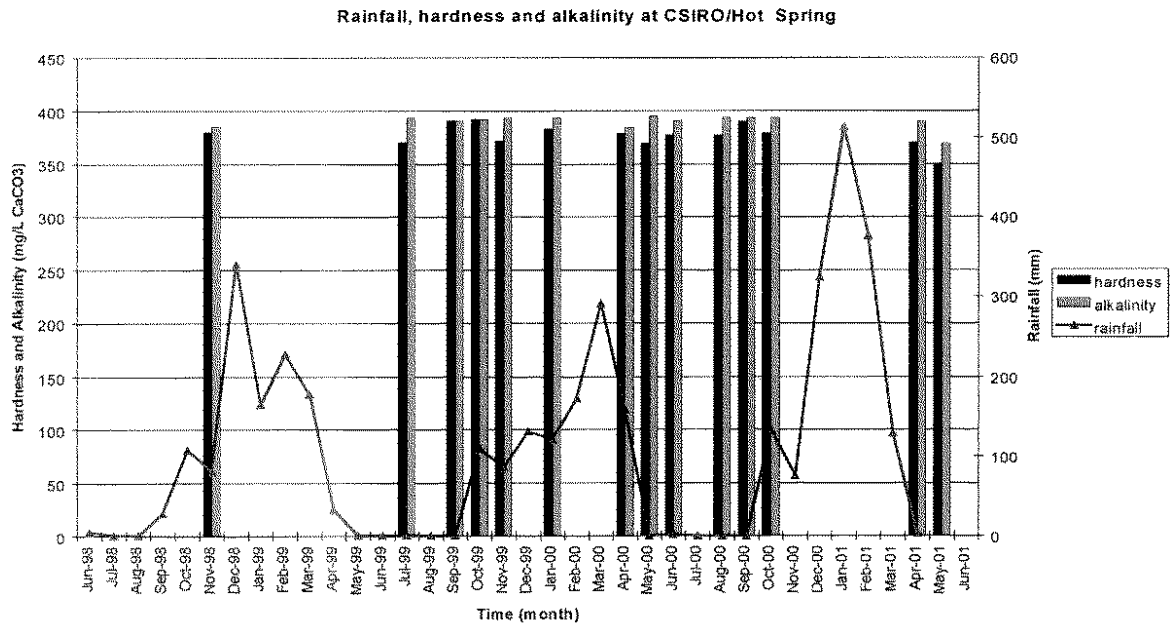
Figure 10 Hydrograph and chemograph of the CSIRO/Hot Spring G8140312 at AMG coordinate 53L 203800-8397300

Springs flows show discharge variations controlled by rainfall but no significant changes in water quality (alkalinity and hardness) were observed (Figure 10, 11 and 12). It is likely that the frequency of sampling was inadequate to provide data for more comprehensive (discrete) analysis of water quality changes in the Tindall aquifer. Such changes may be detectable if automatic data loggers (recording per hour) were installed in the springs. In summary, the response of aquifer water quality to recharge was not readily detectable from the data collected during this study.

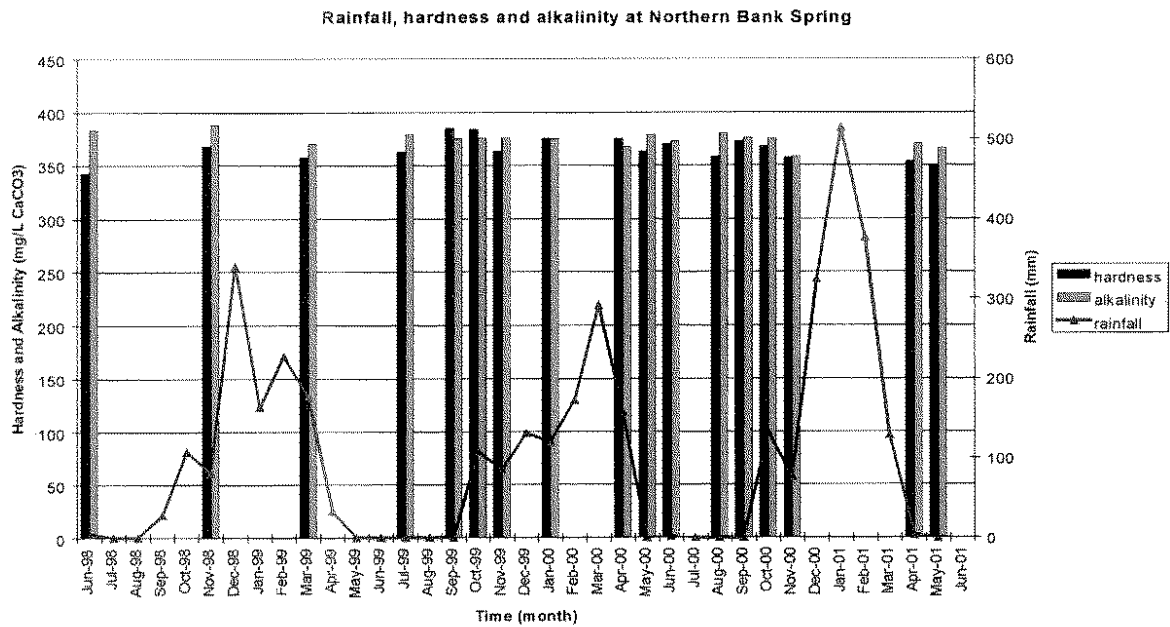
Figure 11 Hydrograph and chemograph of the Northern Bank Spring G8145358 at AMG coordinate 53L 203528-8397324

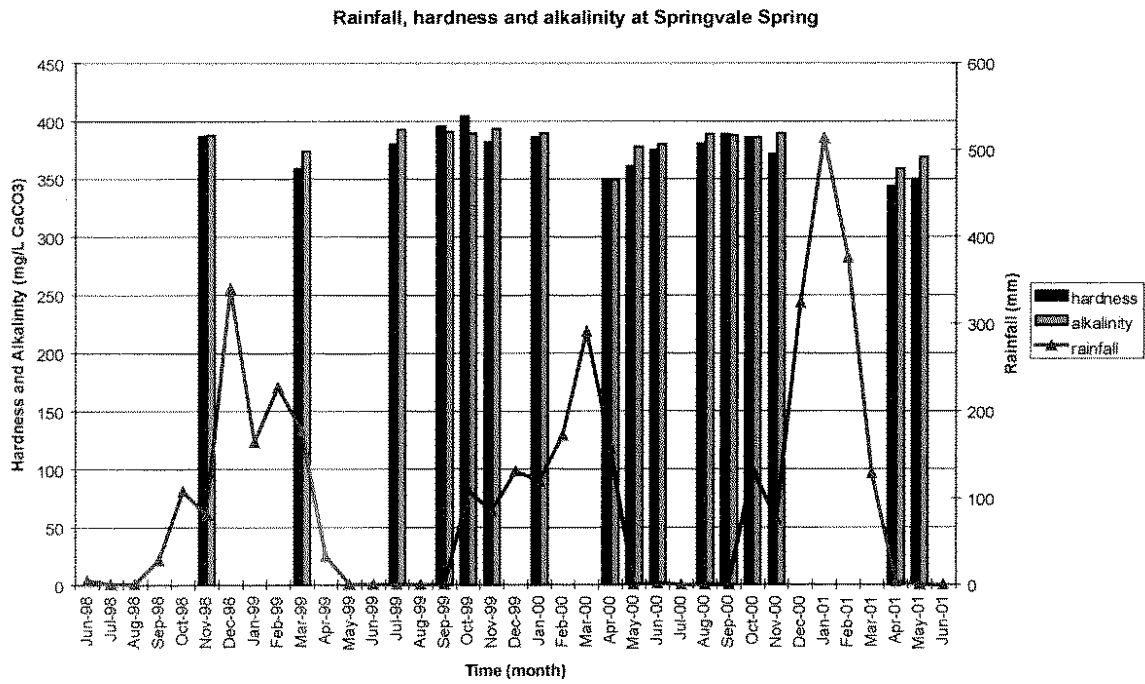
Figure 12 Hydrograph and chemograph of the Springvale Spring G8140317 at AMG coordinate 53L 201615-8395300

Spring G8140317 shows the biggest response to rainfall whereas G8125358 shows fairly stable flow throughout the year. A few big springs exist in the bed of the Katherine River between the Railway Bridge and Low-Level Crossing but in this investigation, the specific locations of the springs were unknown.

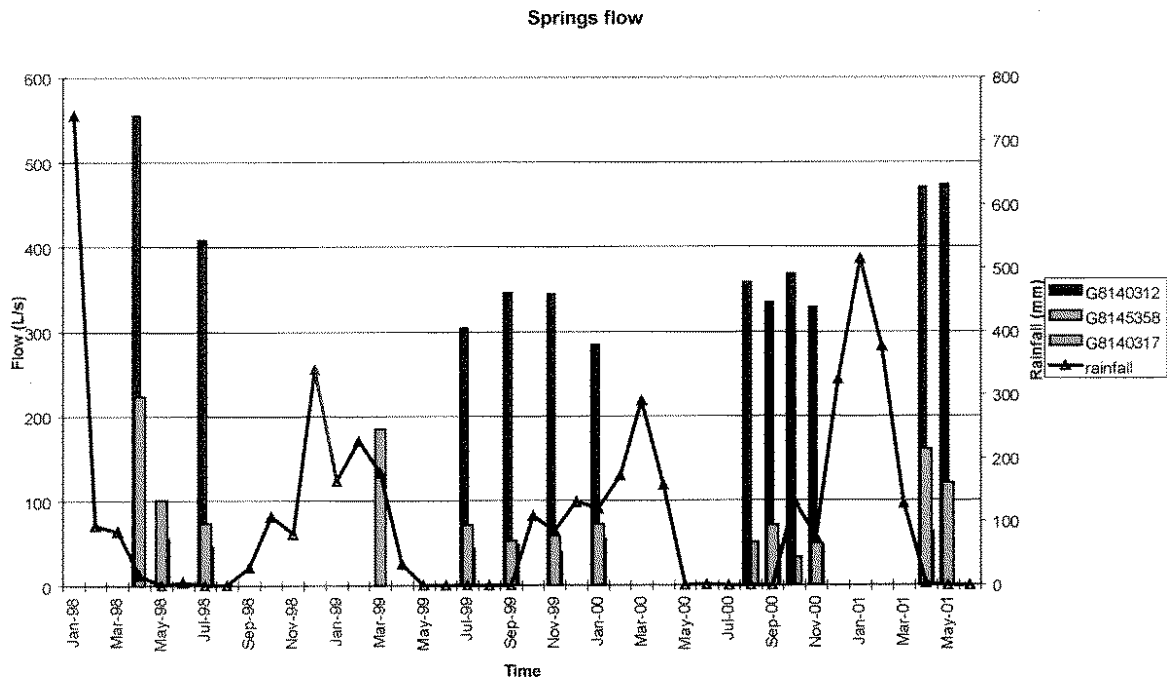
Figure 13 Springs flow for G8140312, G8145358, G8140317 and rainfall data obtained during the 1998-2001

Springs discharge was measured monthly (Figure 13), however during the wet season between December and March, the Katherine River level was above the springs level. Springs are located in the Katherine River Valley only slightly above "dry season" river levels. As result, after December rains, springs are not accessible. As expected, spring flow shows a marked response to rainfall with the biggest flow recorded after the 1998 flood. From three observed springs:

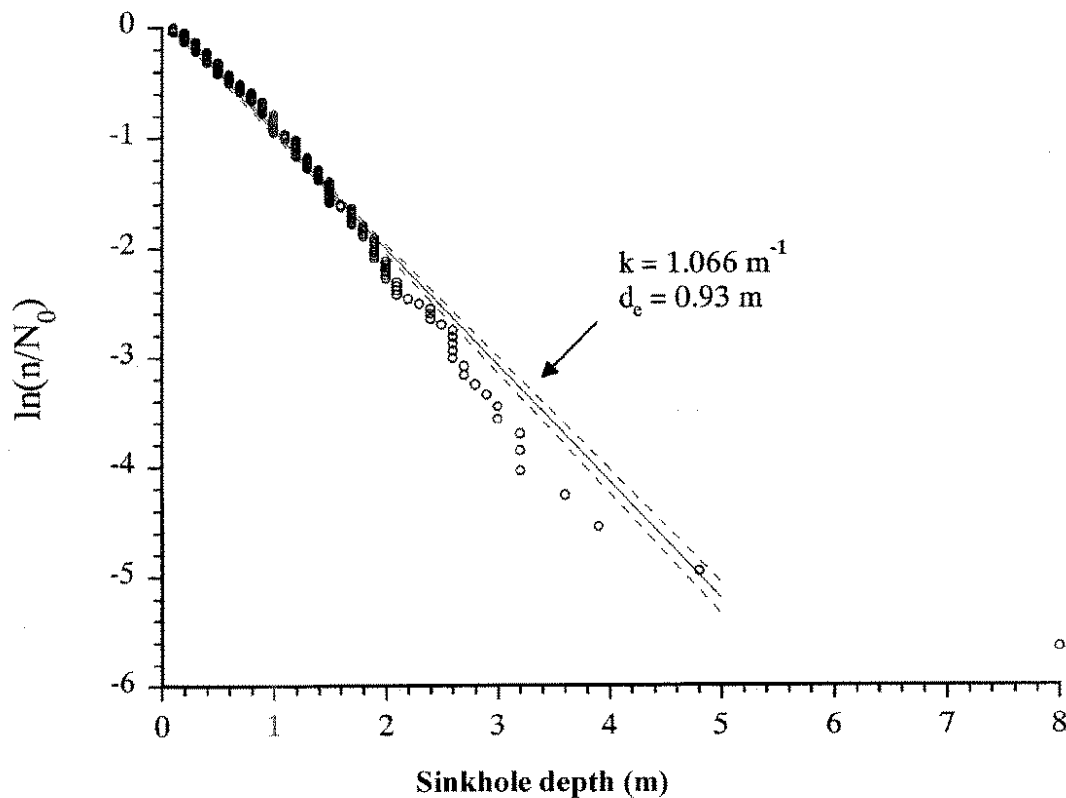
**Figure 16** Depth-rank relationship for 283 sinkholes in the Tindall karst

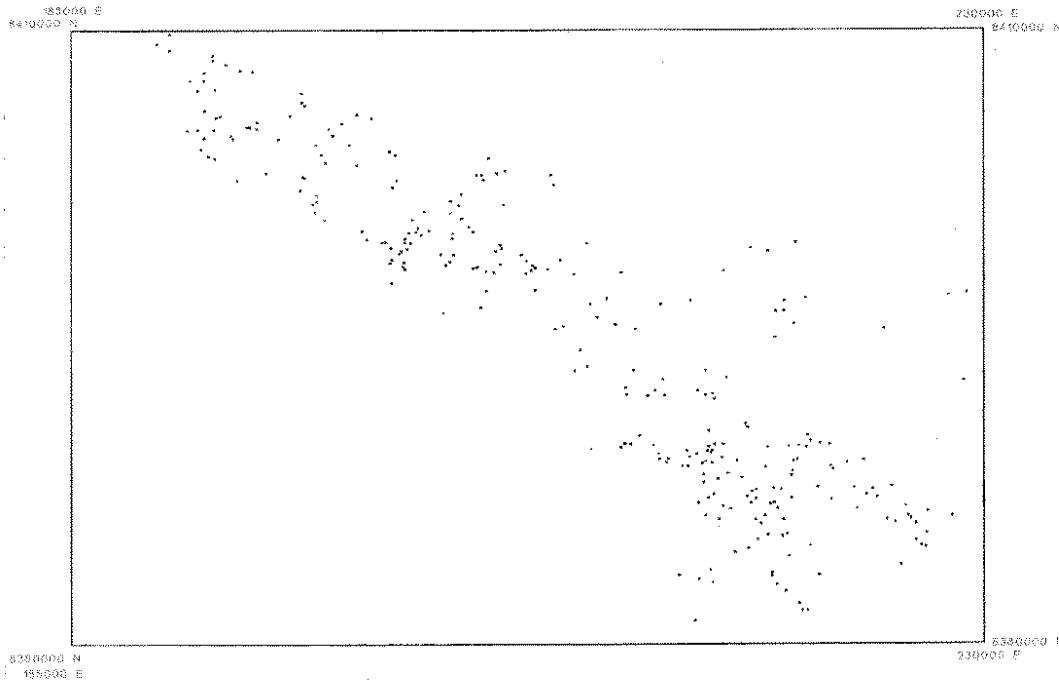
Figure 23 Map showing sinkhole distribution in the study area

During the desktop study and subsequent field reconnaissance, 283 sinkholes were identified and assessed. These are shown in Figure 23.

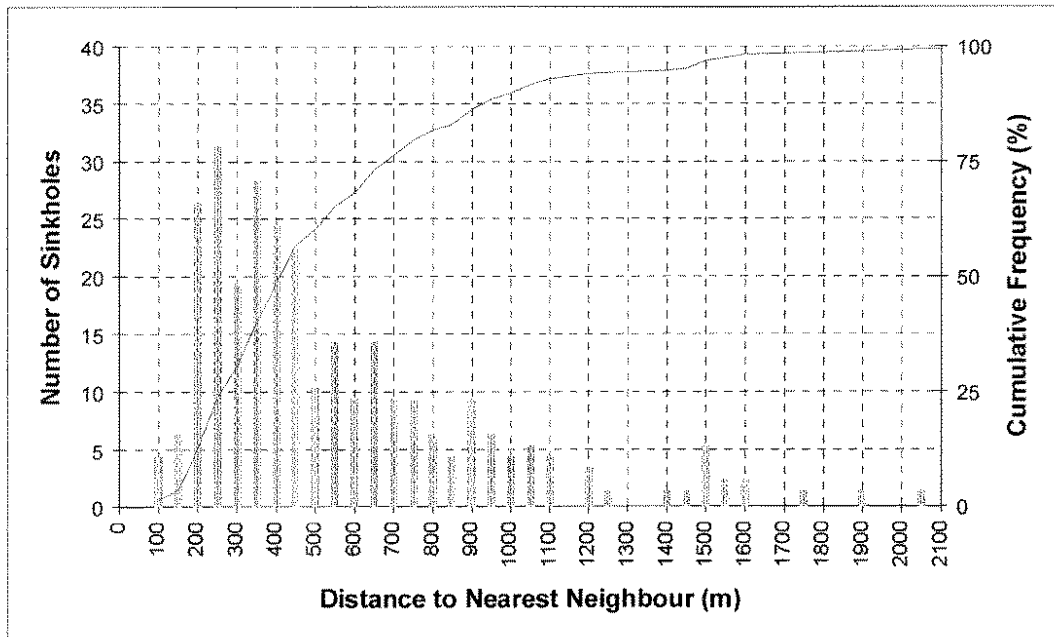
Figure 24 Histogram and cumulative frequency of nearest-neighbour distances of sinkholes in Tindall Limestone. The mean distance = 539 m; median = 404 m; Stan.dev = 454 m

0.8 shows that sinkhole distribution in Tindall Limestone area of Katherine region is essentially random.

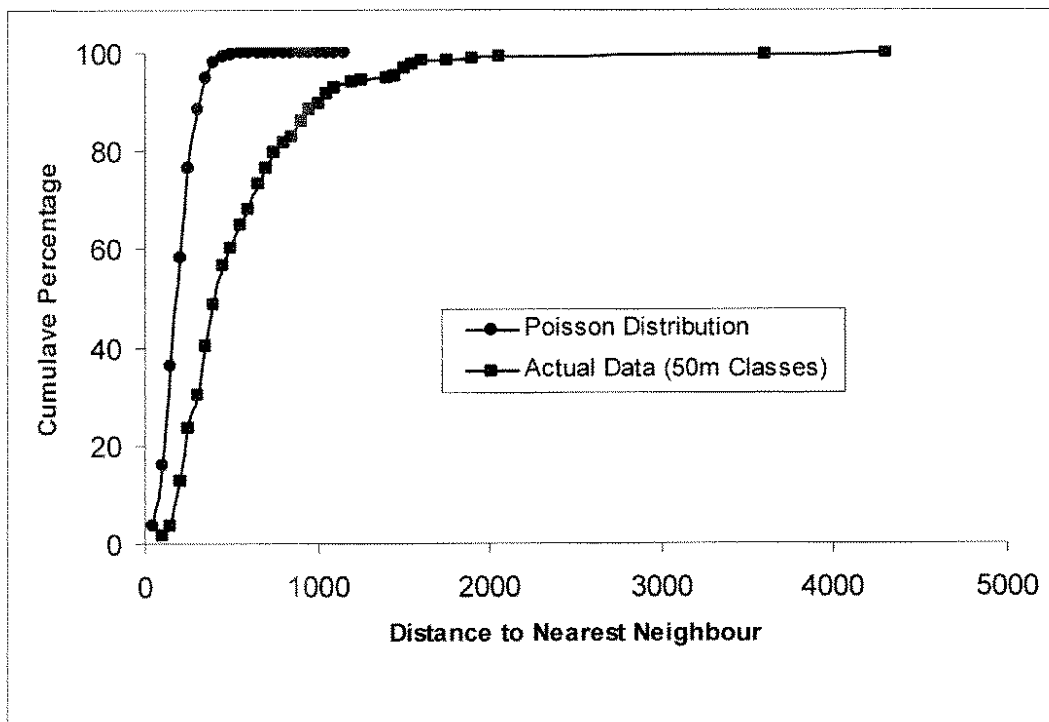
Figure 25 Nearest neighbour and Poisson distribution of sinkholes in the study area.
